PRELIMINARY REPORT

**ALBUQUERQUE STORM WATER PUMPING STATIONS
REHABILITATION STUDY - PHASE I
STATIONS : 26, 27, 32, 34, 35, 36, 37,
AND ALCALDE (PROPOSED)**

BOVAY ENGINEERS, INC.

BELL/COMMERCIAL S.E. STATION NO. 37

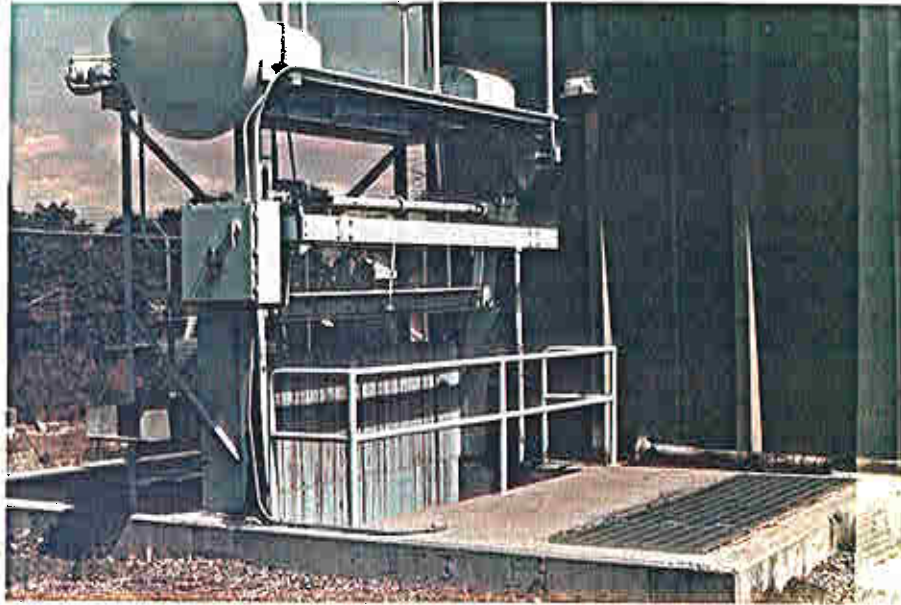
- D. This station is equipped with a 5-ton capacity overhead hoist/crane. Due to the space constraints within the station, any retrieval of equipment from the dry well would require the dismantling of a motor/pump unit. The hoist/crane may be able to be extended a few feet east along the ceiling in order to be positioned over open areas. The latter suggestion would allow retrieval of some dry well equipment via hoisting without motor dismantling. A floor jack and gantry crane equipment located in the dry well would greatly facilitate equipment removal.
- E. A vertically cleaned mechanical bar screen was observed in operation here. The device operates quite well with trash screenings collected at ground level. Some sediment has collected at the entrance channel basin which needs manual removal. See Photo No. 1.

PHOTO NO. 1
VERTICALLY CLEANED, MECHANICAL BAR
SCREEN AT ENTRANCE TO STATION.
(BELL & COMMERCIAL STATION NO. 37)

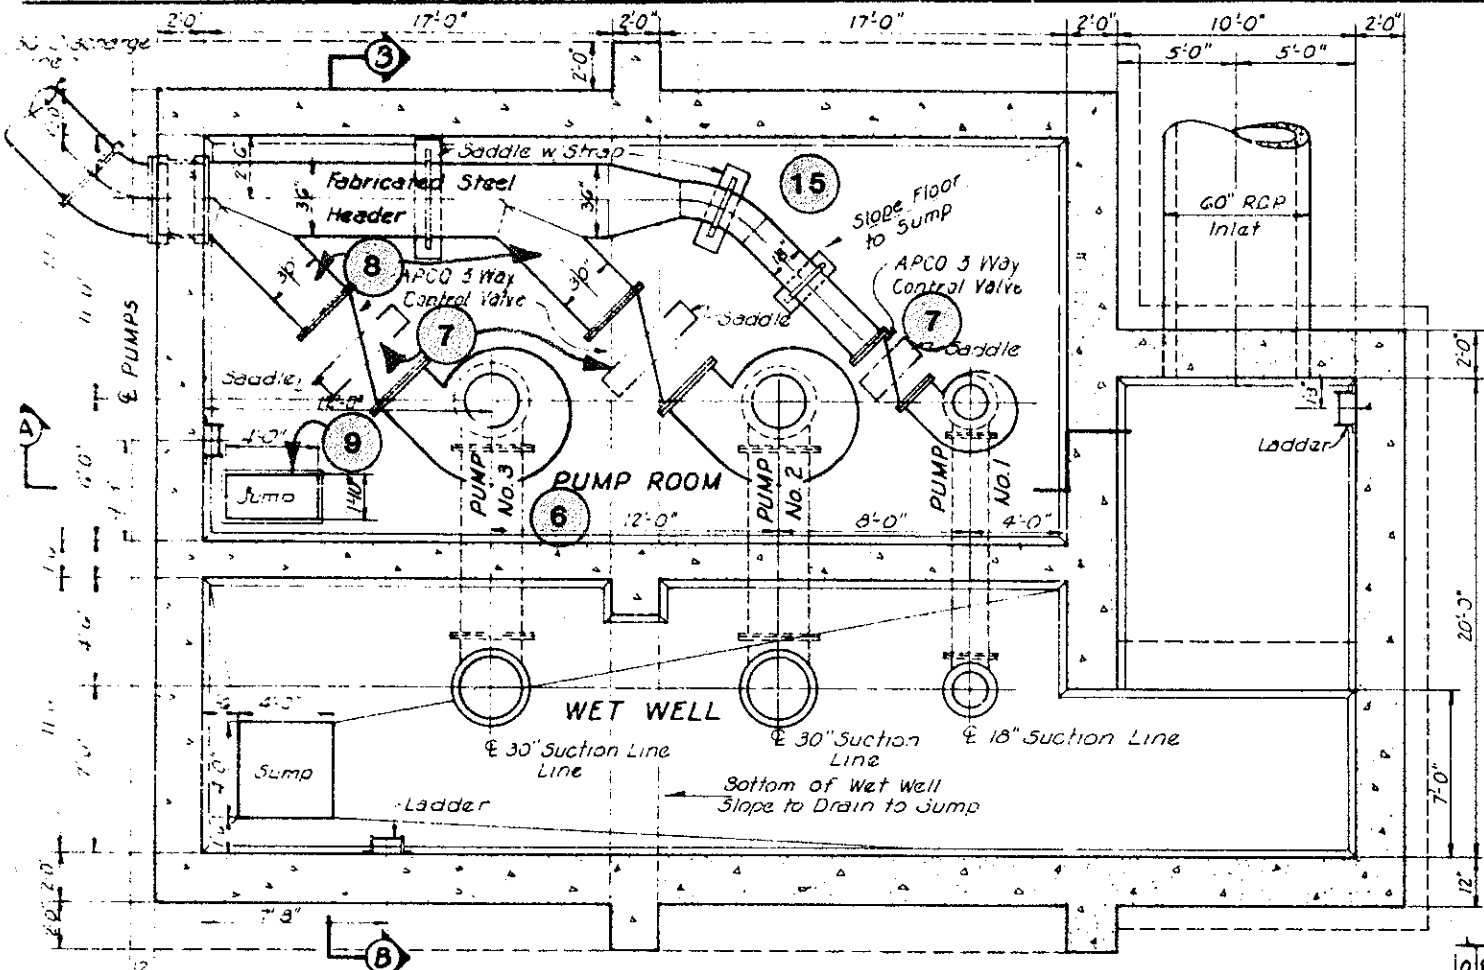
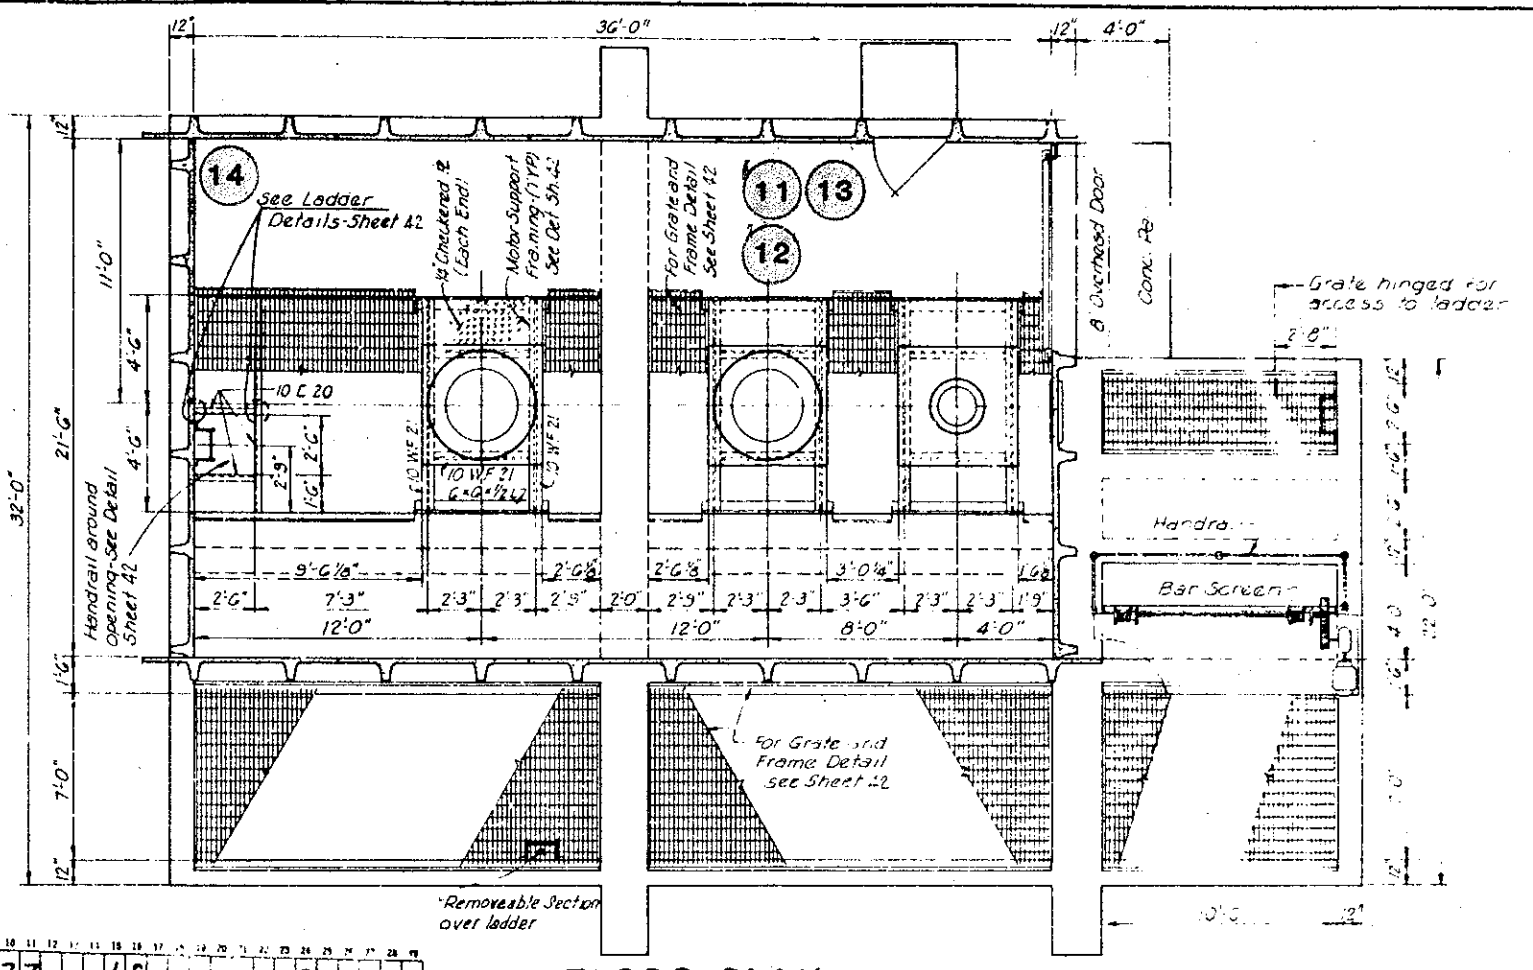
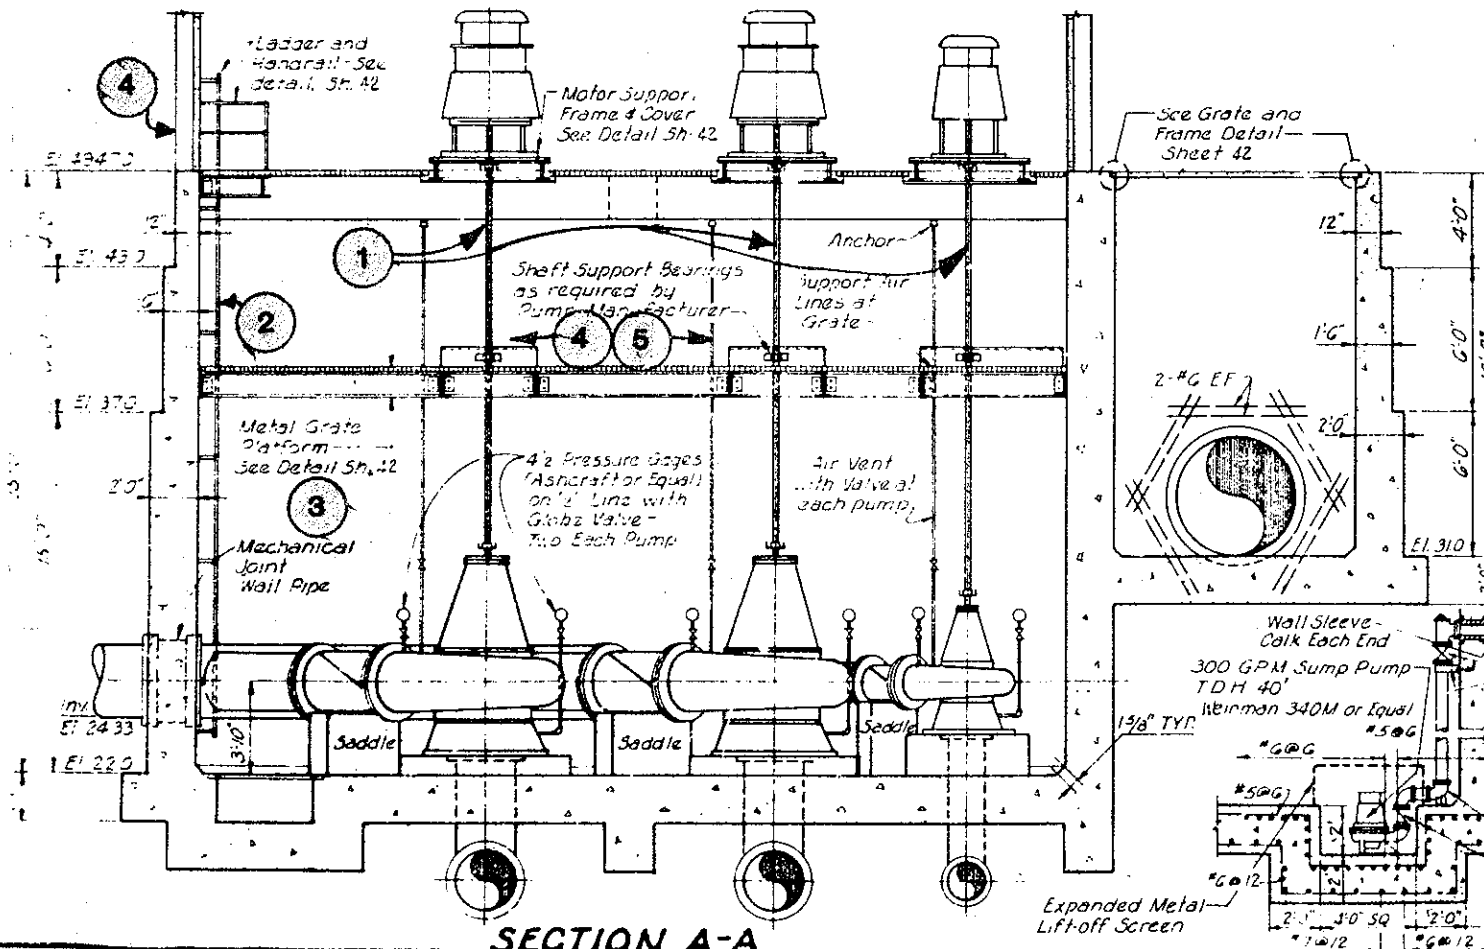
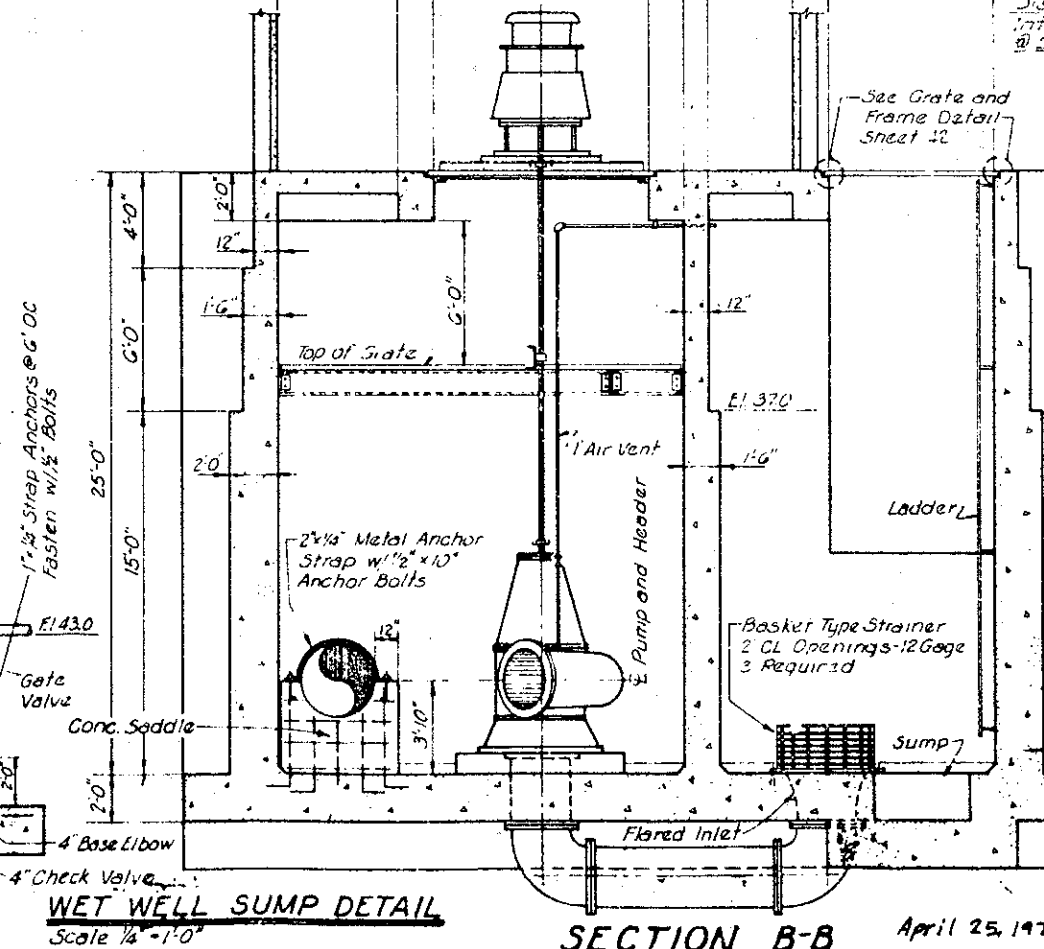
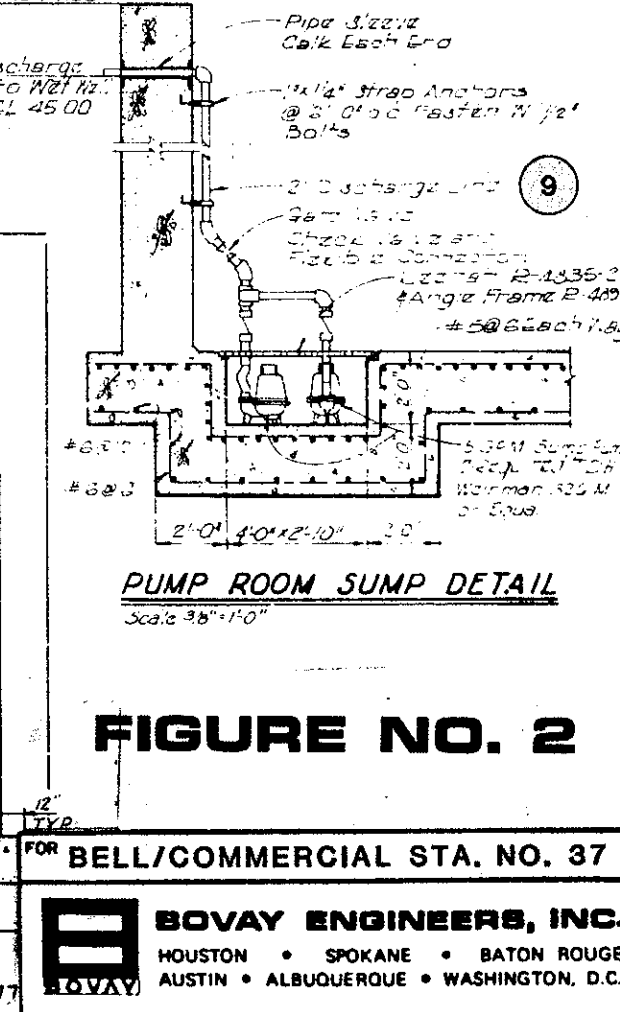
FIGURE NO. 2

1. All motors line shaft protective guards at intermediate level.
2. Safety-climb devices added; split level ladder run modification.
3. Second dry well exit ladder added with safety provisions.
4. Extension added to ladders; toeboards additions to platforms.
5. Intermediate railings added at platforms.
6. Floor conduit yellow safety painting/markings.
7. All pumps - control valves repair/overhauls, replace seals/repacking.
8. Pumps 2 & 3 - isolation valves added (knife gate valves).
9. Sump pumps - overhauling/renovating.
10. All equipment markings, identification with vinyl markers.
11. All gauges/recorders testing/recalibrating.
12. Running time meters added for motors 2 & 3.
13. Back up duplicate air compressor.
14. Overhead hoists/crane extension
15. Dry well - floor level mechanical jack and gantry crane.
16. Power supply back up to station.
