Date & Time: 04-23-2020 at 3:45 PM

## NATIONAL STORM WATER QUALITY PROGRAM SITE INSPECTION REPORT (SIR)

Community Name:		Pulte: Campo Del Norte, Albuquerque, NM 87113 NPDES: NMR1001LO								
		(Include Site Name, City, State, Zip Code and NPDES/Construction Storm Water Permit Number)								
Master Site List ID:		1261	1261 Inspection performed by: Mario Alderete, CESSWI CISEC, Green Globe Environmental							
				(Print Na	ame, Company, and Title / Qua	ifications)				
Stages	of Construction:	(check all that apply)	Land Development	Inactive	Vertical Construction	Post-Construction				
			Land and Vertical							
Type of Inspection:		(check all that apply)	Routine Inspection Other:	Storm-Event Related	Final Site Inspection

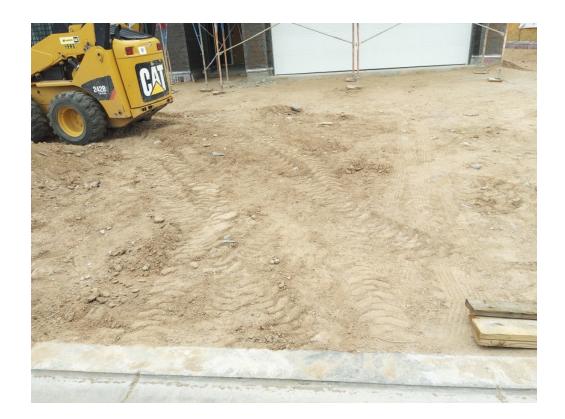
**Deficiency Name:** 8712 la pradera **Corrective Actions:** Curb cut back
