**Re: Senemar, LLC/ Rohan Subdivision; MINOR; UNPERMITTED DISCHARGE / CONSTRUCTION  
STORMWATER; SIC 1521; NPDES Compliance Evaluation Inspection; NPDES #NMU001981;  
October 23, 2018**

**Senemar, LLC  
Rohan Subdivision  
Compliance Evaluation Inspection  
October 23, 2018  
NPDES Permit No. NMU0001981  
Further Explanations**

**City of Albuquerque Drainage Ordinance Inspection  
10-12-18**

**Re: Drainage Ordinance (14-5-2-1) Violations for Erosion and Sediment Control**

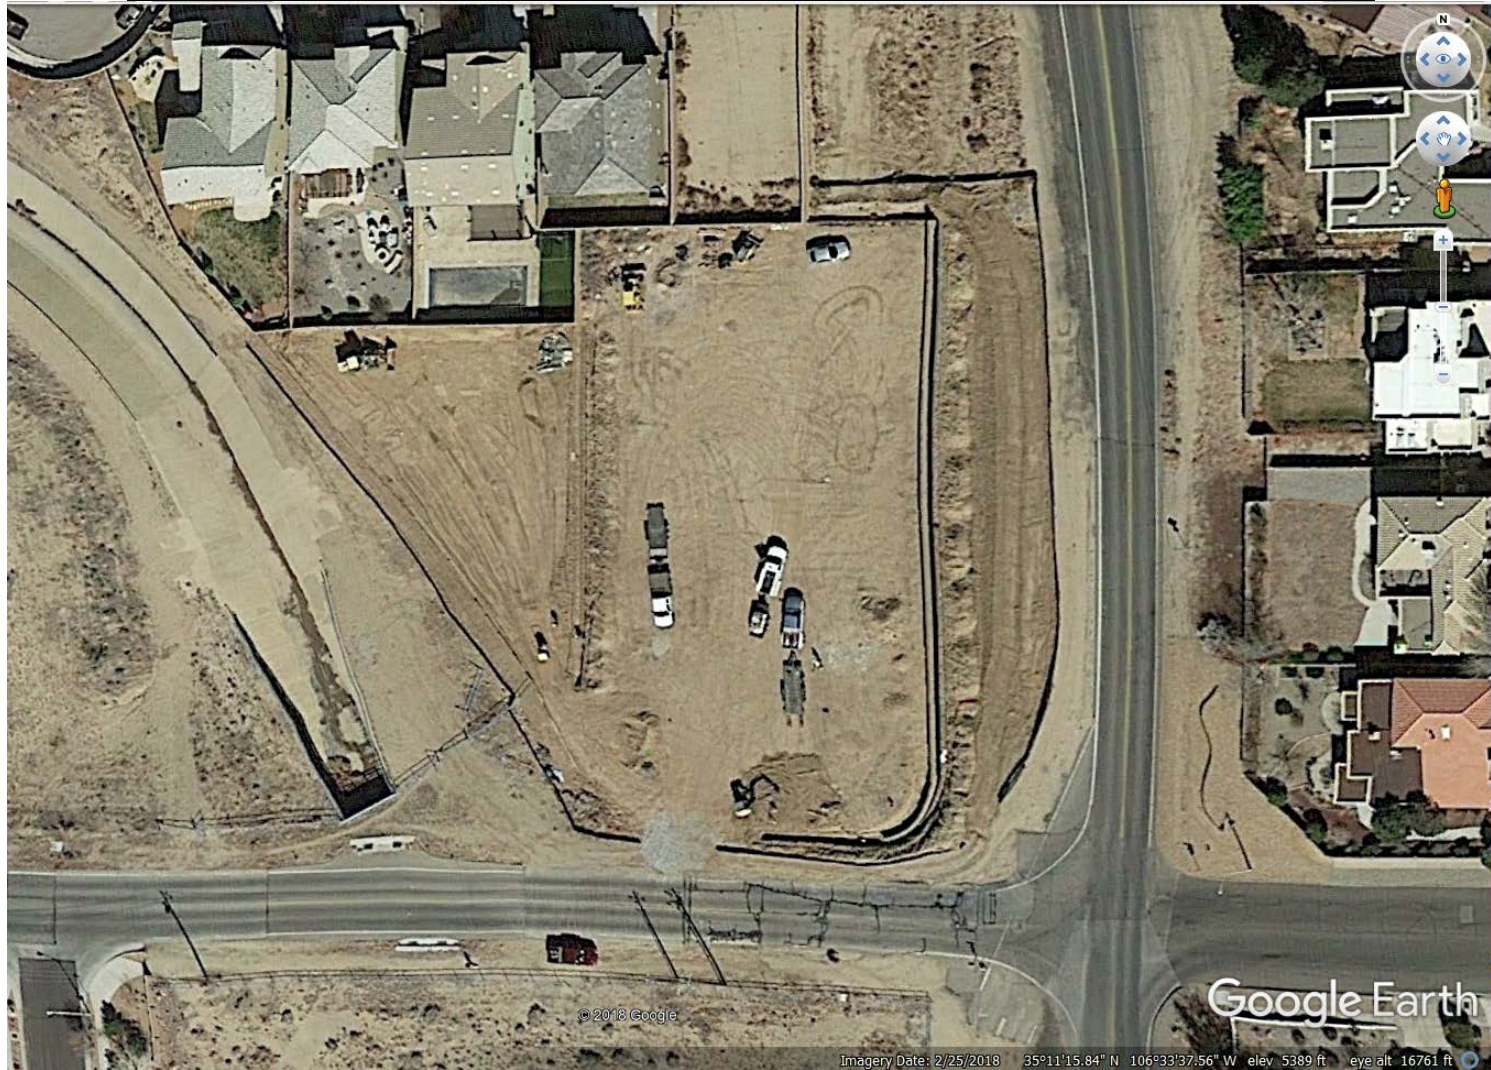
| NMED/SWQB Official Photograph Log | | |
|---|---|---|
| Photo # 1 | | |

As part of the city permitting process, builders are required to perform infrastructure improvements. For this project, drainage and road improvements work were done, and an adjacent lot was also disturbed as indicated on the Google Earth photo. The project drawings included the area of disturbance of the housing lots as well as the road improvements. The total area disturbed for by this project was 1.6 acres.

| NMED/SWQB Official Photograph Log | | |
|---|---|---|
| Subject: Aerial photo Feb 2018 of Project area, La Cueva Arroyo is drainage channel to west | | |

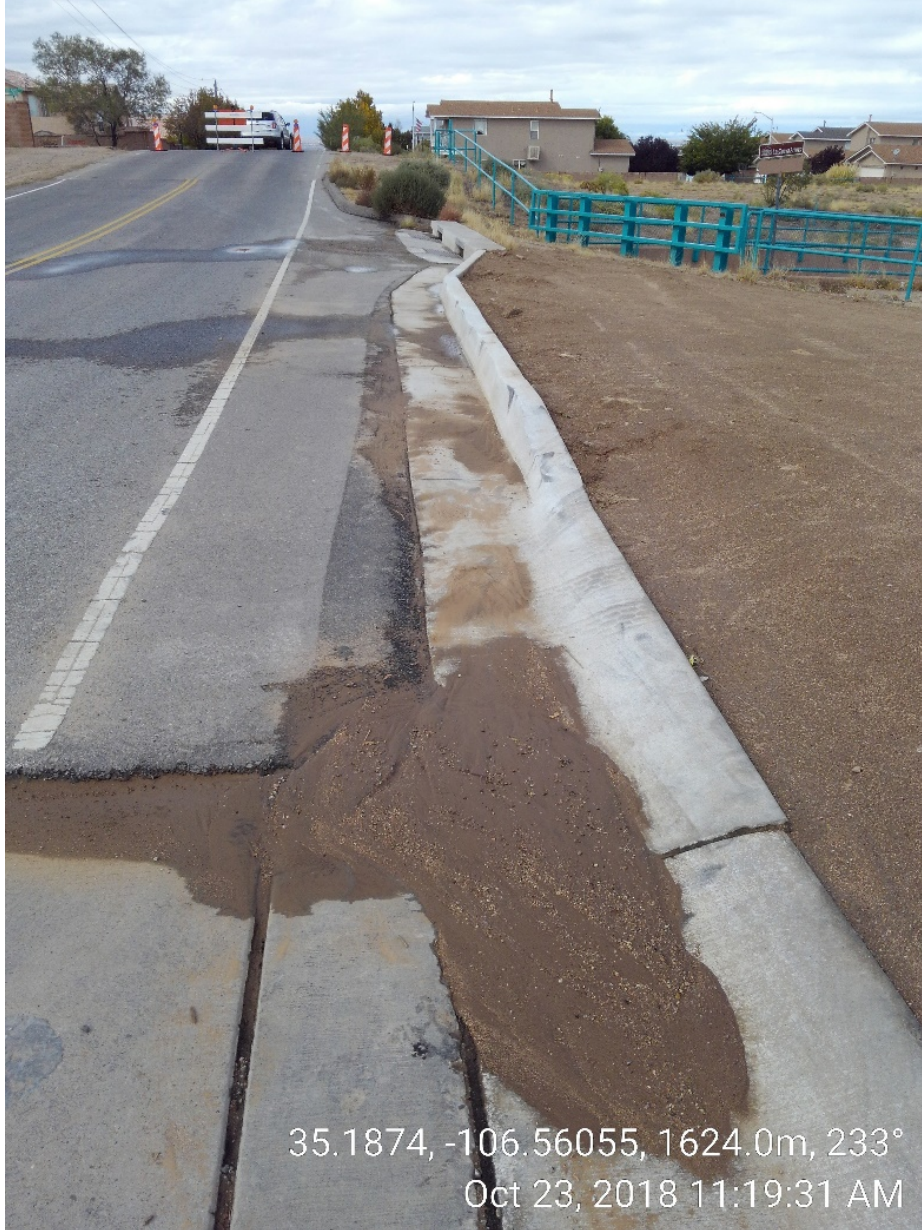
NMED/SWQB Official Photograph Log  
Photo # 2

According to the facility's representative and based on a review of the EPA storm water permit database, it has been determined that neither the owner or operator had NPDES construction general storm water permit coverage on the date of this inspection and BMPs had not been adequately installed to prevent a discharge of pollutants to the adjacent La Cueva Arroyo.

Subject: sediment from the site going towards La Cueva arroyo

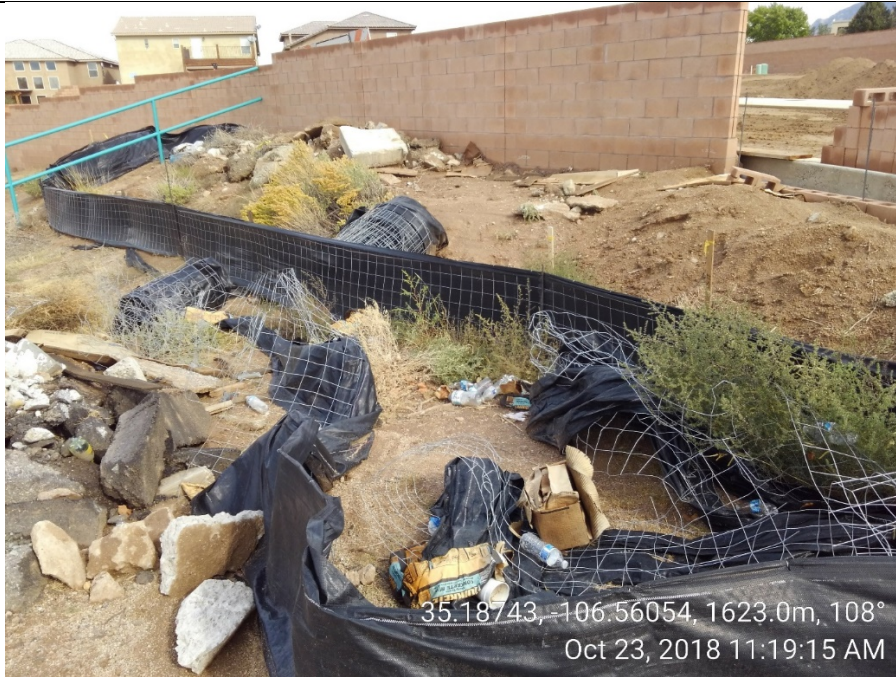
| NMED/SWQB Official Photograph Log<br>Photo # 3 | | |

During the site visit, the inspectors noted that there was minor tracking, the porta potty was not anchored, construction debris was not in covered containers, and BMPs were not installed on the downhill side to prevent sediment from migrating from the road to the storm drains.

| NMED/SWQB Official Photograph Log<br>Photo # 3 | | |
|---|---|---|
| Subject: construction debris on ground | | |

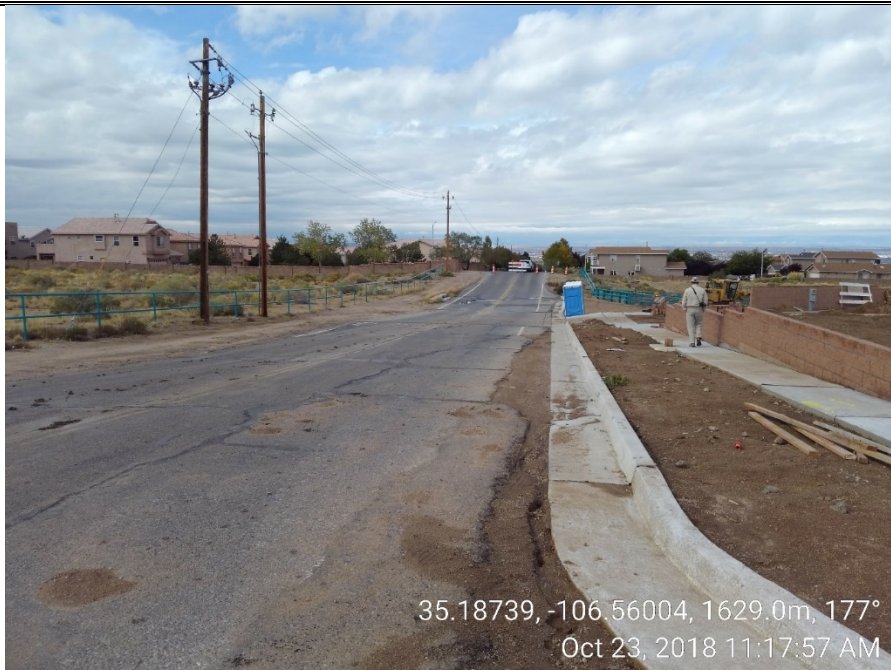
| NMED/SWQB Official Photograph Log<br>Photo # 4 | | |

| NMED/SWQB Official Photograph Log<br>Photo # 4 | | |
|---|---|---|
| Subject: minor tracking and sediment from the site going towards La Cueva arroyo | | |

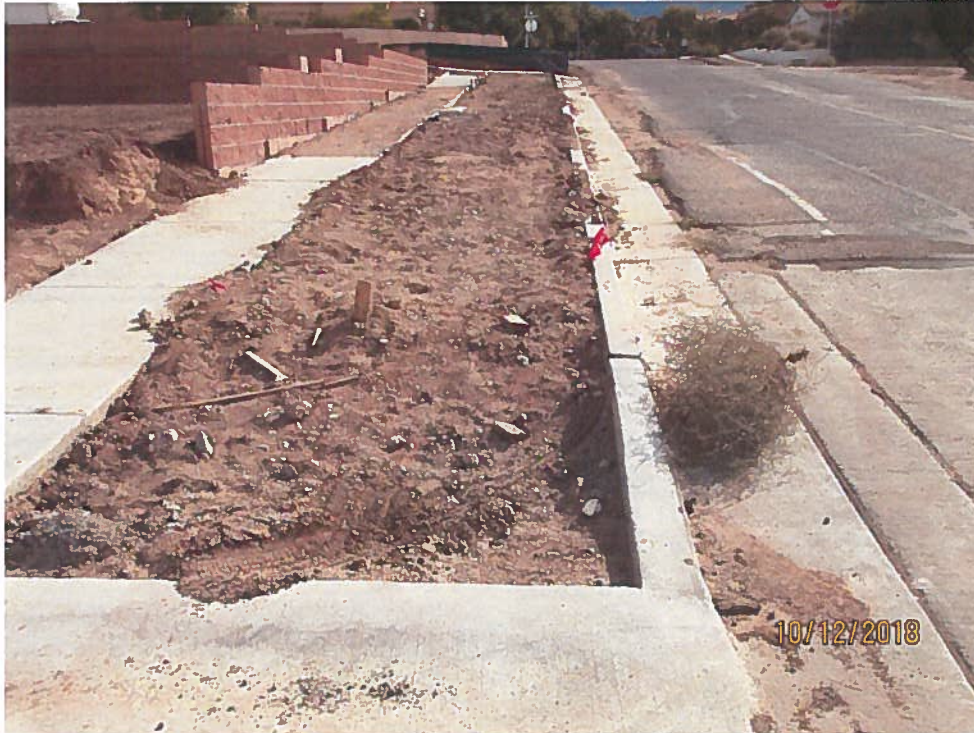
No sediment BMP.

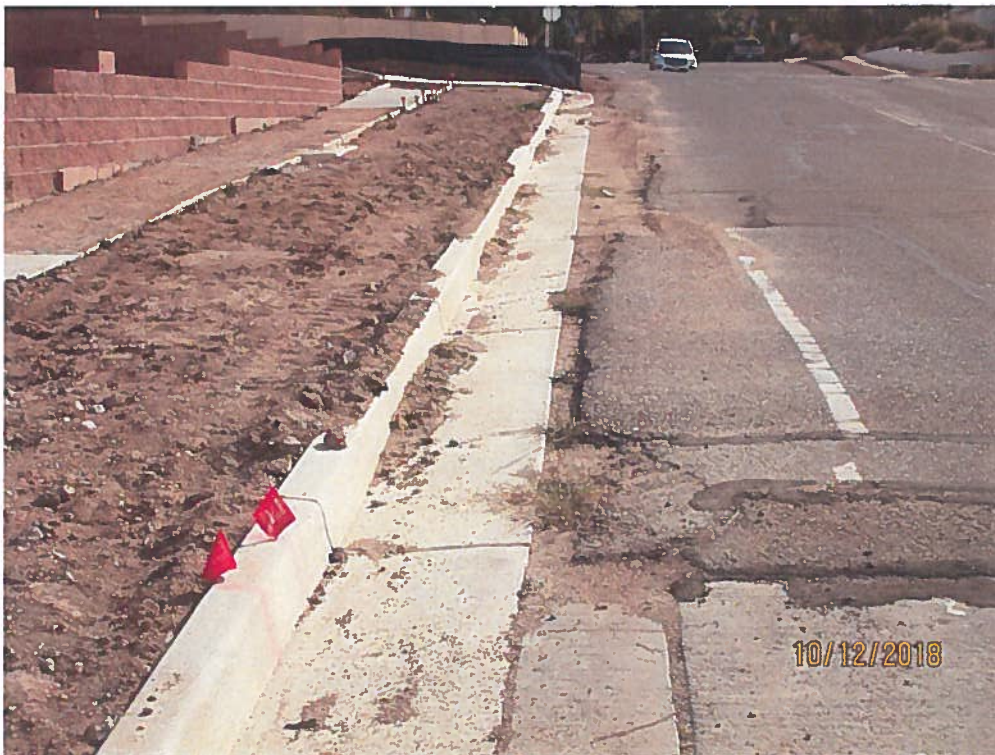
Sediment in gutter and on top of curb.

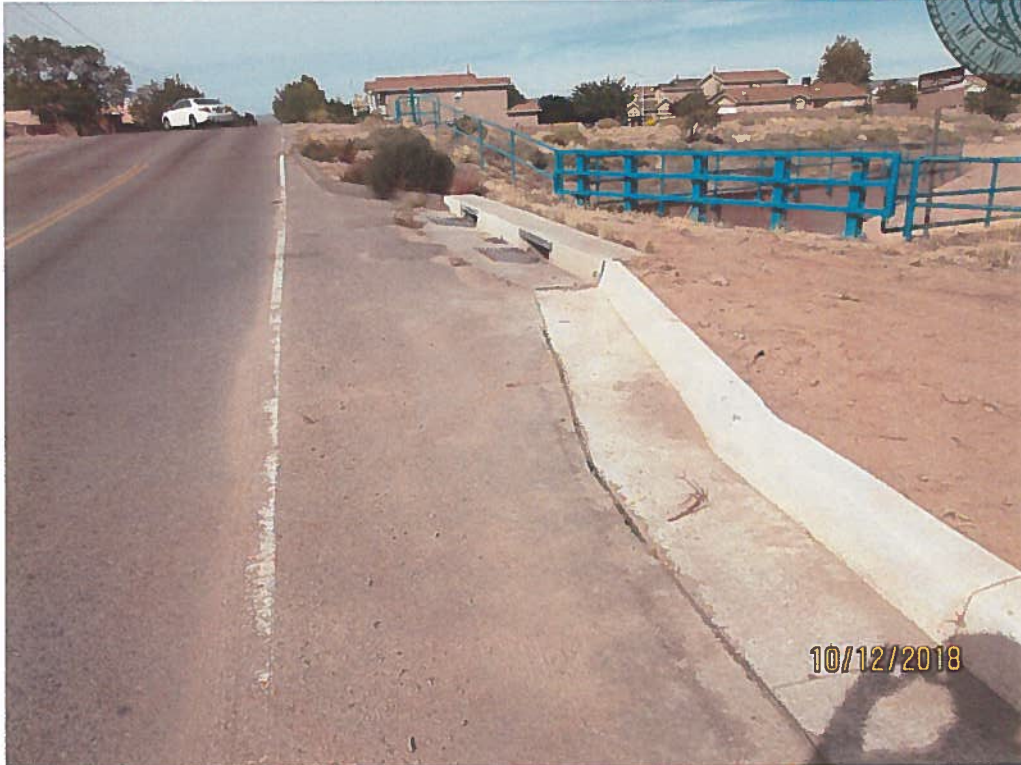
**No inlet protection.**

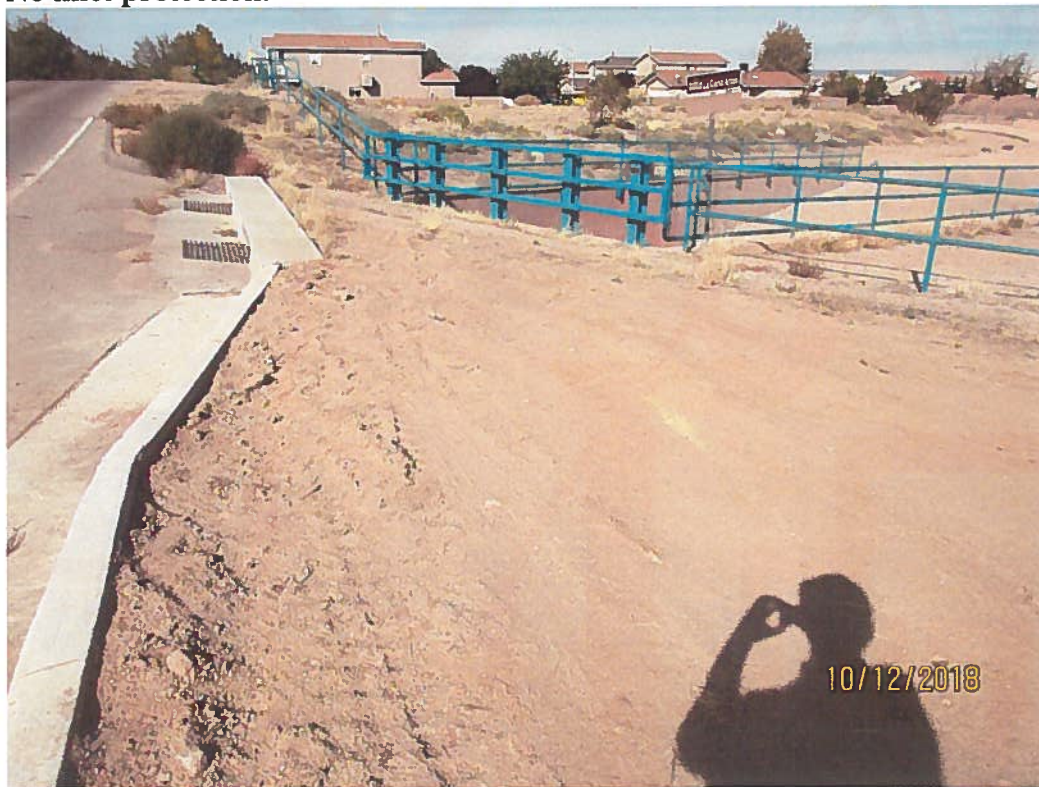
**Disturbed area uphill from channel with no sediment BMP.**

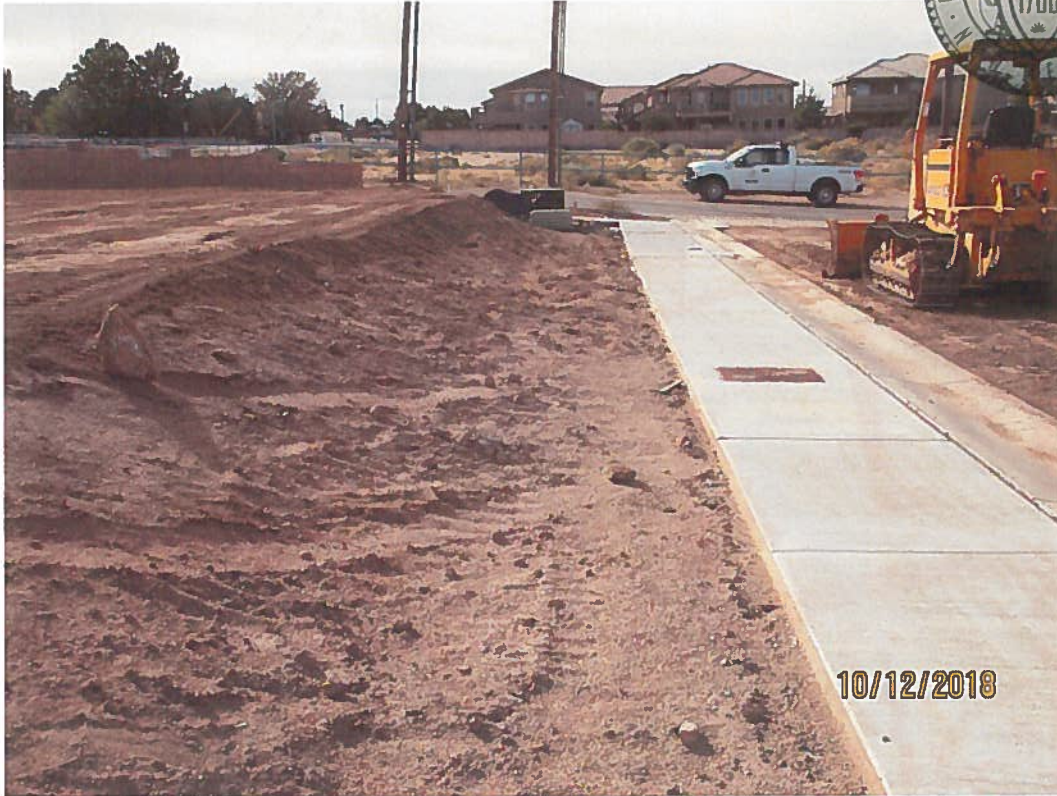
No sediment BMP for graded lots.

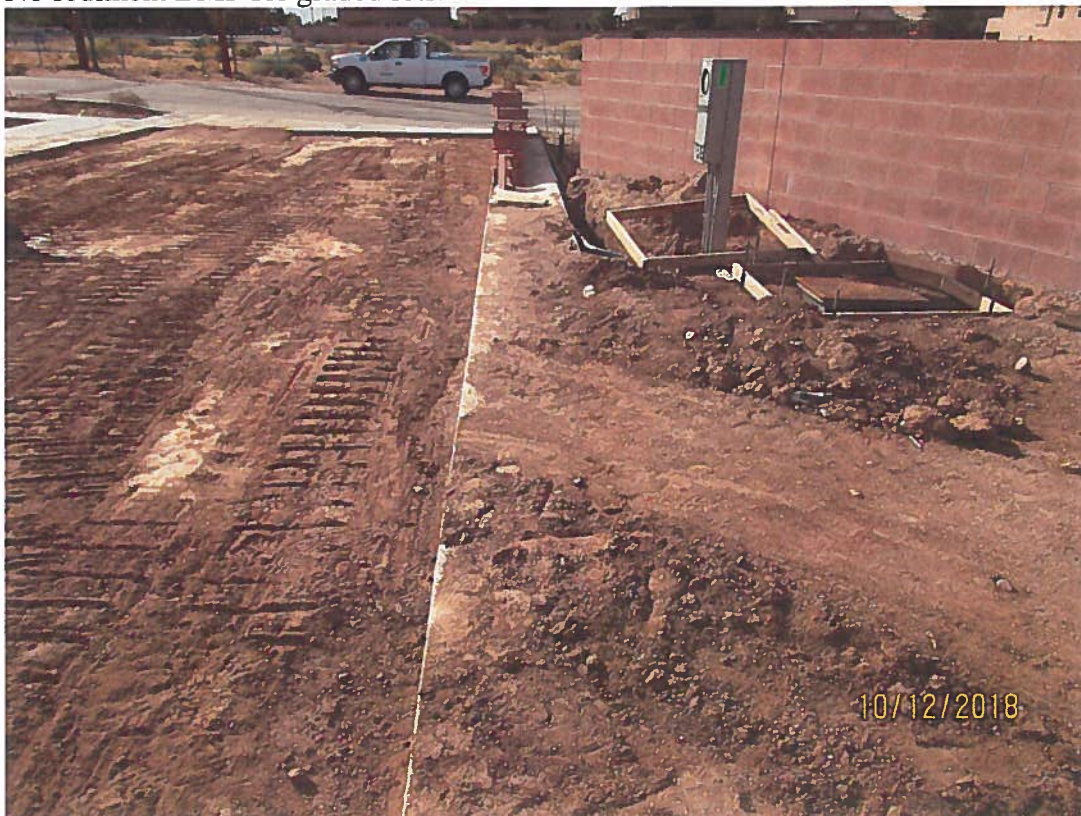
West gutter-No sediment BMP.

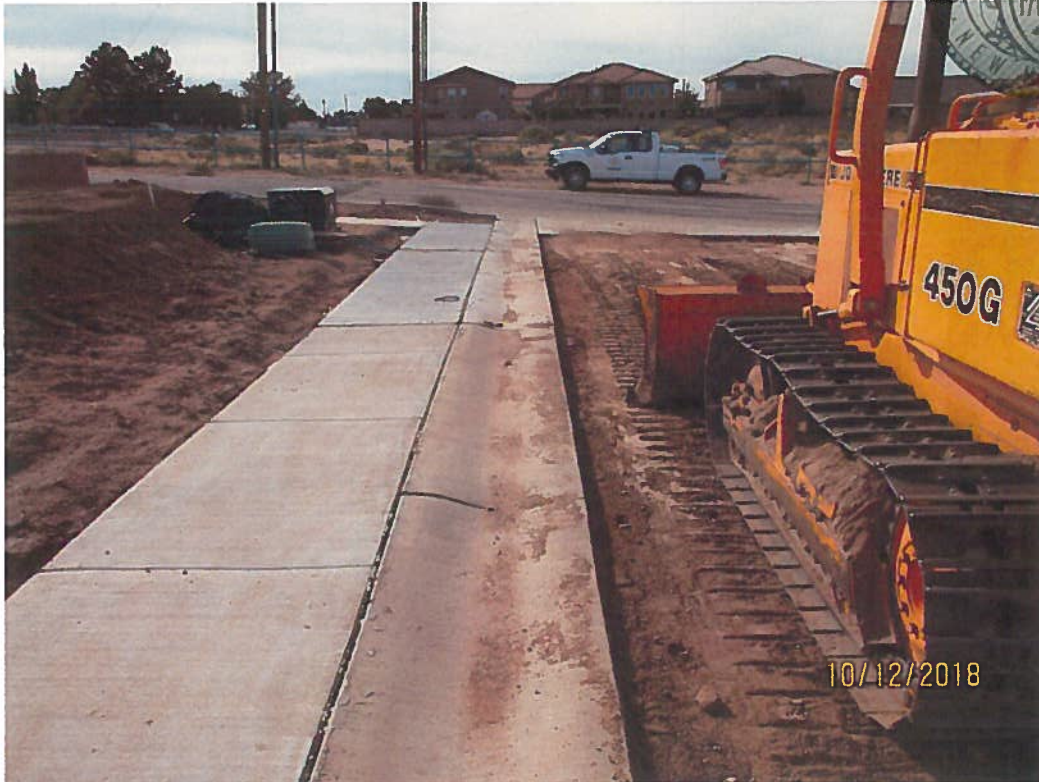
East gutter- No sediment BMP

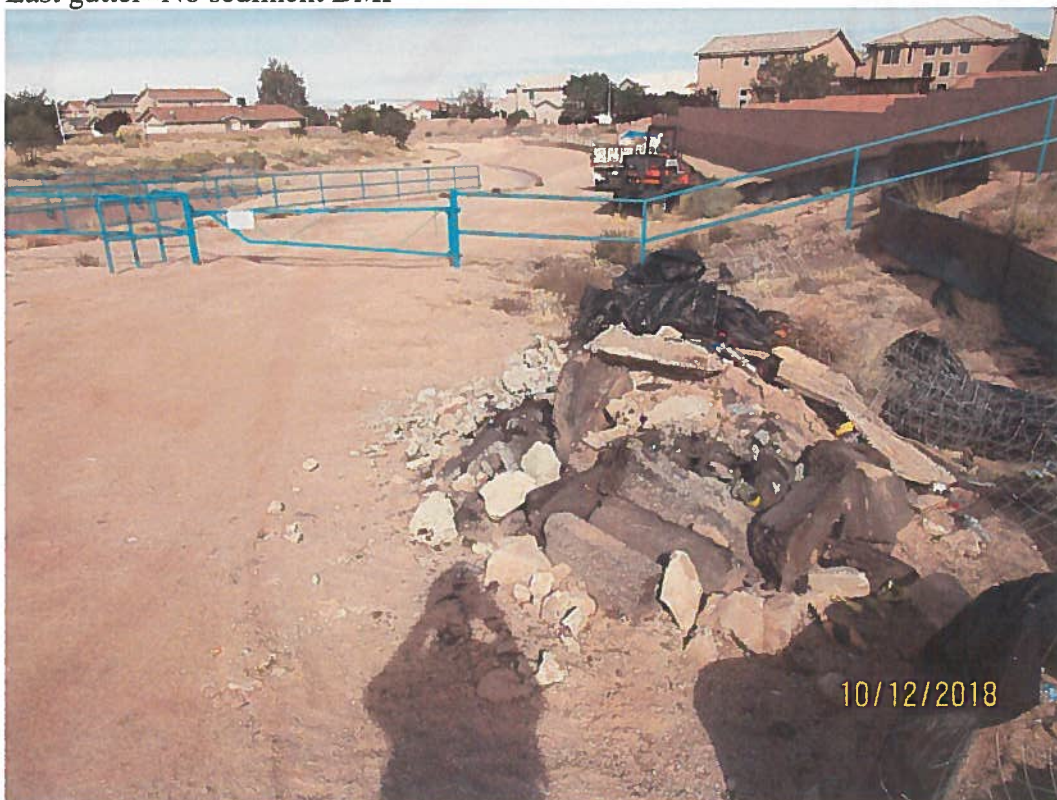
Construction waste and litter pile near channel.

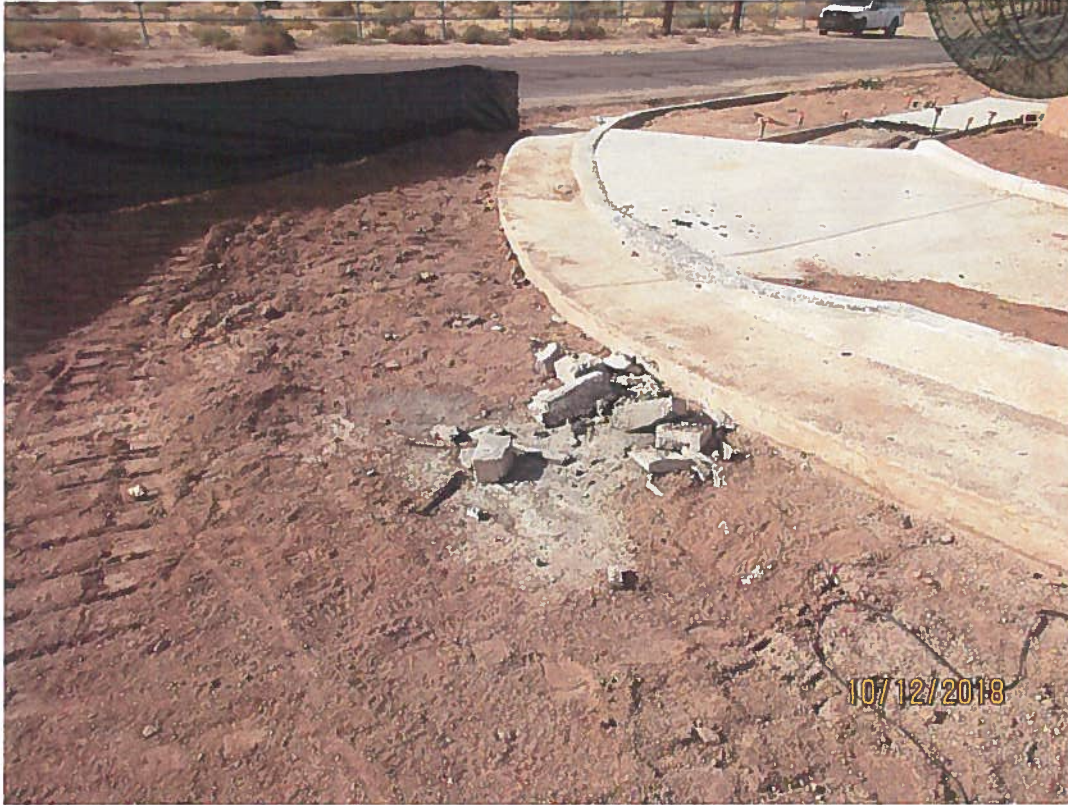
Concrete wash-out.

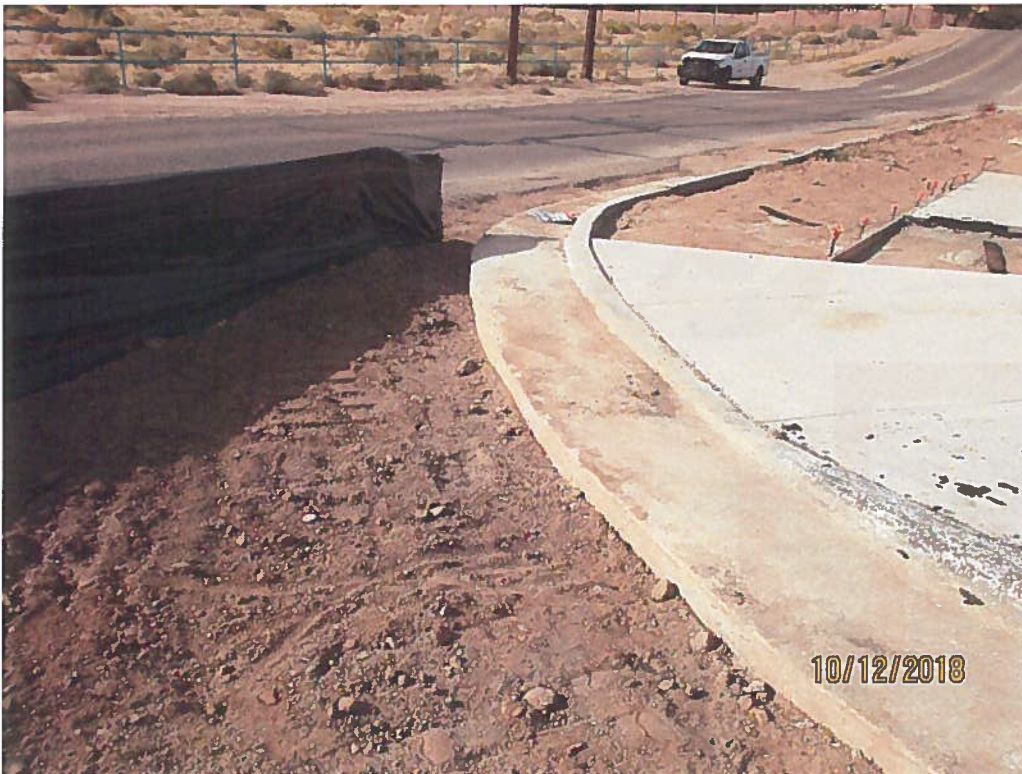
Wyoming south end- No sediment BMP for gutter and gap next to gutter.

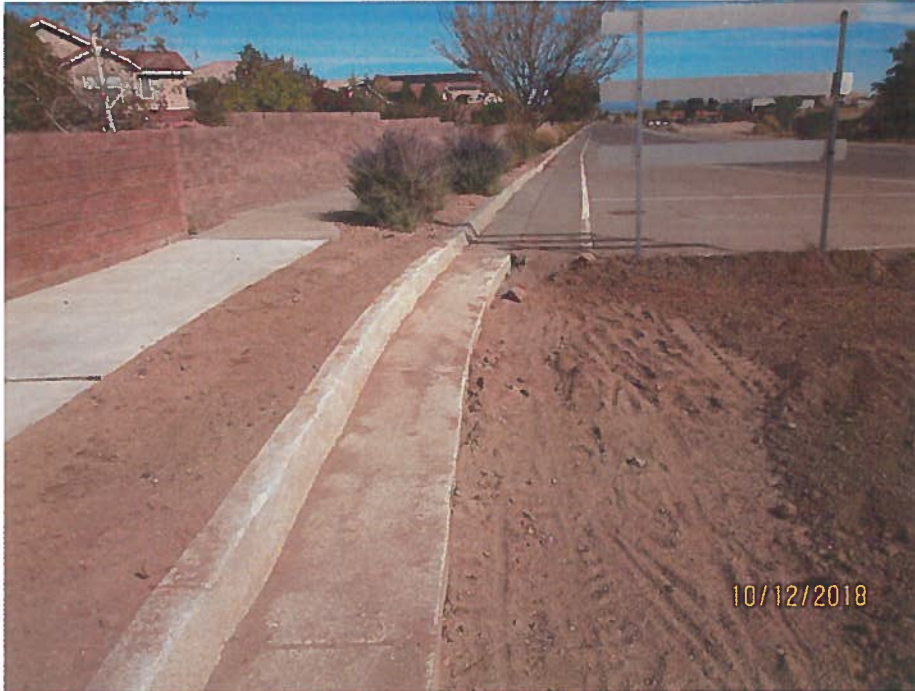
Wyoming Blvd North end-no sediment BMP.
