# CITY OF ALBUQUERQUE

November 6, 2017

Site: Montecito Vistas

**Re: Drainage Ordinance (14-5-2-1) Violations for Erosion and Sediment Control**

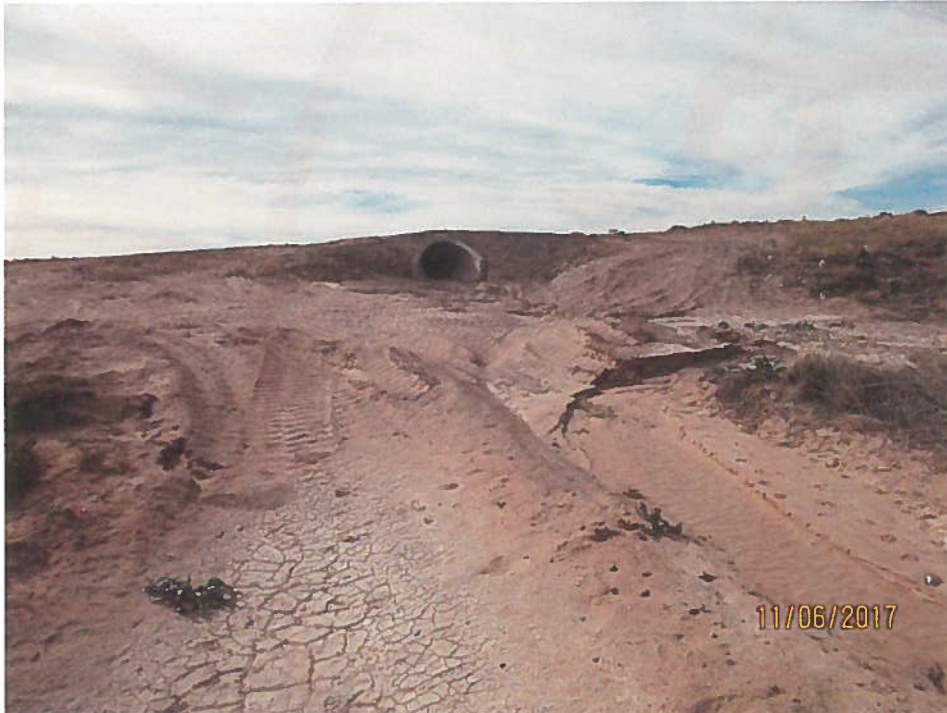
Storm drain outfall with no erosion protection.

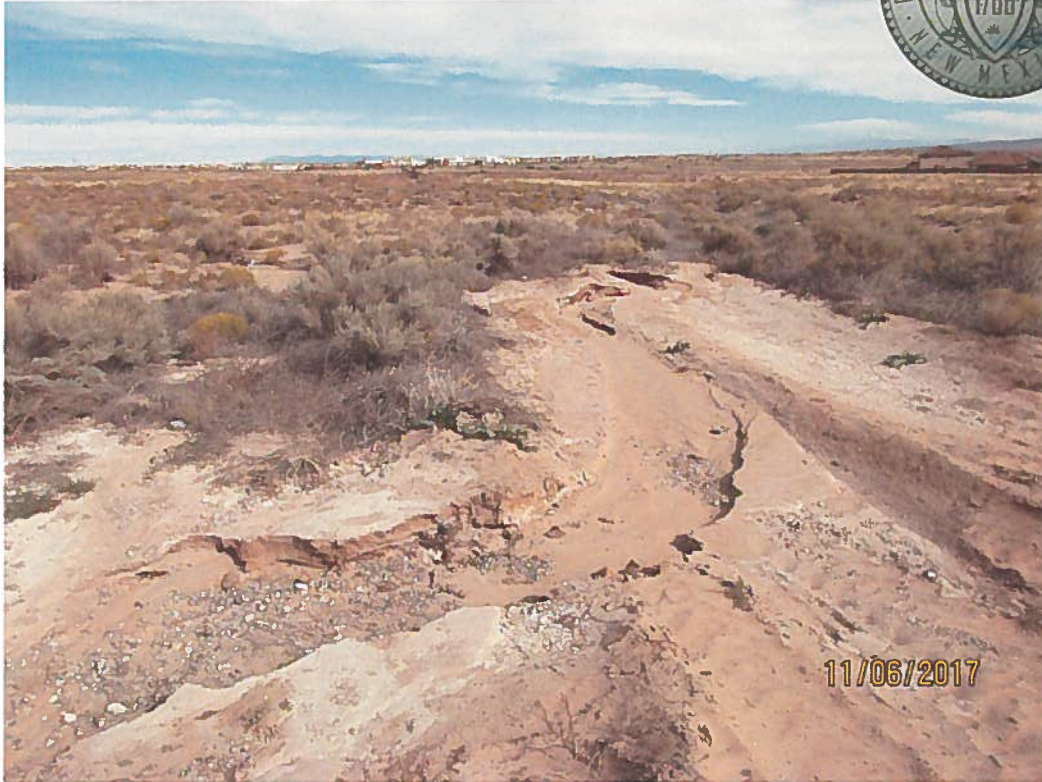
Erosion and sediment deposition in arroyo.

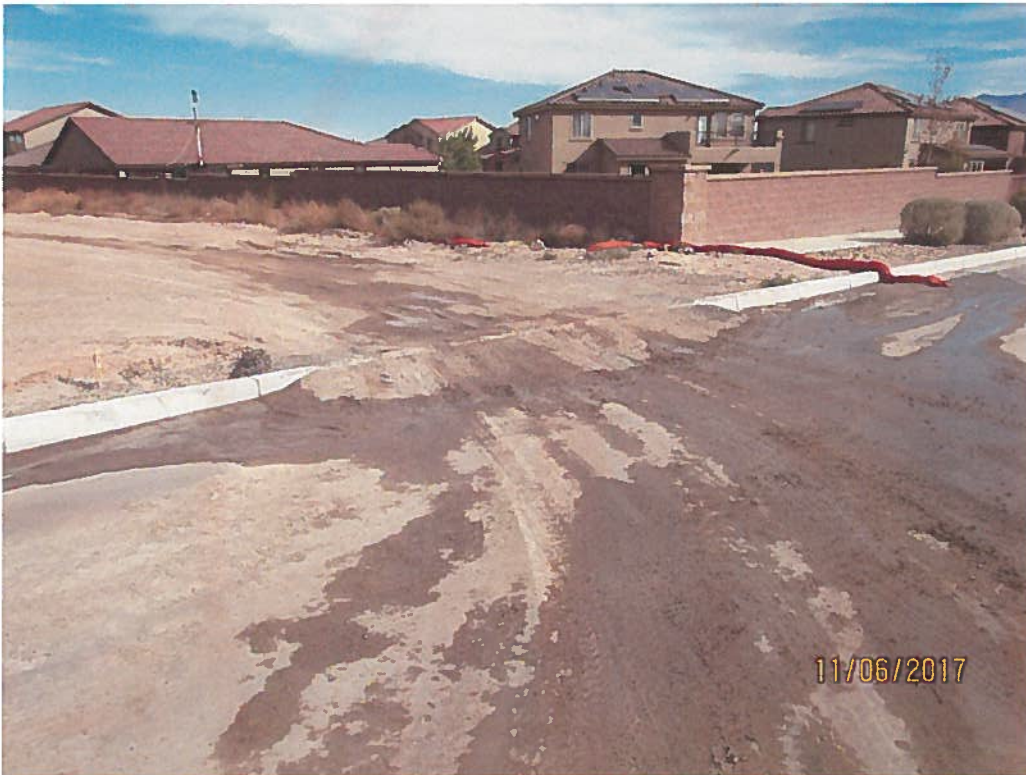
Require track-out pad at water truck haul road entrance onto Vista Vieja Ave.

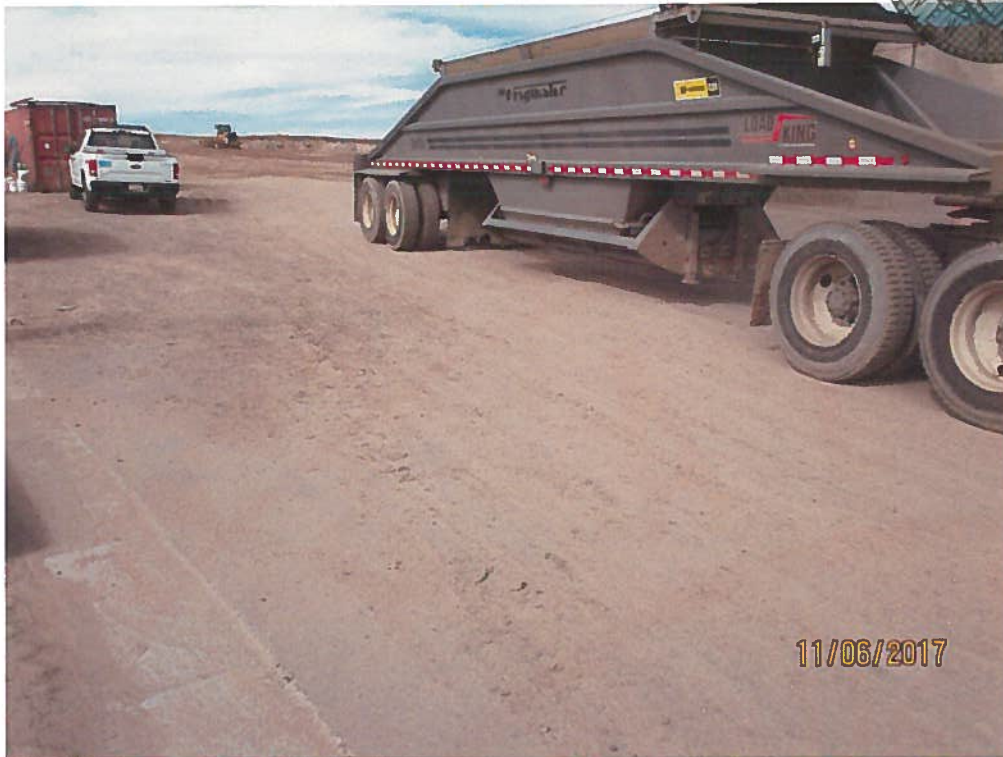
No track-out pad from west dirt area onto Vista Vieja Ave.

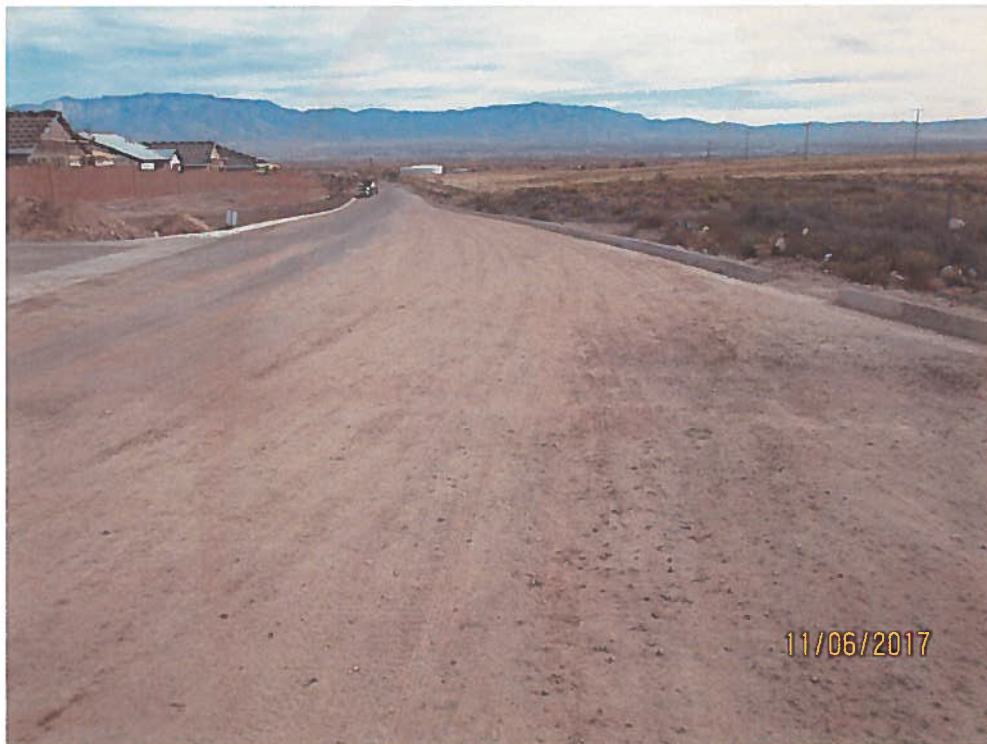
Track-out onto Vista Vieja Ave from west dirt area.

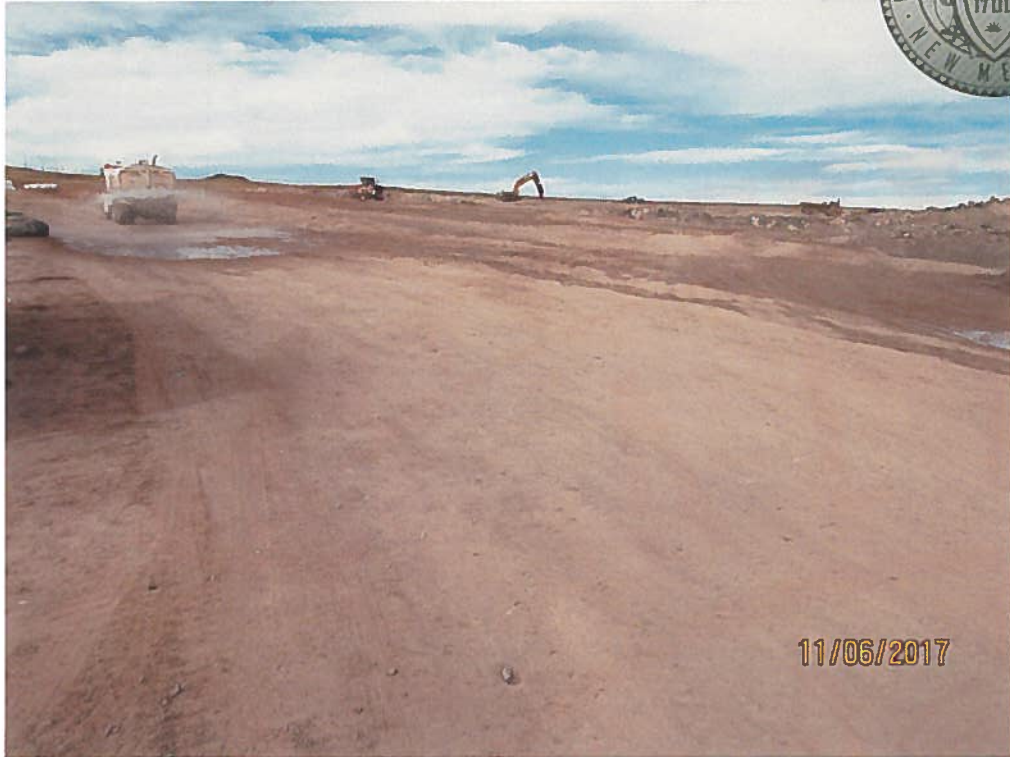
No erosion or sediment BMP-west area.

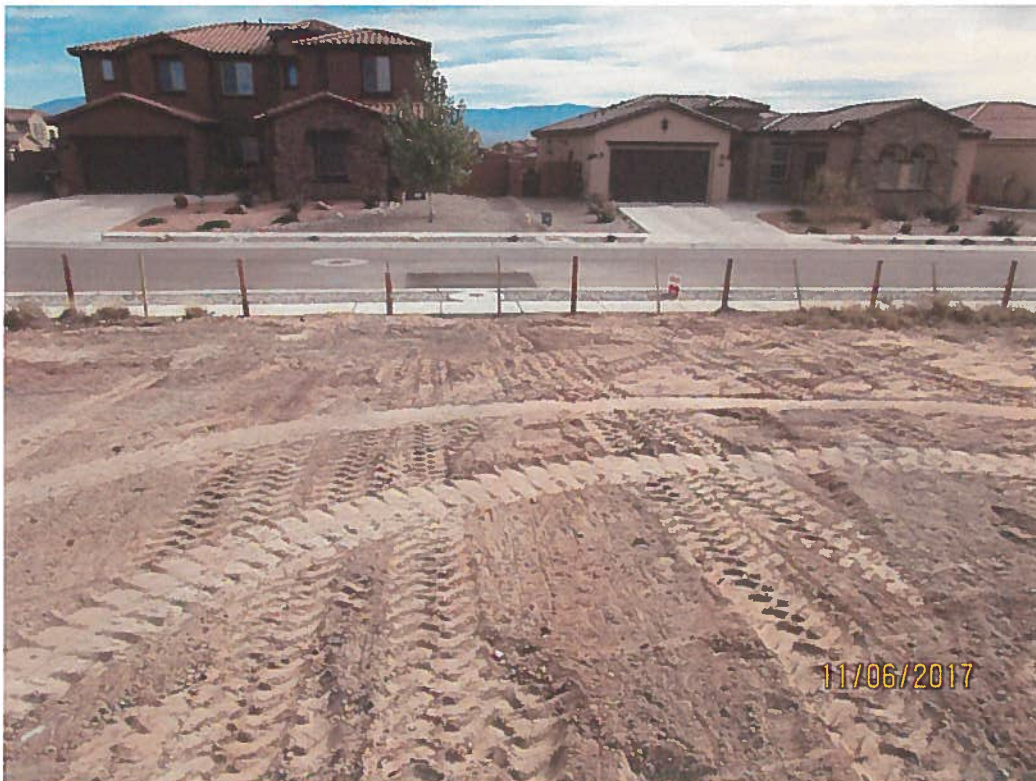
No sediment BMP. Location may be Retablo Rd.

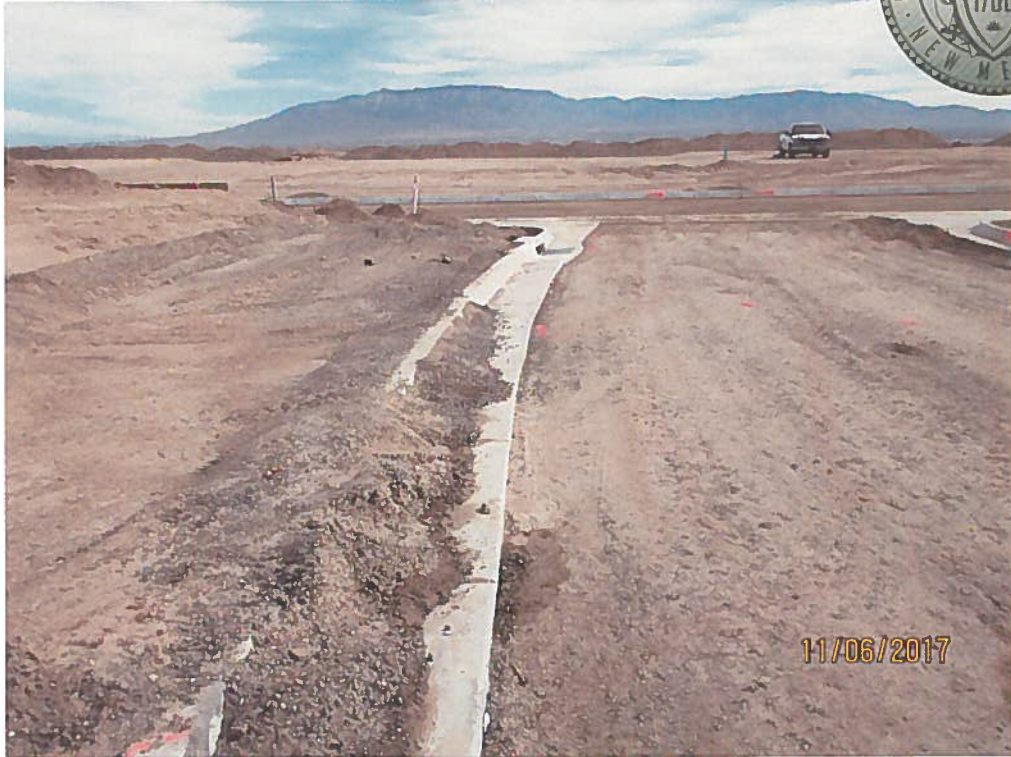
Sediment in gutter. No inlet protection. Numerous locations.

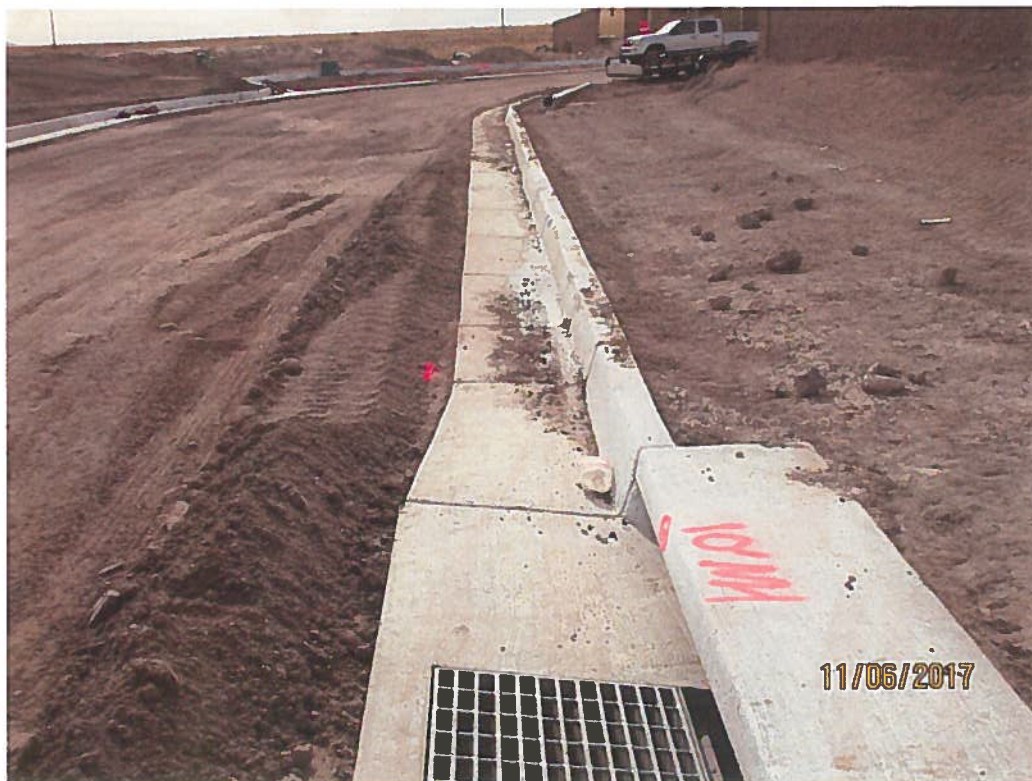
Sediment and trash in gutter. No inlet protection.
