City of Albuquerque
Stormwater Construction Site
Inspection Report

Project Name and Location	O'Reilly Auto Parts 8001 Ventura St NE		
Site Contact Name & Agency	Steve Haglan Hutton Construction	ESC File No. NPDES ID No.	020 E0706 NMP 1001 E6
Date of Inspection	1-3-19	Start/End Time	11:10/11:15
COA Inspector Name	Curtis Cherne, Stormwater Quality		
Describe Present Phase of Construction	Stabilized		
Type of Inspection:	<input checked="" type="radio"/> Regular • During storm event • Post-storm event (> 0.25 inch) • 311 / Complaint Response • Follow-Up

Project: O'Reilly's Ventura

Project Name and Location	O'Reilly Auto Parts 8001 Ventura St NE		
Site Contact Name & Agency	Robert Duncan Hutton Exchange 400, LLC	ESC File No.	D20E010C
Date of Inspection	7-10-18	Start/End Time	9:20 / 9:40
Inspector Name, COA Dept.	Curtis Cherne, Stormwater Quality		
Describe Present Phase of Construction	Rough grading		
Type of Inspection:	<input checked="" type="radio"/> Regular • During storm event • Post-storm event (> 0.5 inch) • 311 / Complaint Response • Follow-Up

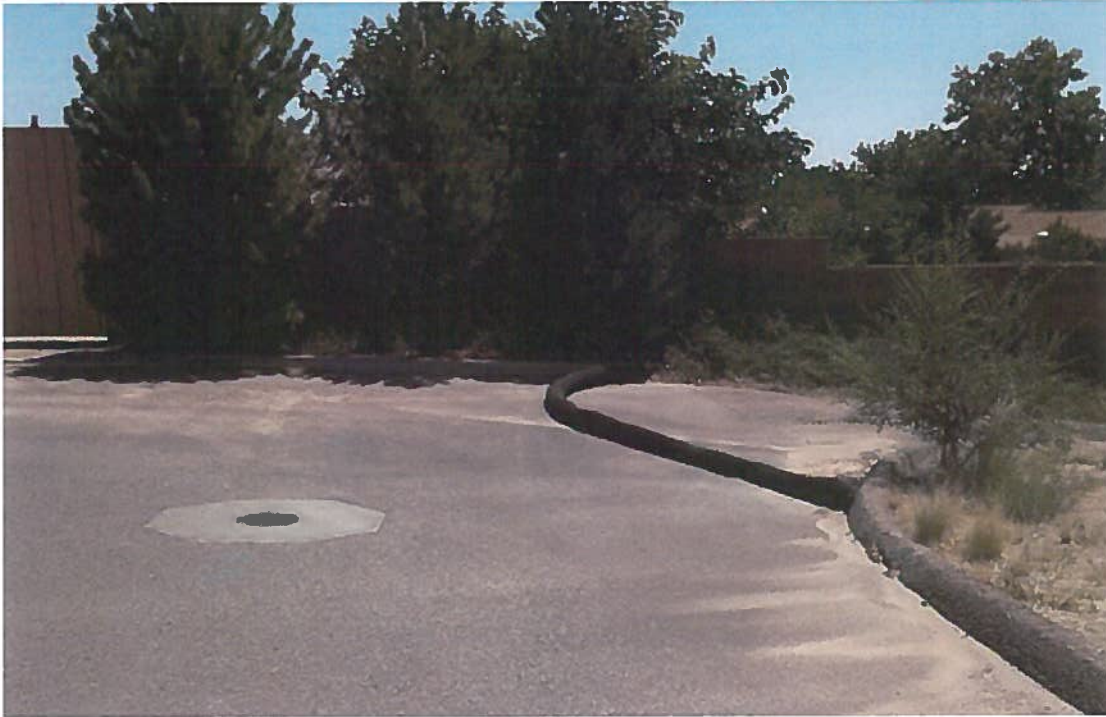
Item 1: There was no sediment BMP at the inlet to the channel in the SW corner of the site. (Corrected, see photo)

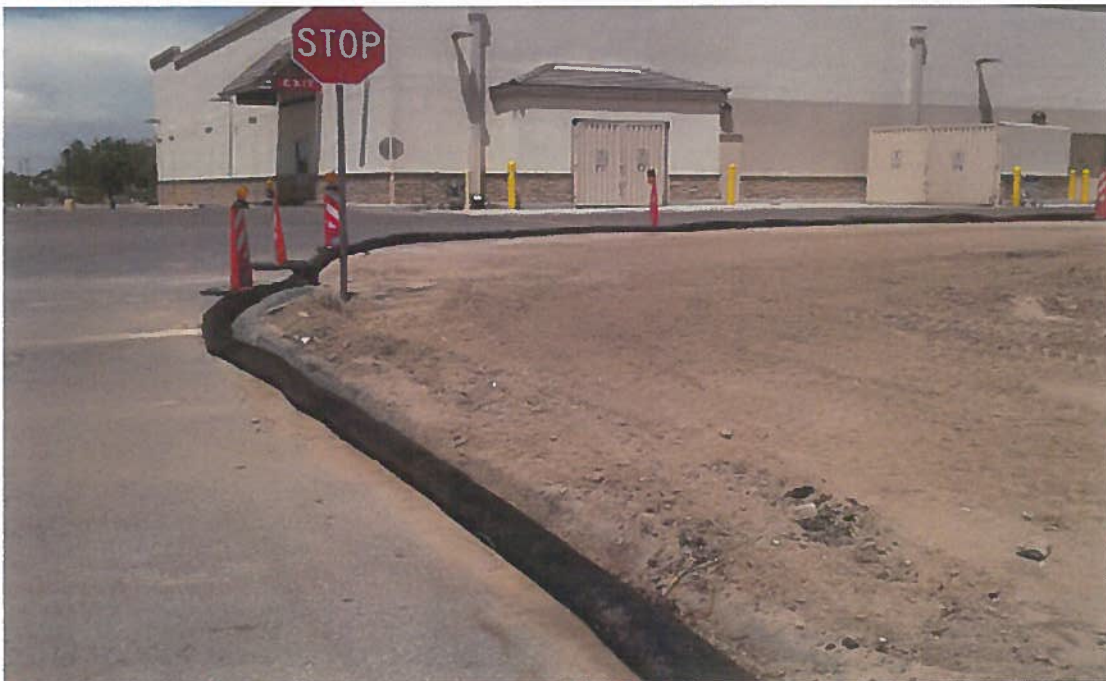
Item 2: In the NW corner, there was a gap in the filter socks and sediment washed through it. Please close the gap. This portion of the site is receiving offsite flows, which never helps. Also, there is a small dirt pile in the access drive outside the mulch sock. (Corrected, see photo below)

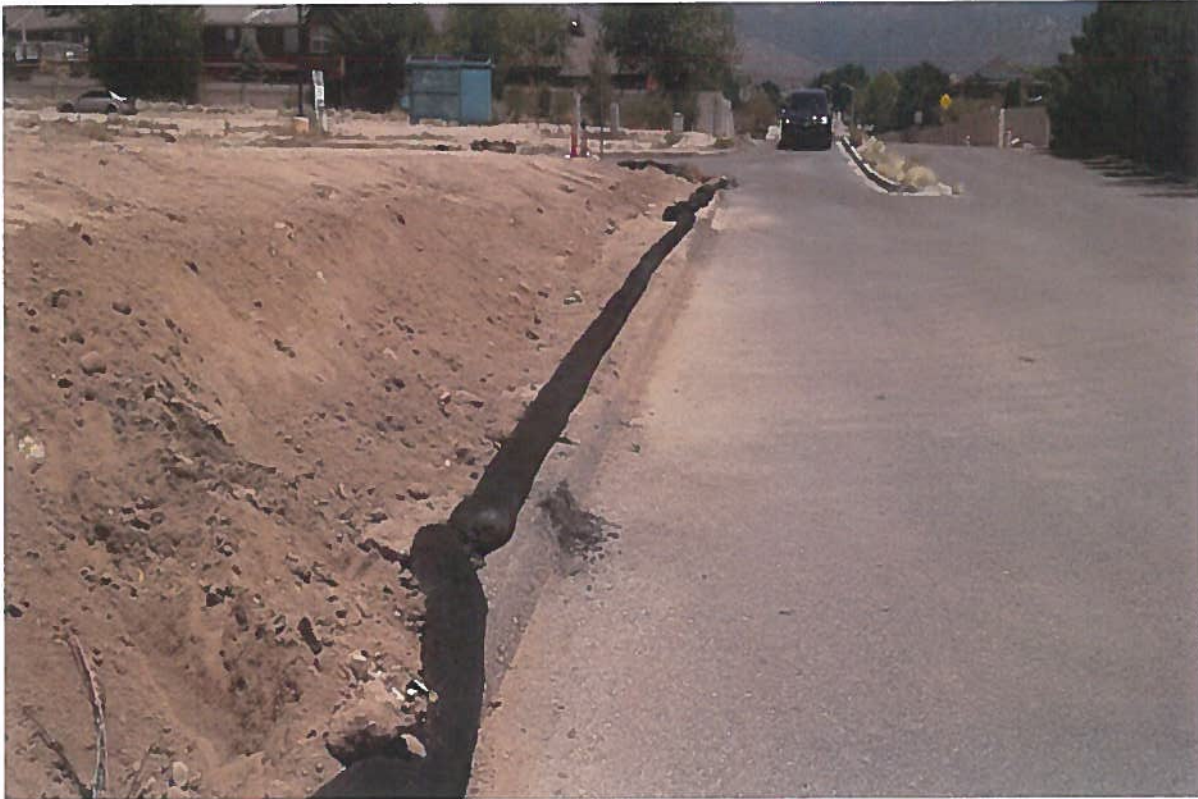
Item 3: On the south edge, a dirt ramp was built to get over the curb. This area drains to the channel that did not have a sediment BMP. A sediment BMP (rock bags or similar) the inlet to the channel would help catch it, but I advise to remove it as it will load-up the BMP faster than you want and maintenance will be required. A similar condition exists on the west edge. No ramp, but dirt in the drive aisle that drains to the channel. (Corrected, photo below)

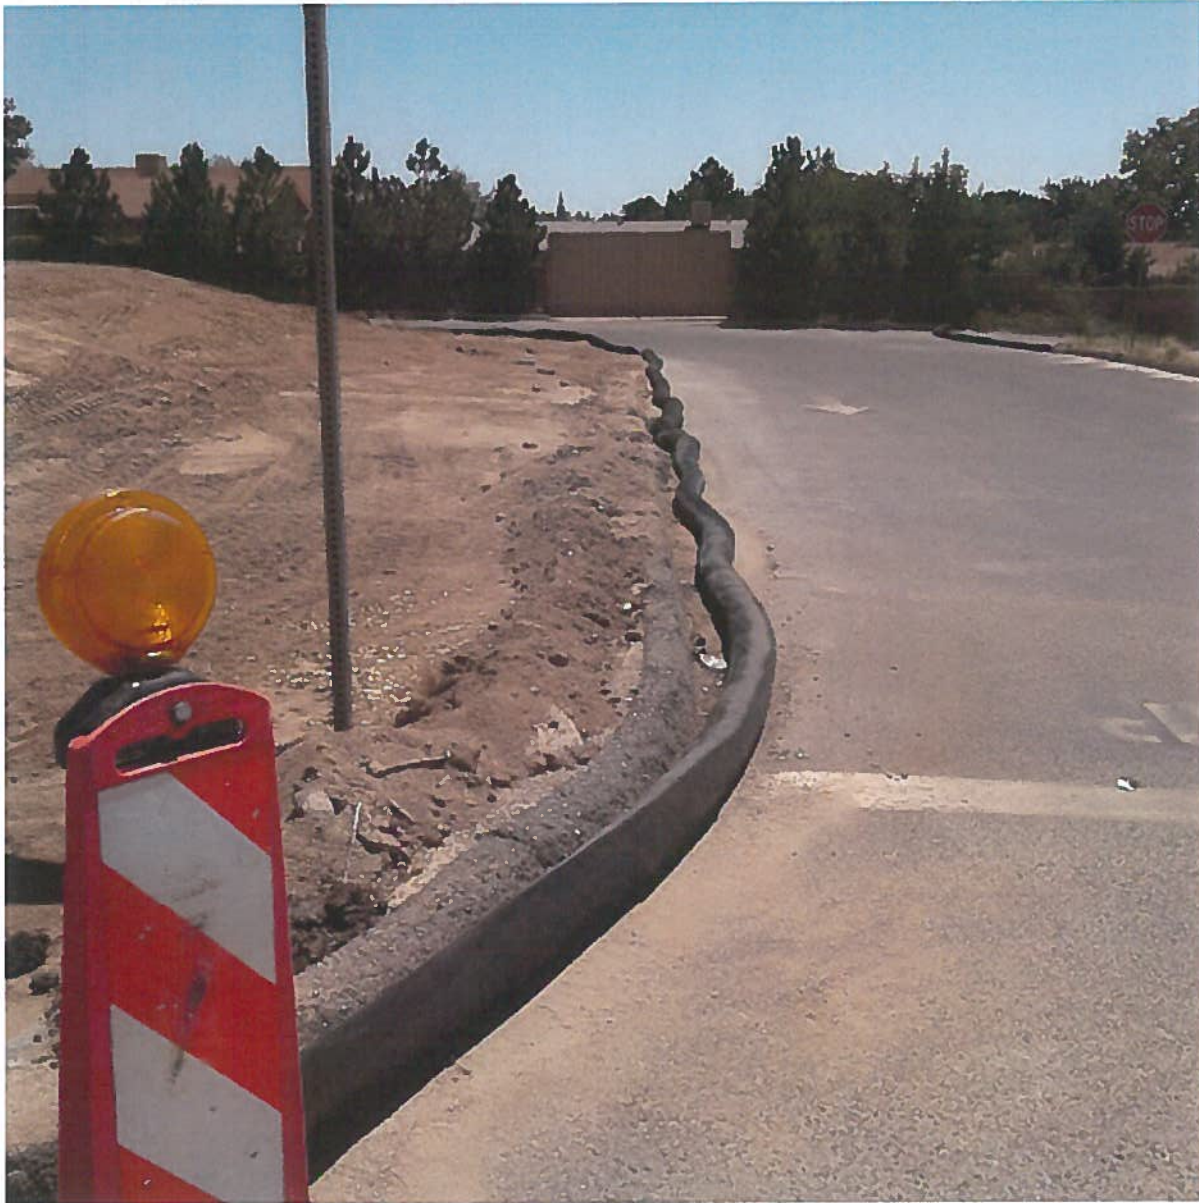
Item 4: There was a gap in the filter socks at the southwest corner and the dirt pile behind it is too high.

(Corrected, photo below)
