**NEW MEXICO  
ENVIRONMENT DEPARTMENT**

**Re: Hutton Exchange Albuquerque (Coors), LLC. / O'Reilly Auto Parts (Coors); Construction Stormwater; SIC 1542; NPDES Compliance Evaluation Inspection; NPDES # NMR1001DZ; May 21, 2019**

## NPDES Compliance Inspection Report

### NPDES Construction General Permit Inspection Report – State of New Mexico

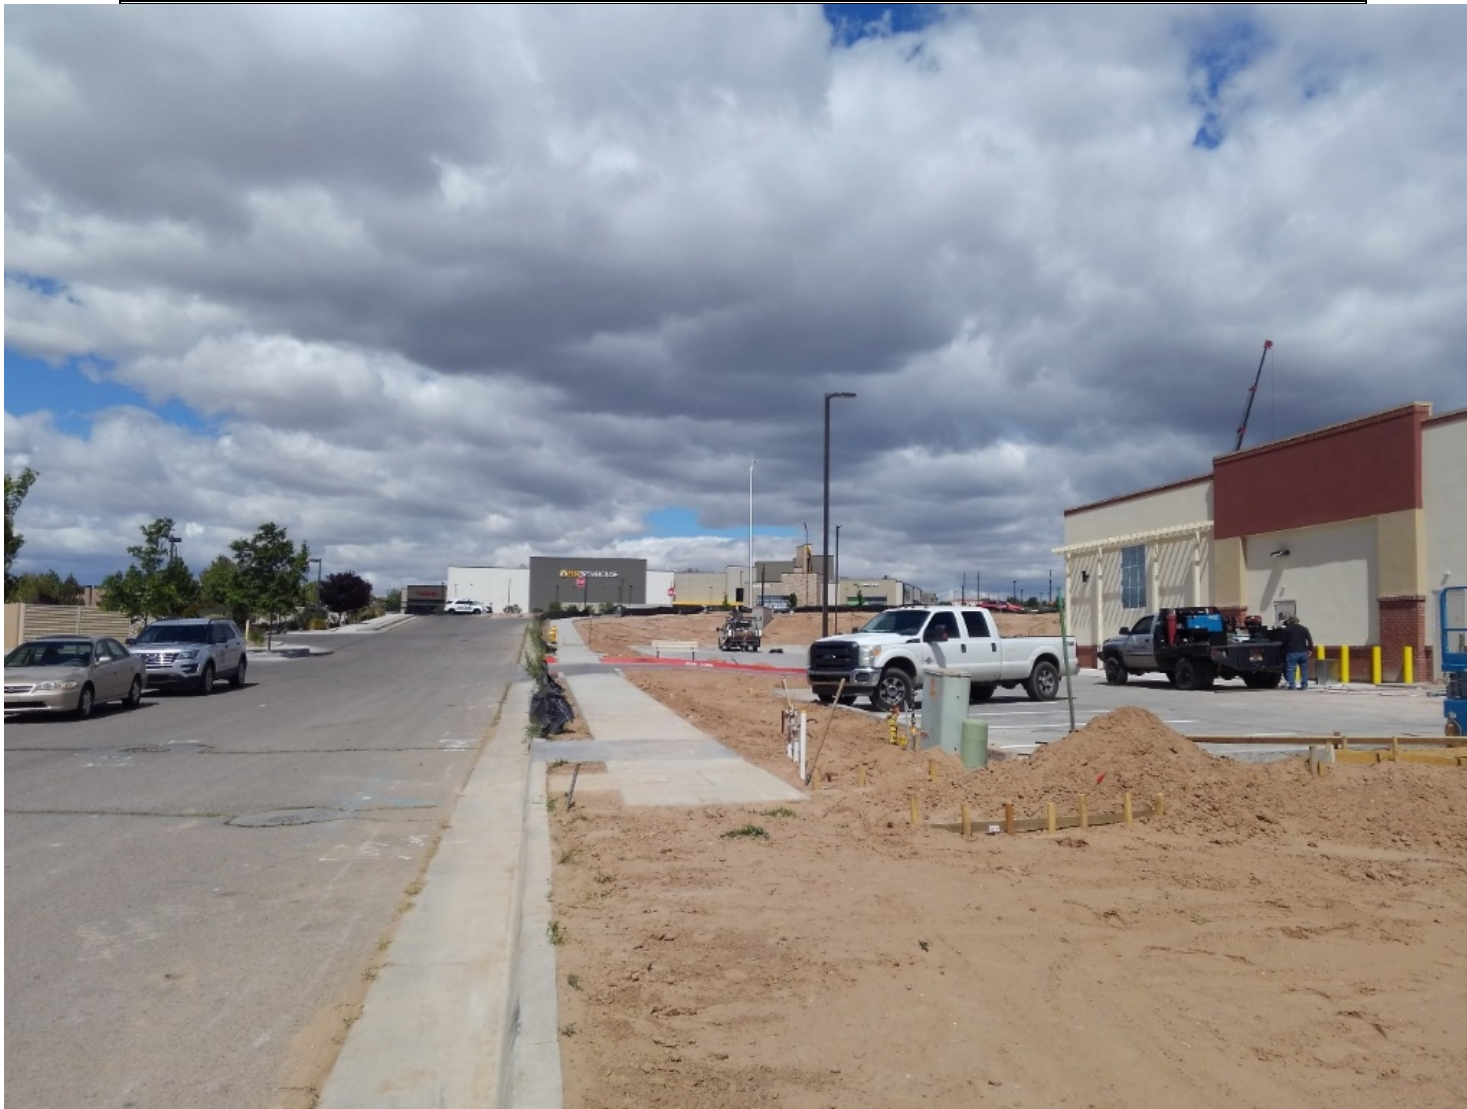
When the inspector arrived, the Operators were just finishing shoveling the gutters clean of sediment. BMPs have been removed except for the far east end. The water quality pond had not yet been constructed as utilities had been located within it and need to be relocated (photo 1). It is unclear if the water quality pond and discharge culvert was sized to accommodate the two 36" DOT culverts that discharge to the site, the map states the pond is slightly undersized to meet the local ordinance.

The waste container was not covered (photo 2). No stabilization has been planned for the adjacent lot on the east side that was disturbed during this project, including the area within the driveway loop. (photo 1-2). Silt fence on the west side is wind damaged (photo 3) and a review of the inspections indicates an ongoing problem.

NMED/SWQB Official Photograph Log Photo # 1		
Photographer: J. Foote	Date: 5/21/19	Time: 10:45 am
City/County: Albuquerque/Bernalillo		State: New Mexico
Location: O'Reilly Auto Parts (Coors)		
Subject: silt fence removed from east side, future drainage pond filled with dirt/utilities, BMP for under sidewalk drain is backfill.

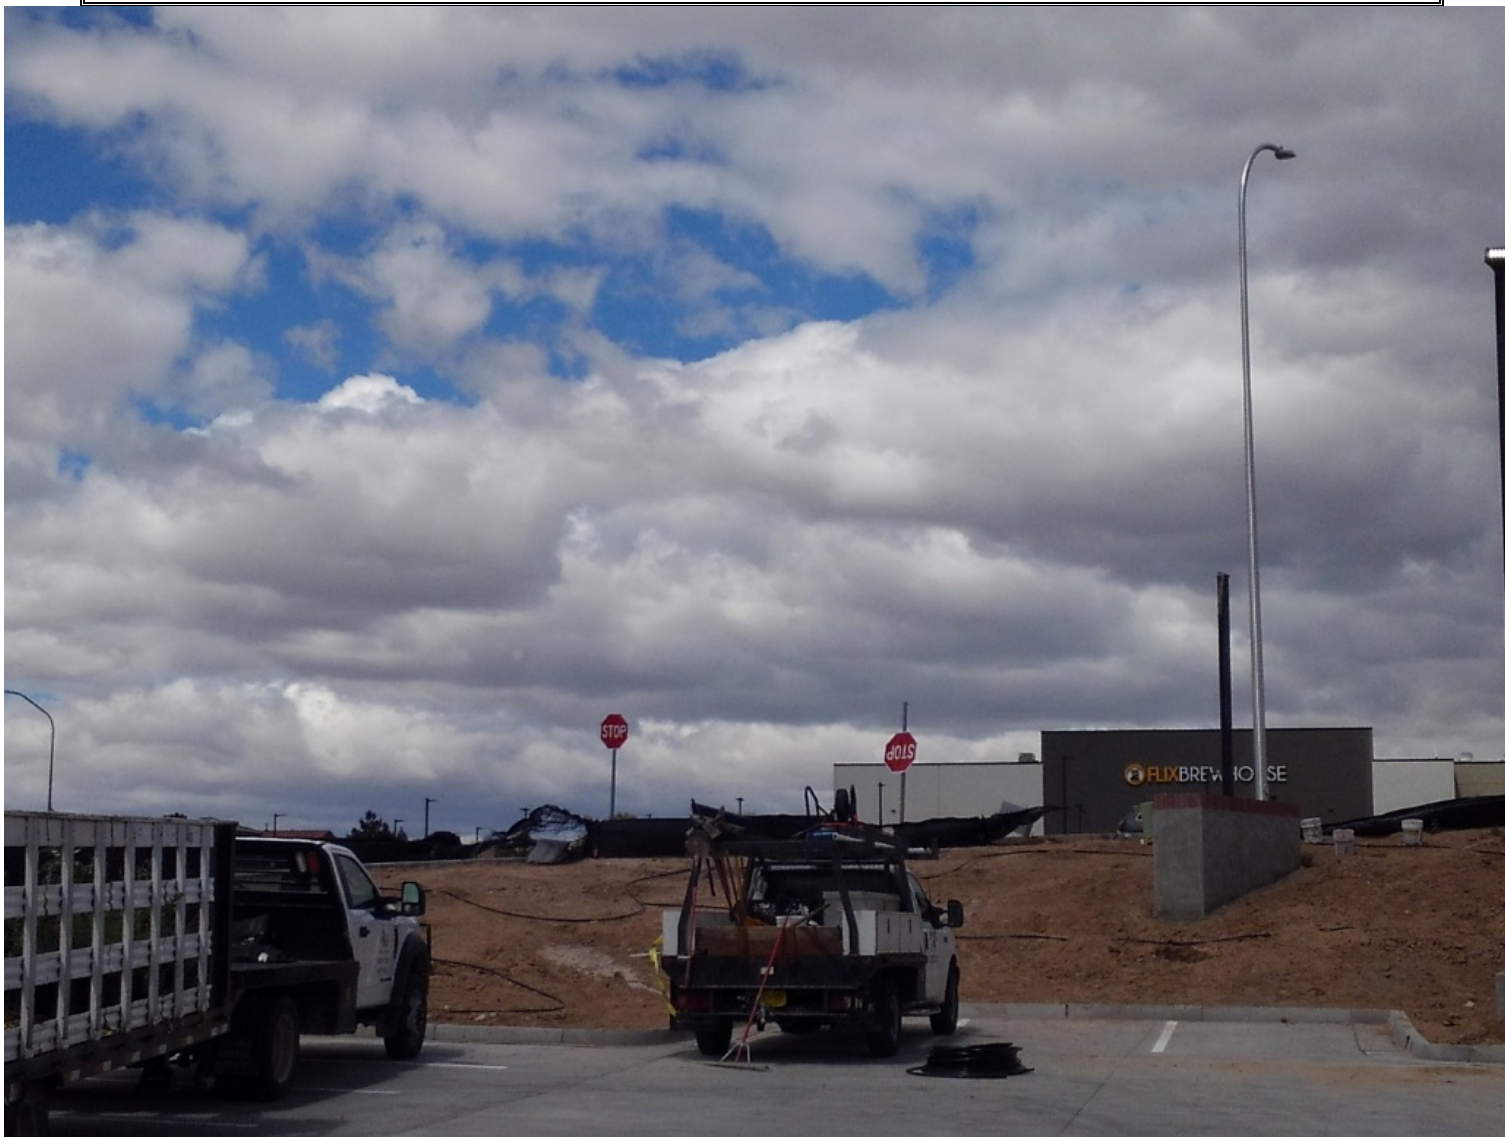
Stucco washout was occurring directly on the ground(Photo 3).

- Part 2.1.4 Silt fence was not maintained or installed per SWPPP locations.
- Part 2.2.14 No documentation for temporary stabilization of disturbed areas.
- Part 2.3.3 Waste containers were not covered when not in use.
- Part 2.3.4 Stucco washout was occurring directly on the ground and not into a leakproof container.

NMED/SWQB Official Photograph Log Photo # 3		
Photographer: J. Foote	Date: 5/21/19	Time: 10:45 am
City/County: Albuquerque/Bernalillo		State: New Mexico
Location: O'Reilly Auto Parts (Coors)		
Subject: silt fence blowing in wind, stucco washout on ground
