**NEW MEXICO
ENVIRONMENT DEPARTMENT**

Re: HBC Construction/ O'Reilly Auto Parts (Coors); Construction Stormwater; SIC 1542; NPDES Compliance Evaluation Inspection; NPDES # NMR1001QY; May 21, 2019

NPDES Compliance Inspection Report

NPDES Construction General Permit Inspection Report – State of New Mexico

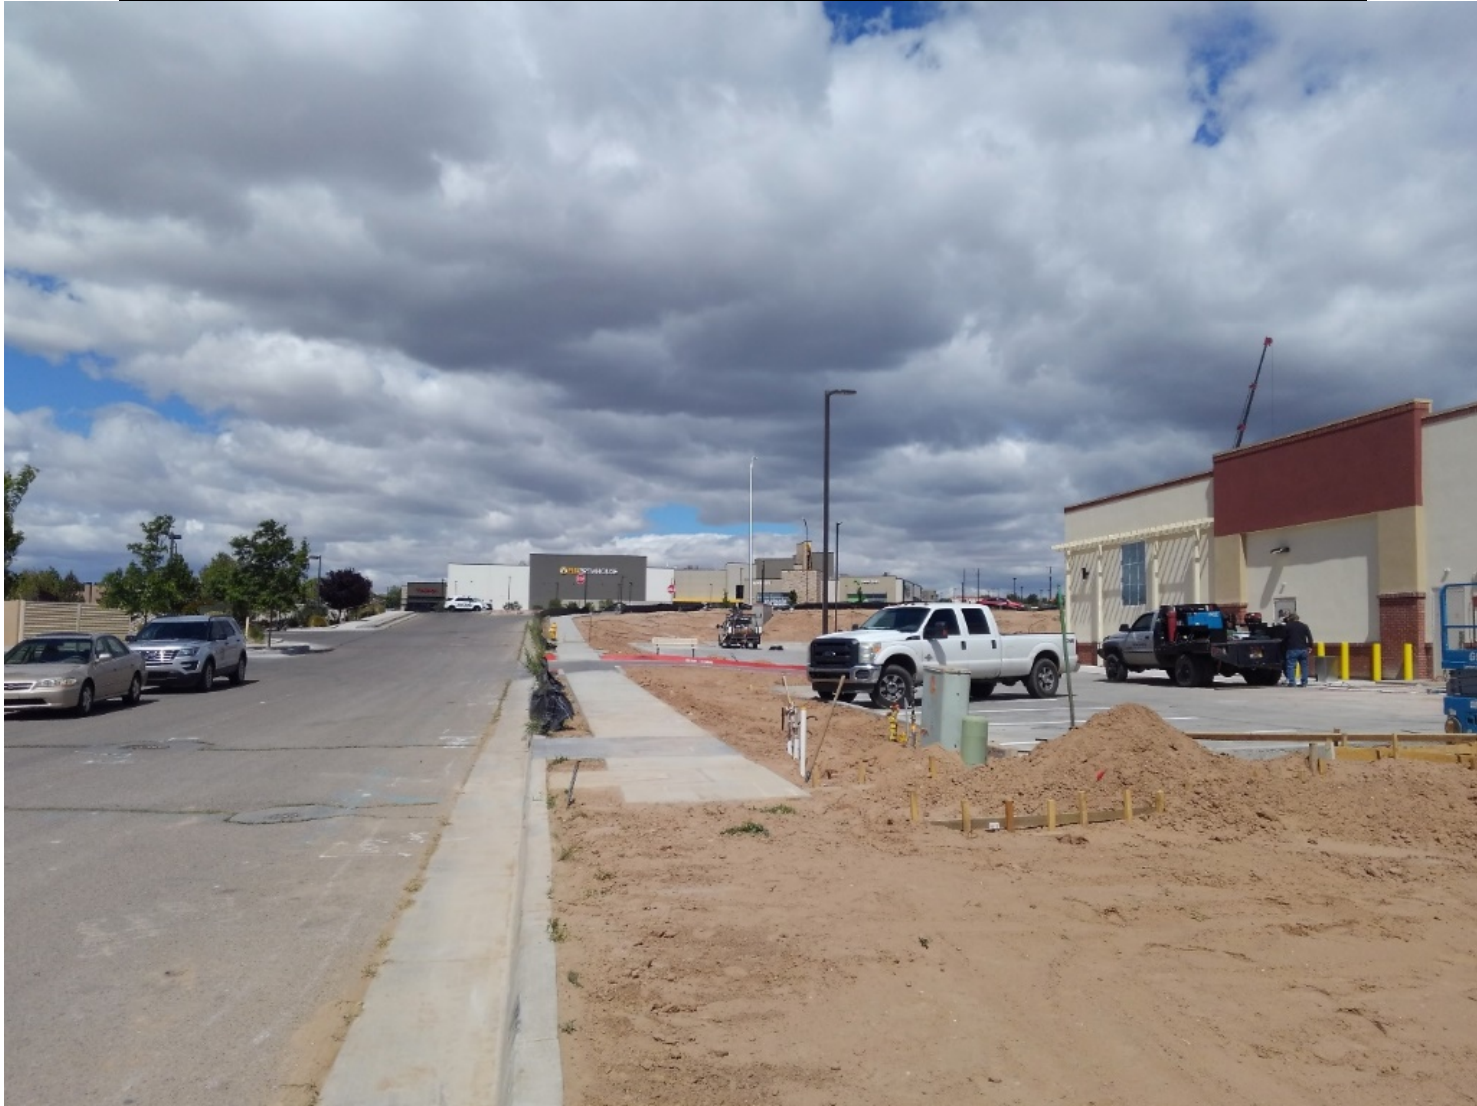
When the inspector arrived, the Operators were just finishing shoveling the gutters clean of sediment. BMPs have been removed except for the far east end. The water quality pond had not yet been constructed as utilities had been located within it and need to be relocated (photo 1). It is unclear if the water quality pond and discharge culvert was sized to accommodate the two 36" DOT culverts that discharge to the site, the map states the pond is slightly undersized to meet the local ordinance.

The waste container was not covered (photo 2). No stabilization has been planned for the adjacent lot on the east side that was disturbed during this project, including the area within the driveway loop. (photo 1-2). Silt fence on the west side is wind damaged (photo 3) and a review of the inspections indicates an ongoing problem.

NMED/SWQB Official Photograph Log Photo # 1		
Photographer: J. Foote	Date: 5/21/19	Time: 10:45 am
City/County: Albuquerque/Bernalillo		State: New Mexico
Location: O'Reilly Auto Parts (Coors)		
Subject: silt fence removed from east side, future drainage pond filled with dirt/utilities, BMP for under sidewalk drain is backfill.

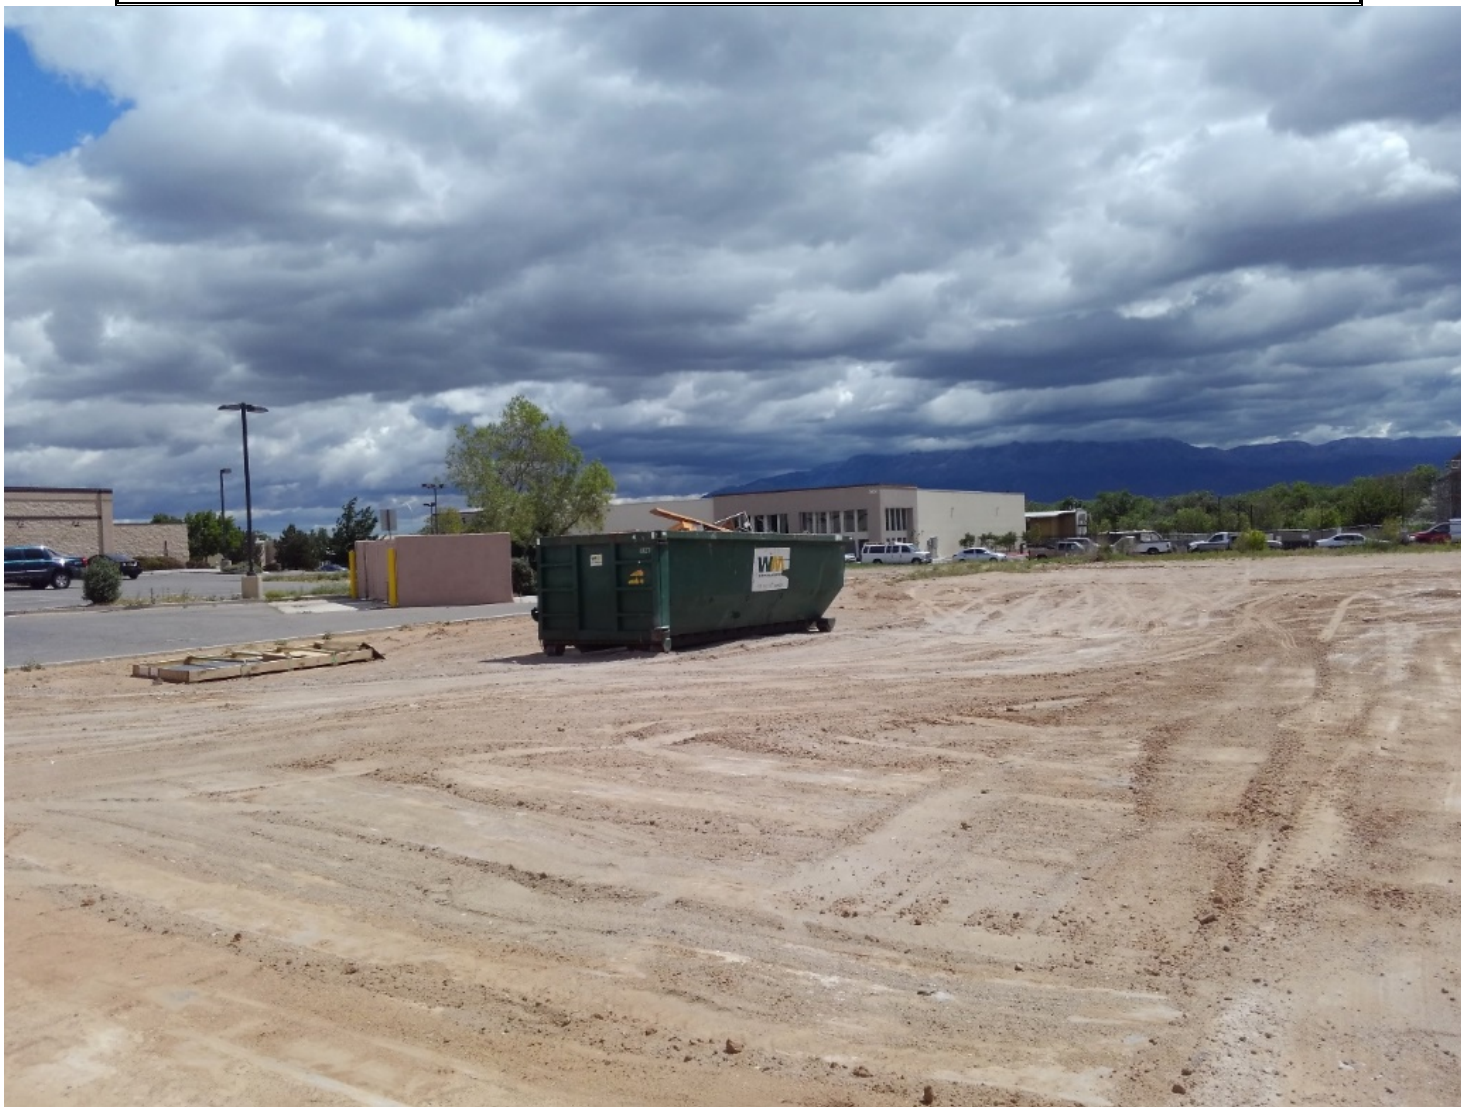
NMED/SWQB Official Photograph Log Photo # 2		
Photographer: J. Foote	Date: 5/21/19	Time: 10:45 am
City/County: Albuquerque/Bernalillo		State: New Mexico
Location: O'Reilly Auto Parts (Coors)		
Subject: staging area, no stabilization or BMPs, no cover on dumpster

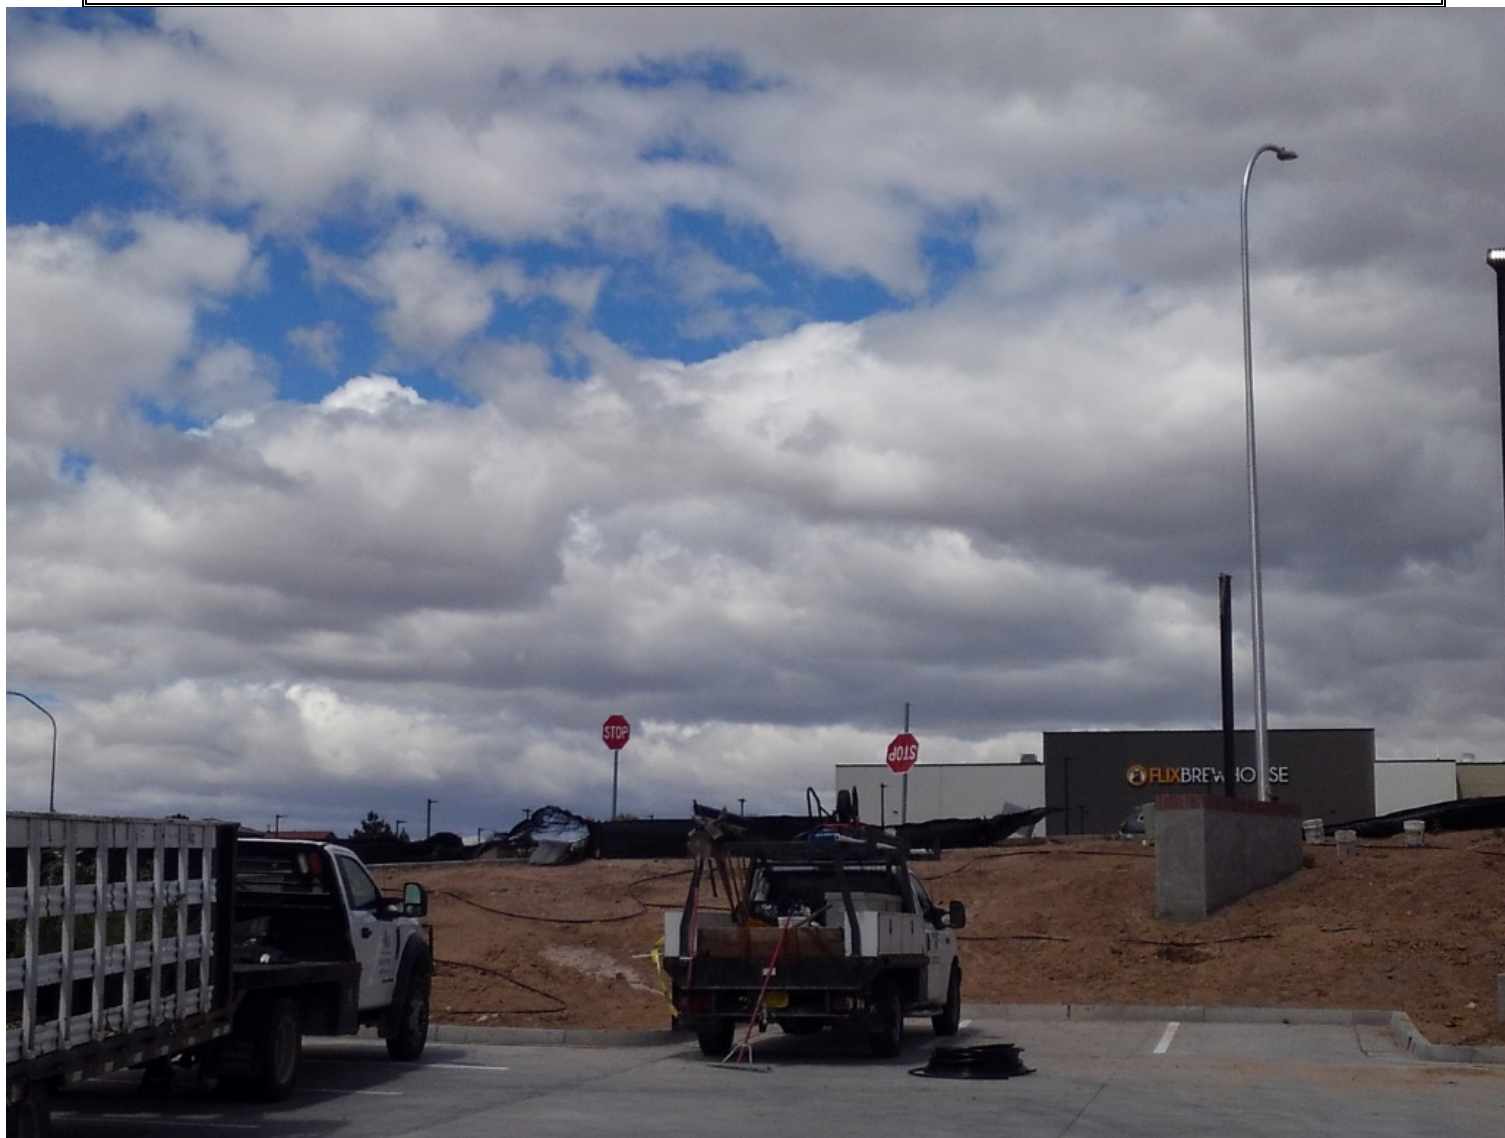
Stucco washout was occurring directly on the ground(Photo 3).

- Part 2.1.4 Silt fence was not maintained or installed per SWPPP locations.
- Part 2.2.14 No documentation for temporary stabilization of disturbed areas.
- Part 2.3.3 Waste containers were not covered when not in use.
- Part 2.3.4 Stucco washout was occurring directly on the ground and not into a leakproof container.

NMED/SWQB Official Photograph Log Photo # 3		
Photographer: J. Foote	Date: 5/21/19	Time: 10:45 am
City/County: Albuquerque/Bernalillo		State: New Mexico
Location: O'Reilly Auto Parts (Coors)		
Subject: silt fence blowing in wind, stucco washout on ground
