City of Albuquerque Stormwater Construction Site Inspection Report

Site: Andalucia

Re: Drainage Ordinance (14-5-2-1) Violations for Erosion and Sediment Control

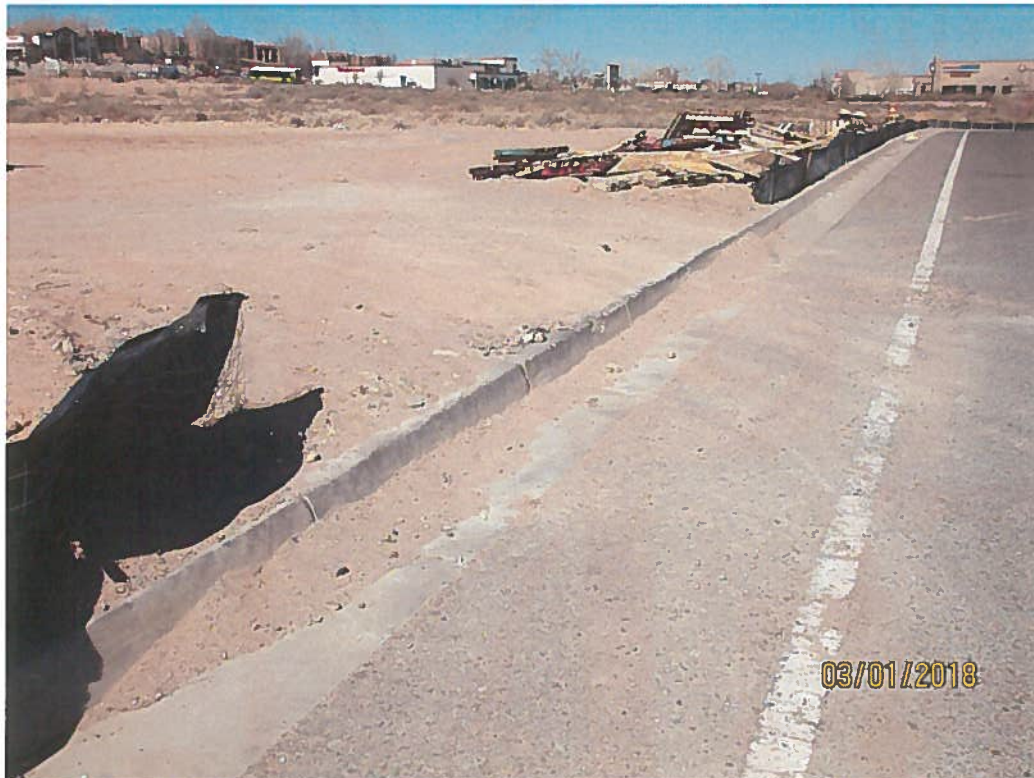
1. There was no track-out pad/stabilized construction entrance from the staging area.
2. There was track-out onto Mirandela St.
3. Remnants of the dirt ramp in the gutter were present.
4. Sediment and rocks in Mirandela St.

No Stabilized Construction Entrance/track-out pad. Remnants of dirt ramp in gutter

1. Install a track-out pad/stabilized construction entrance from the staging area per the approved Erosion and Sediment Control Plan and keep it maintained.
2. Remove track-out from Mirandela St.
2. Remove remnants of the dirt ramp from the gutter.
3. Remove sediment and rocks in Mirandela St.

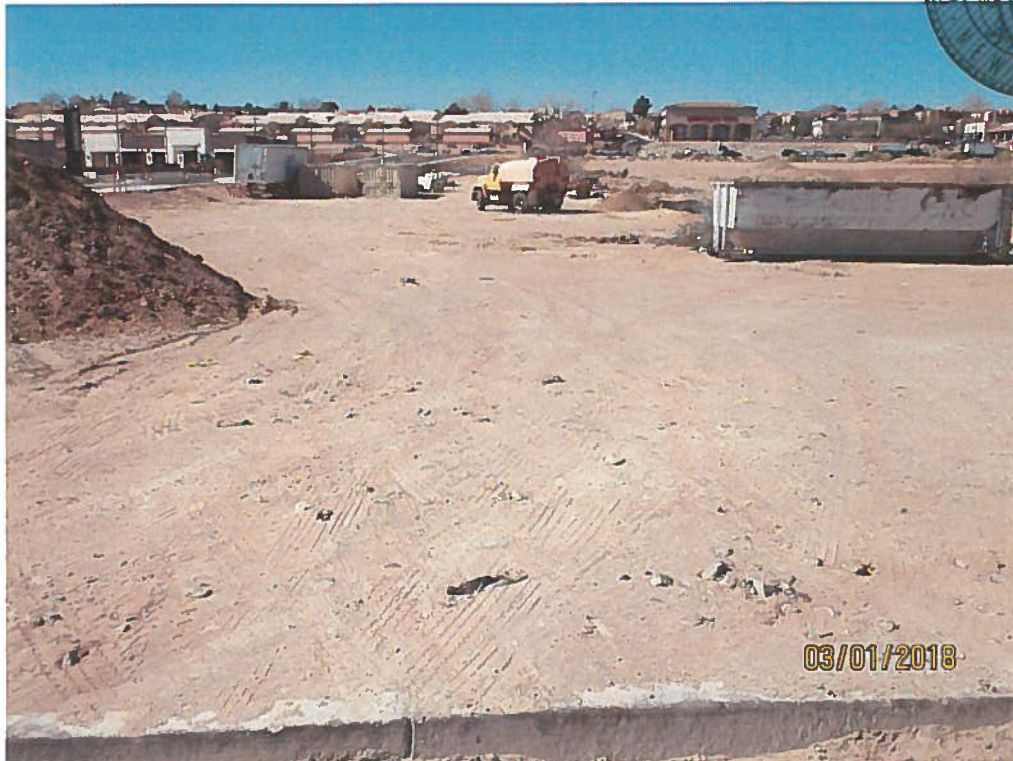
Different view of no track-out pad from staging area.

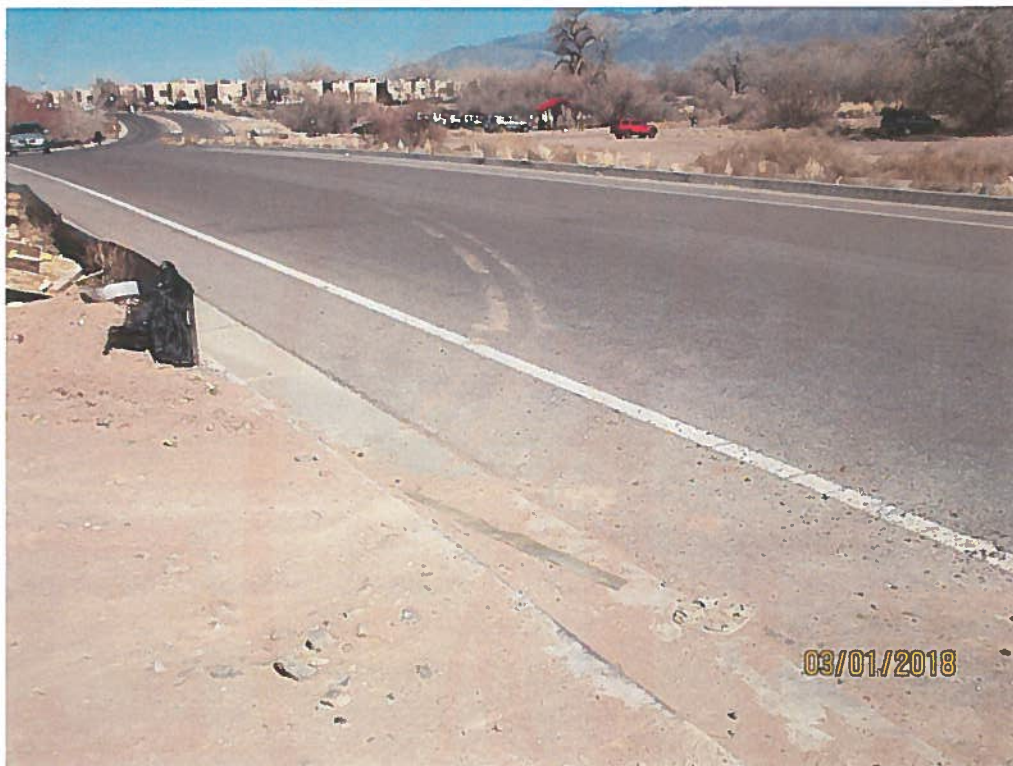
Track-out onto Mirandela St.

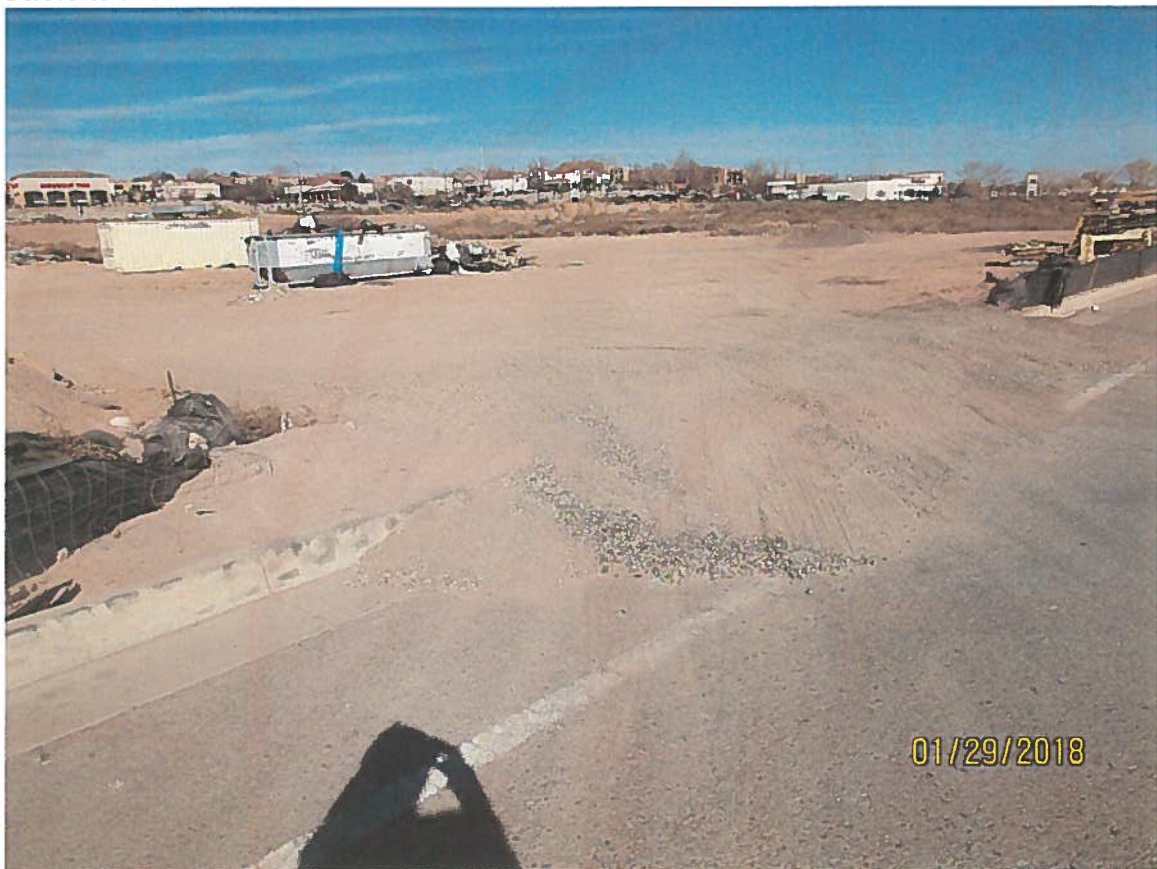
1. Dirt ramp in street.
2. No track-out pad/stabilized construction entrance.

Dirt ramp in street and no track-out pad.

1. Remove dirt ramp and associated dirt from street.
2. If you wish to continue to use this location to exit the site, a track-out pad/stabilized construction entrance is required.

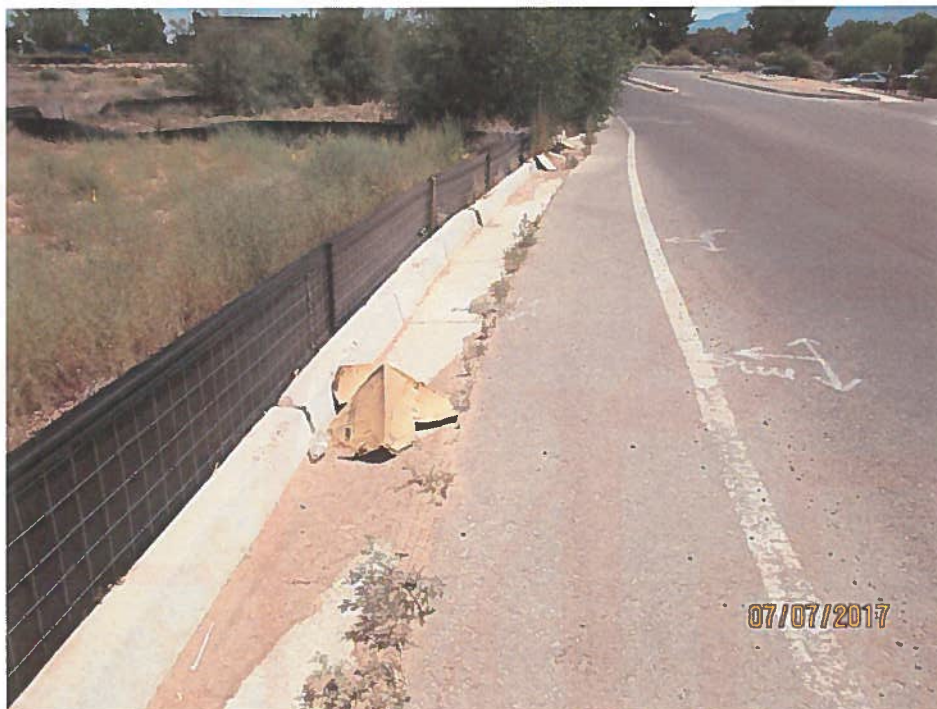
Sediment and trash in Mirandela St.

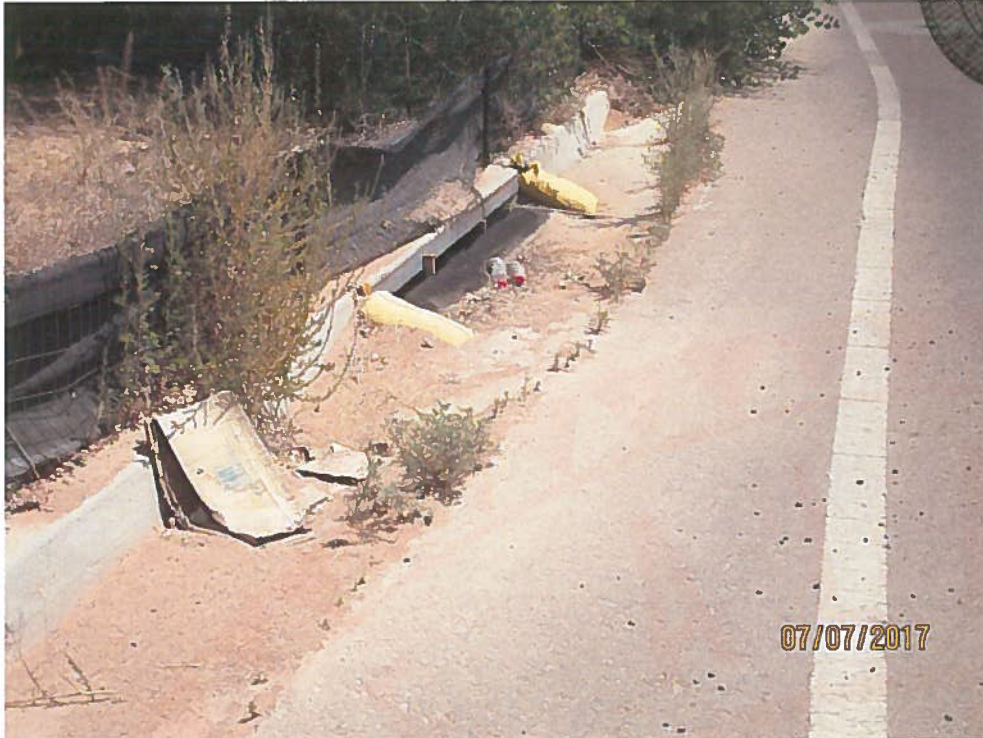
Sediment and trash in Mirandela St.

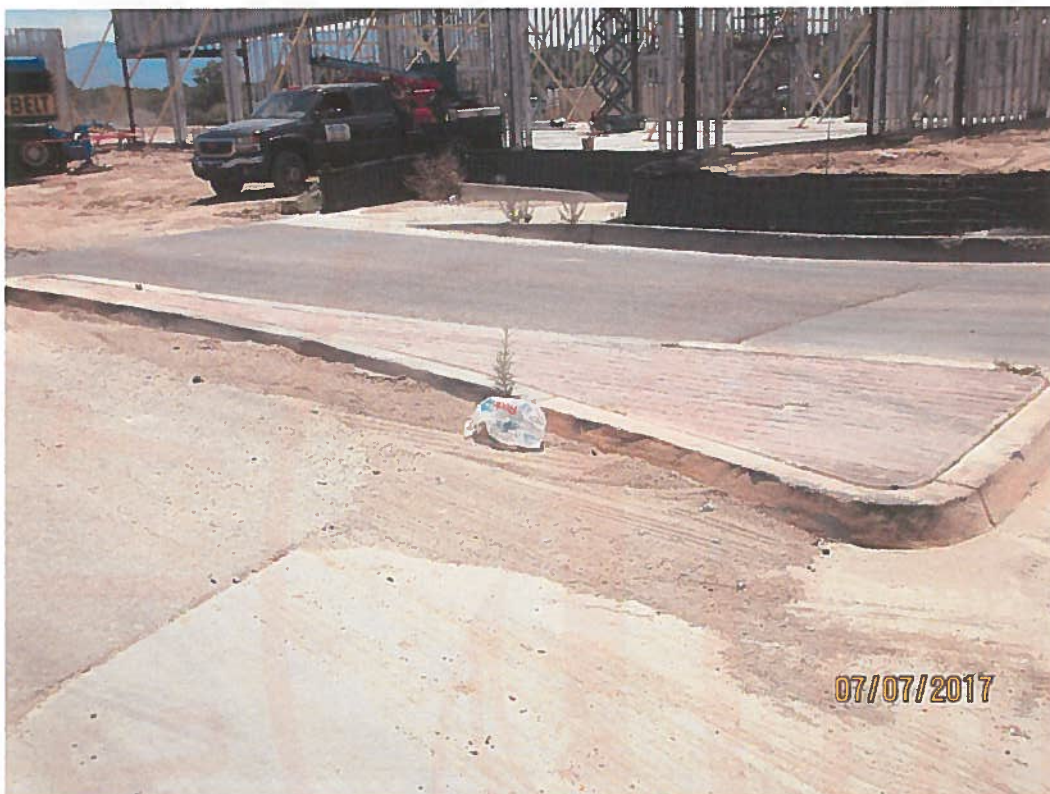
Sediment and trash near site entrance.

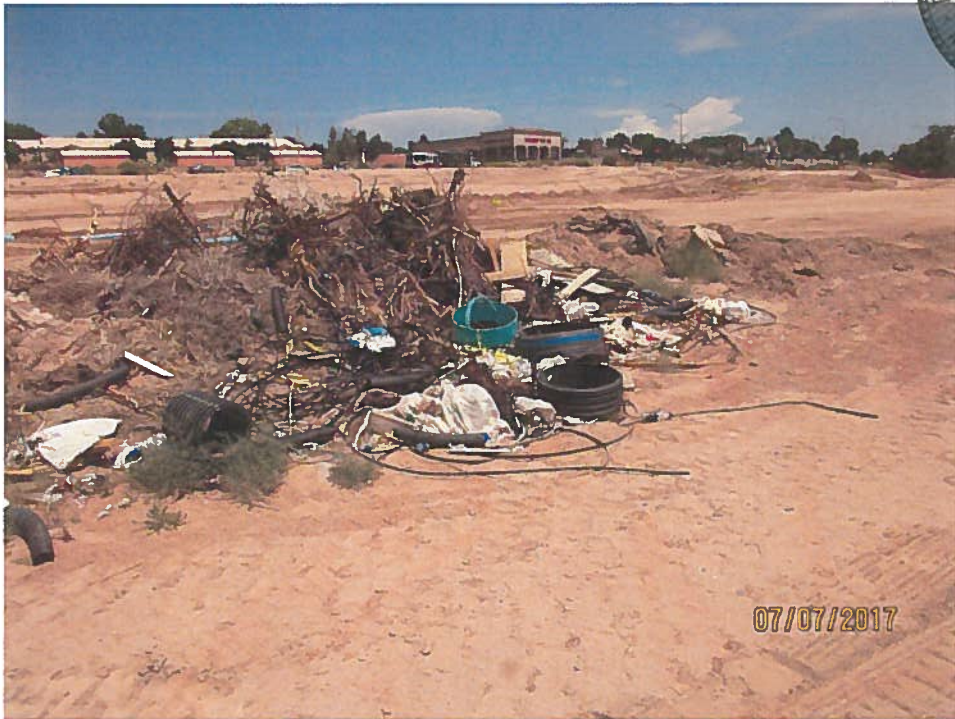
Trash

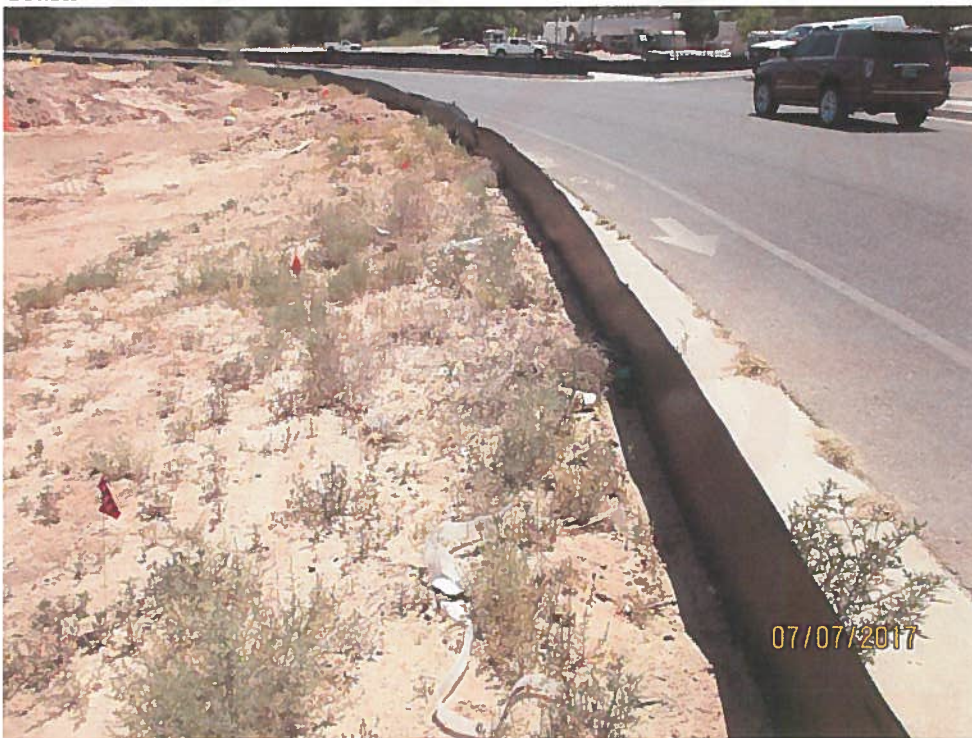
More trash.

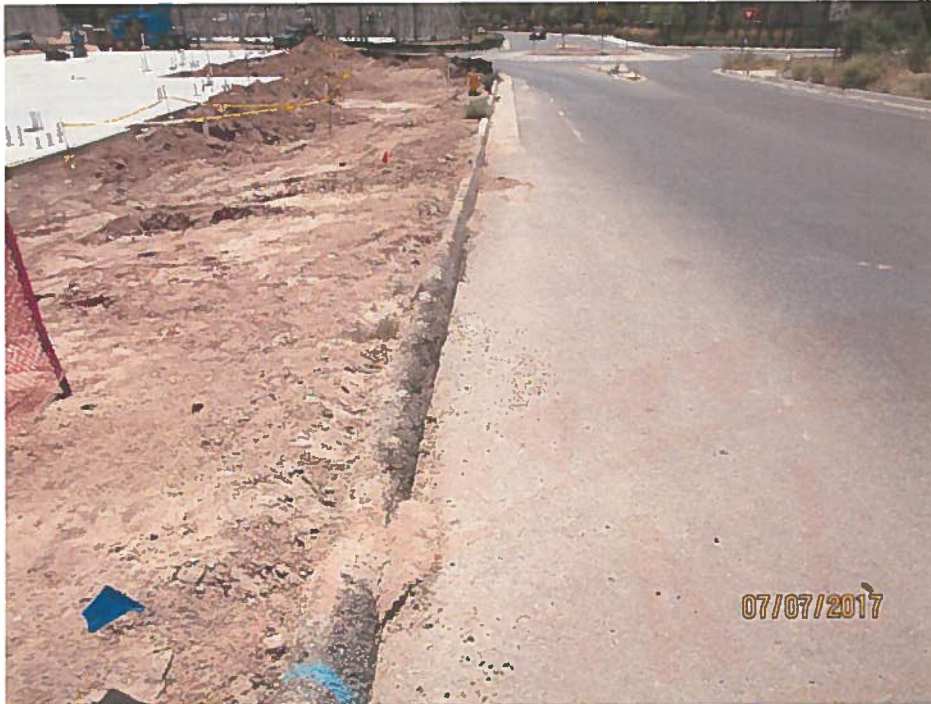
No sediment BMP and sediment spilling into street.

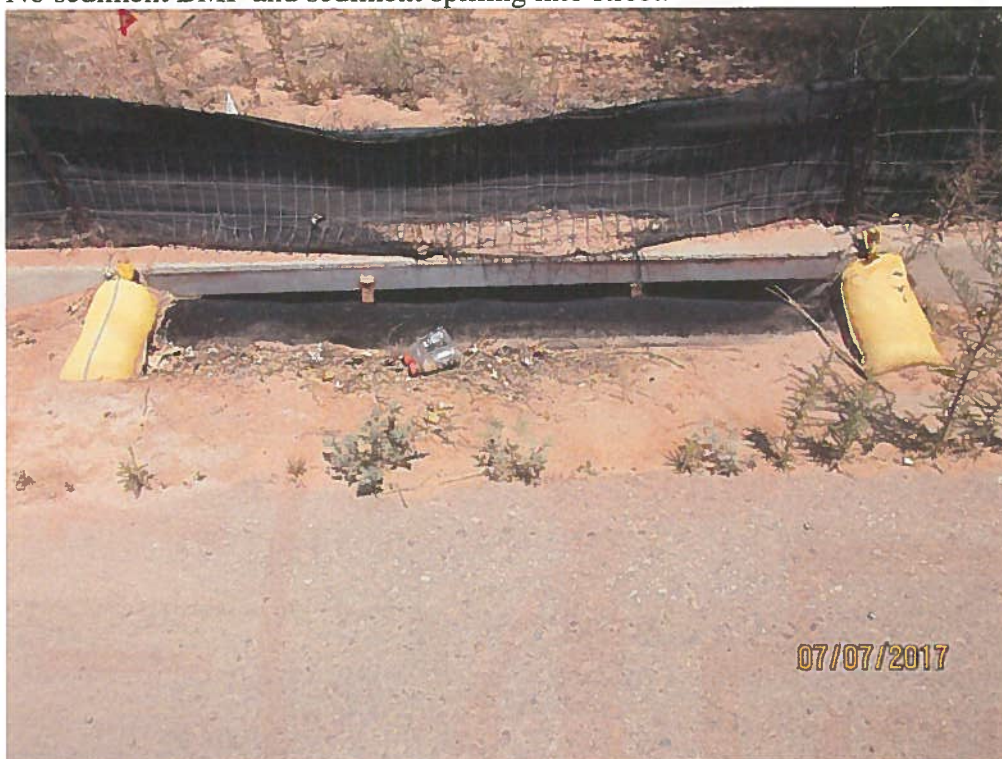
Inlet protection requires maintenance.
