CITY OF ALBUQUERQUE

Hydrology Section Planning Department
David S. Campbell, Director

July 25, 2018

**RE: Tract J-1-B of the Vista Del Norte Subdivision
Drainage & Erosion Problems (E16D022)**

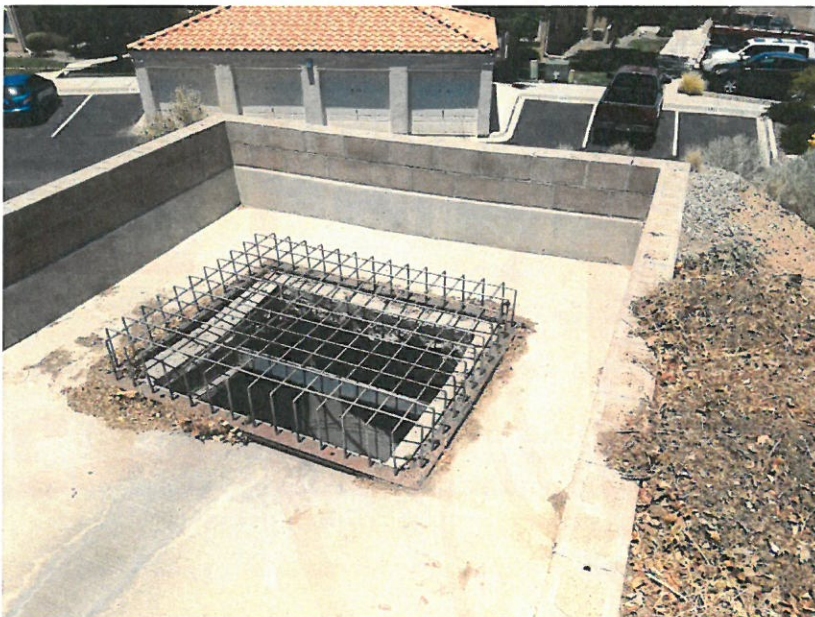
I inspected the City maintained inlet in the northwest corner of Tract J-1-A on June 26, 2018 and found that there was no evidence of erosion around the inlet. Instead the erosion is located on the slope next to the privately maintained floodwall south of the inlet. It is

unclear whether the drainage that caused the erosion came over the top of the floodwall or leaked under the floodwall, but the floodwall footing is hanging in the air in some locations so drainage could easily go under the wall now.

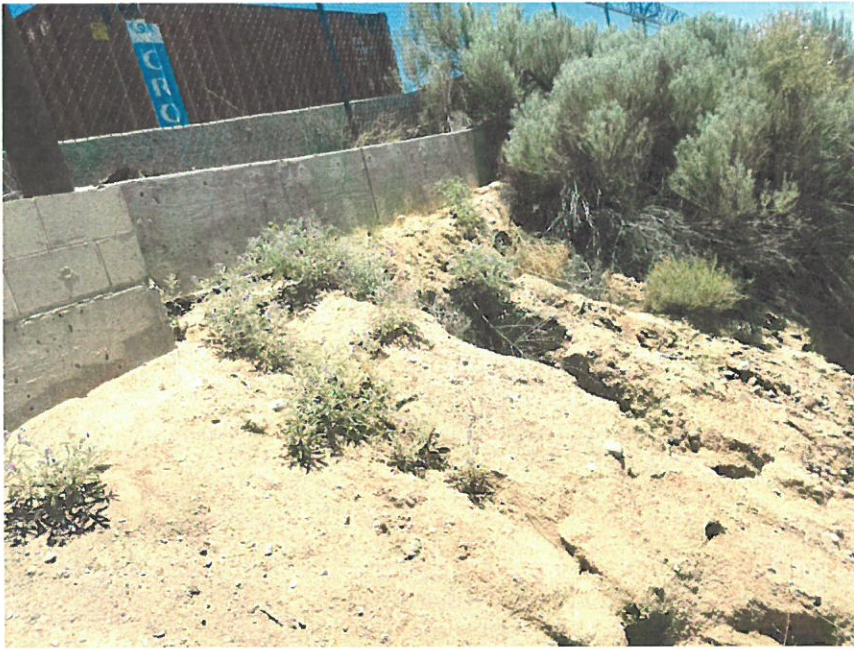
The footing of the wall does not appear to be deep enough to prevent leaks. Furthermore drainage can easily infiltrate through the dirt gap between the wall on Tract J-1-A and the asphalt paving Lot 4 of the Sego-Cox Subdivision.

Repair of both the slope and the floodwall is recommended. Maintenance of the wall and slope appears to be the responsibility of the

It is recommended that the owners of the two lots work together to rebuild the floodwall filling in the gap between the asphalt and the wall and improving the footer for the floodwall.

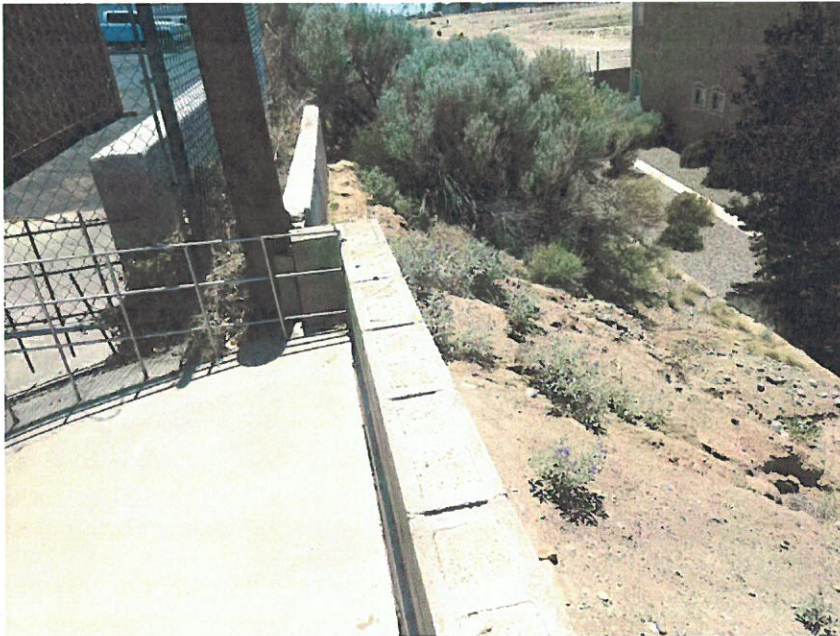
If leaves and debris accumulate on the chain link fence on Lot 4 of the SEGO-COX Subdivision it could back water up on the leaking wall and increase the leakage. The drainage swales in the SEGO-COX Subdivision should not be blocked by leaves and debris.

Redesign and/or relocation of the fence is recommended.

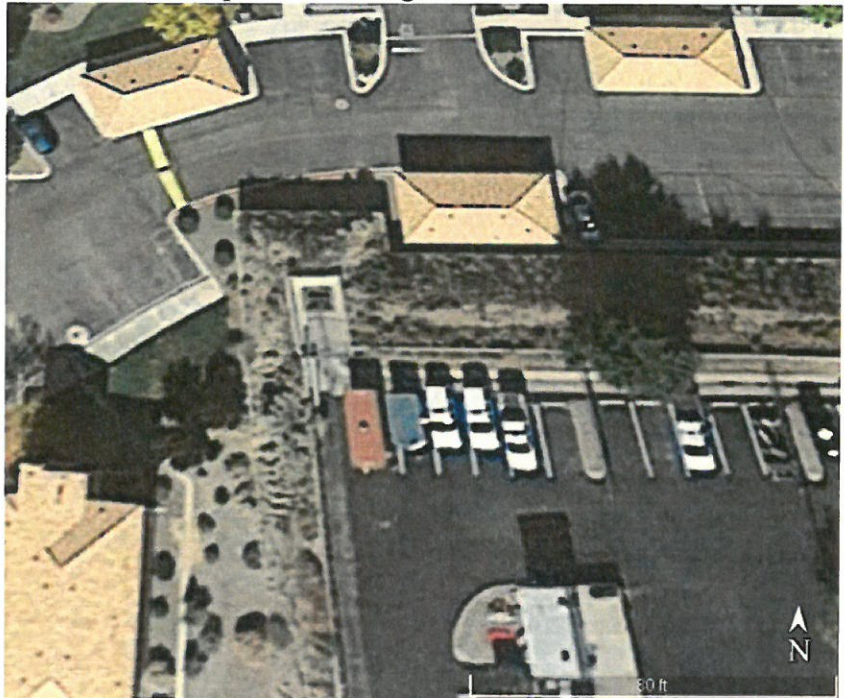
However in June 2016 additional erosion did occur on the slope south of the inlet as can be seen in the Google Earth Photo.

One additional thing that can be done to reduce the depth of water in the northwest corner of lot 4 is increase the width of the choke point where the water exits lot 4 to the inlet. The floodwalls on Tract J-1-B constrict the flow to 10' width on the south side of the inlet.

That opening could be widened by reconstructing the floodwall and expanding the concrete apron around the inlet and thus reduce the height of flooding in the parking lot. If the width of the opening is doubled the depth of the 100 year peak flow in the parking lot may be reduced from 1.4' to 0.9' and significantly reduce the impact of leaves and debris clogging the opening. The perimeter of the grate is 18' so that is not currently the limiting factor on the capacity of the system; instead the limiting factor is the width of the opening in the floodwall south of the inlet.
