# City of Albuquerque Stormwater Construction Site Inspection Report

**Re: Drainage Control Ordinance (14-5-2-1) and NPDES CGP Violations for Erosion and Sediment Control and pollution - La Luz Del Oeste Unit 4**

**Project: La Luz Del Oeste Unit 4**

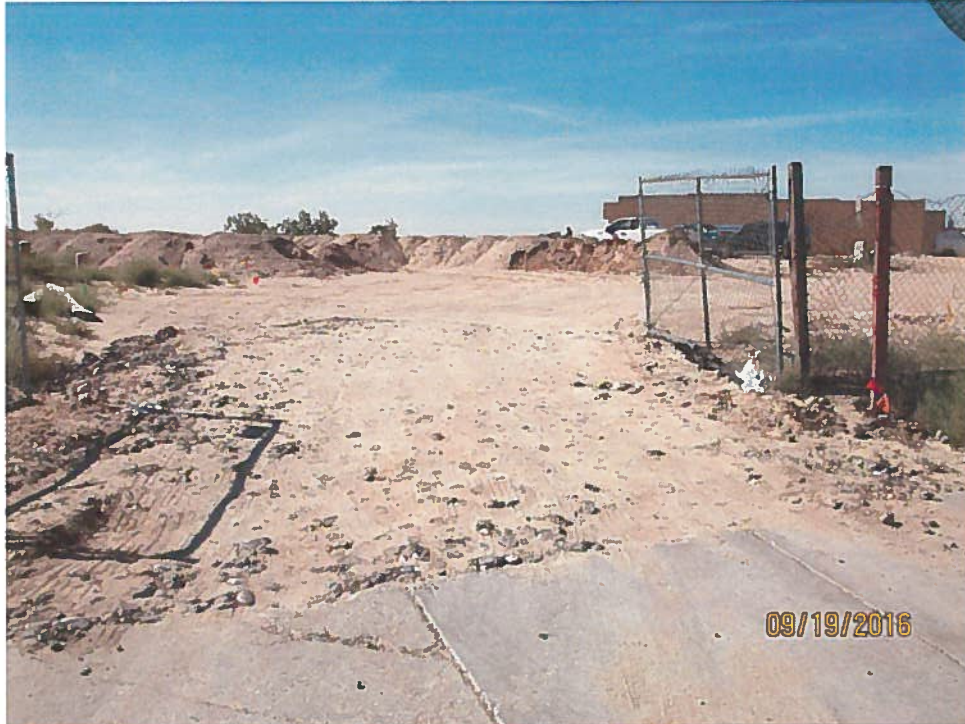
1. Construction entrance needs maintenance.
2. Multiple instances of cement pollution.
3. Silt fence was installed along Dellyne, Ave., however, it was not installed so that it would function to prevent sediment from leaving the site as it was not buried.

Construction entrance to the site poorly maintained.

1. Install/maintain the silt fence at the site per approved plan.
2. Install a stabilized entrance per the approved plan.
2. Remove cement pollution material per acceptable methods.

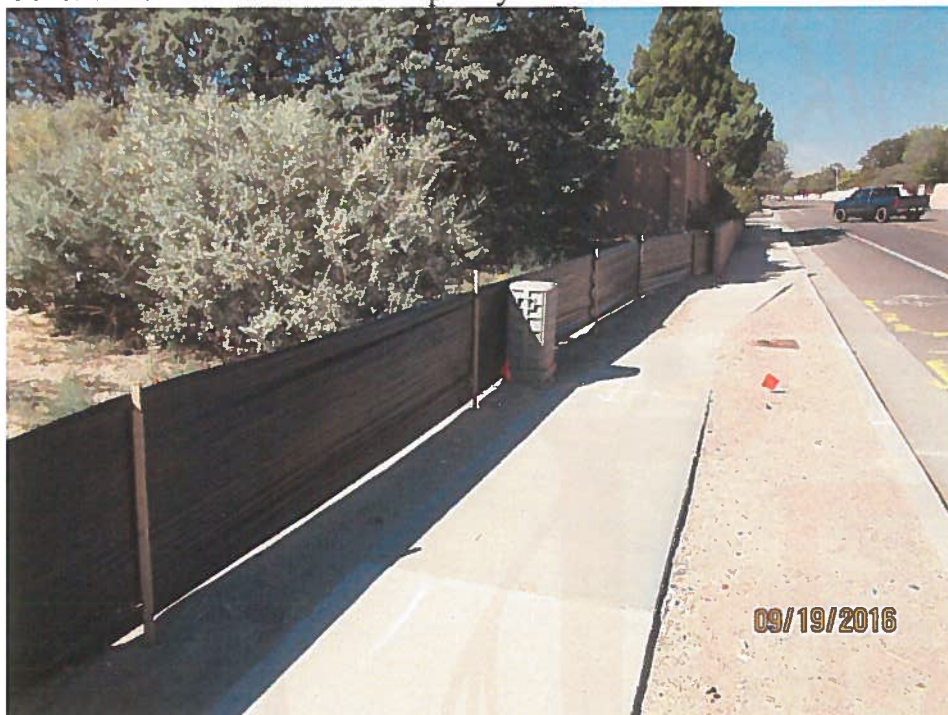
Silt fence along Dellyne Ave. not buried; ineffective.

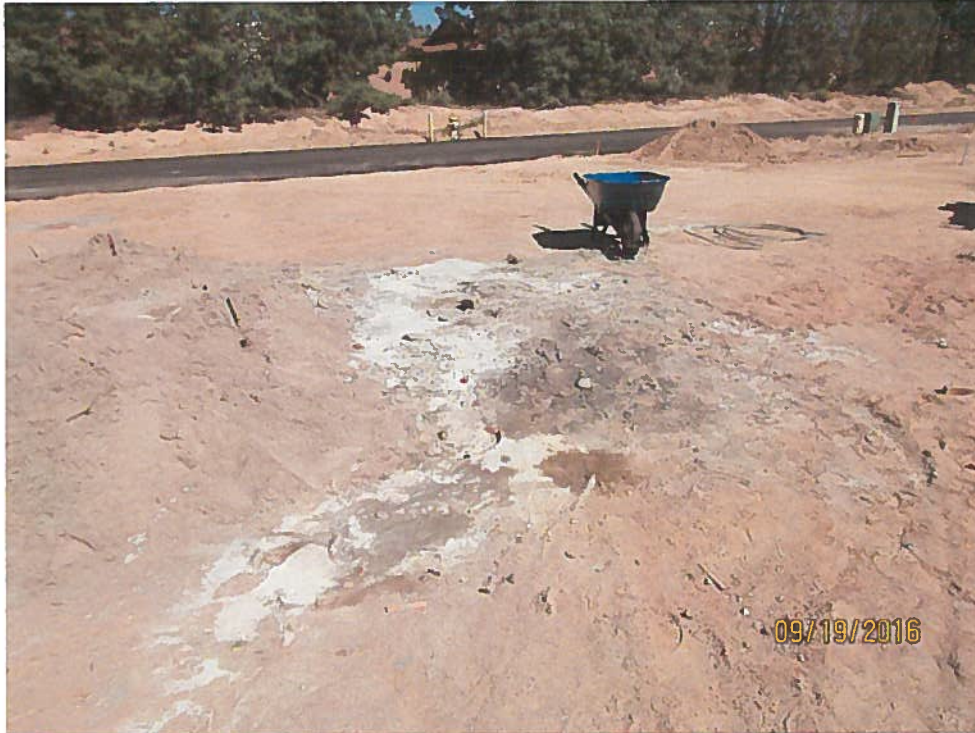
Cement pollution.

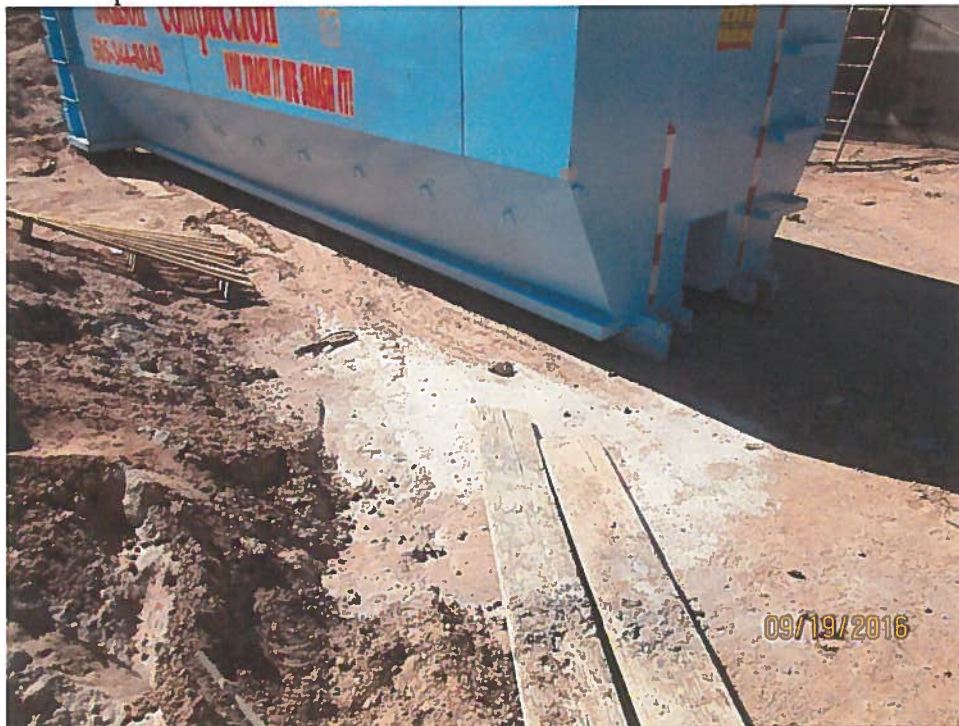
Second photo of cement pollution.

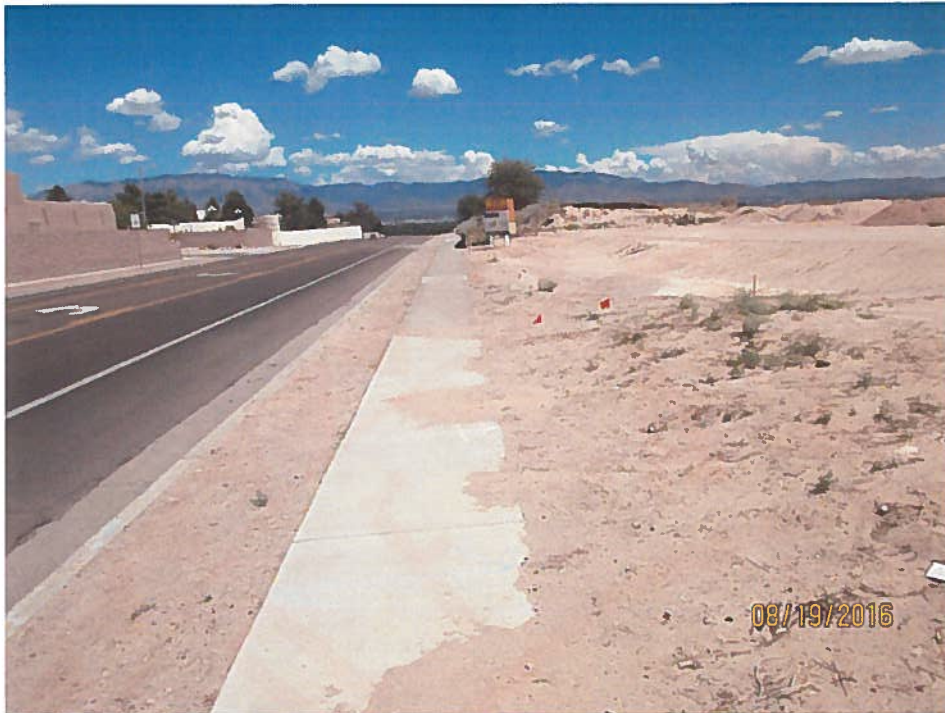
No silt fence along Dellyne Ave. Sediment leaving site.

1. Install silt fence along project boundary along Dellyne Rd and remove sediment from the sidewalk.
2. Improve the construction entrance to Erosion Control Plan specifications.
3. Install the series of wattles across the road to Mill Rd. per the Erosion Control Plan.
4. Remove cement pollution material and have an acceptable concrete wash-out on site.

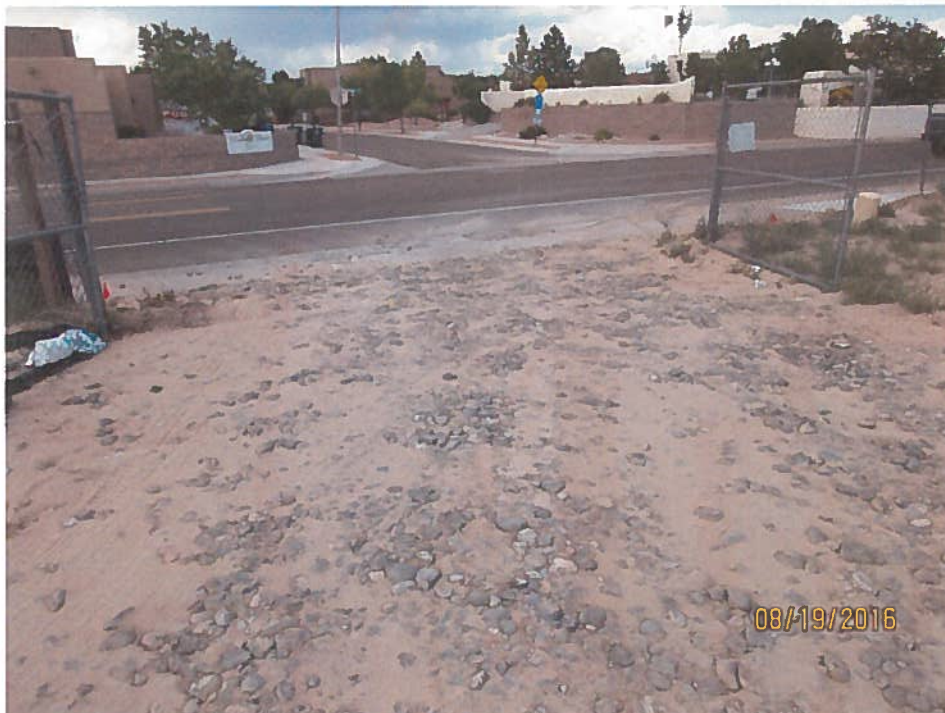
Construction entrance not maintained.

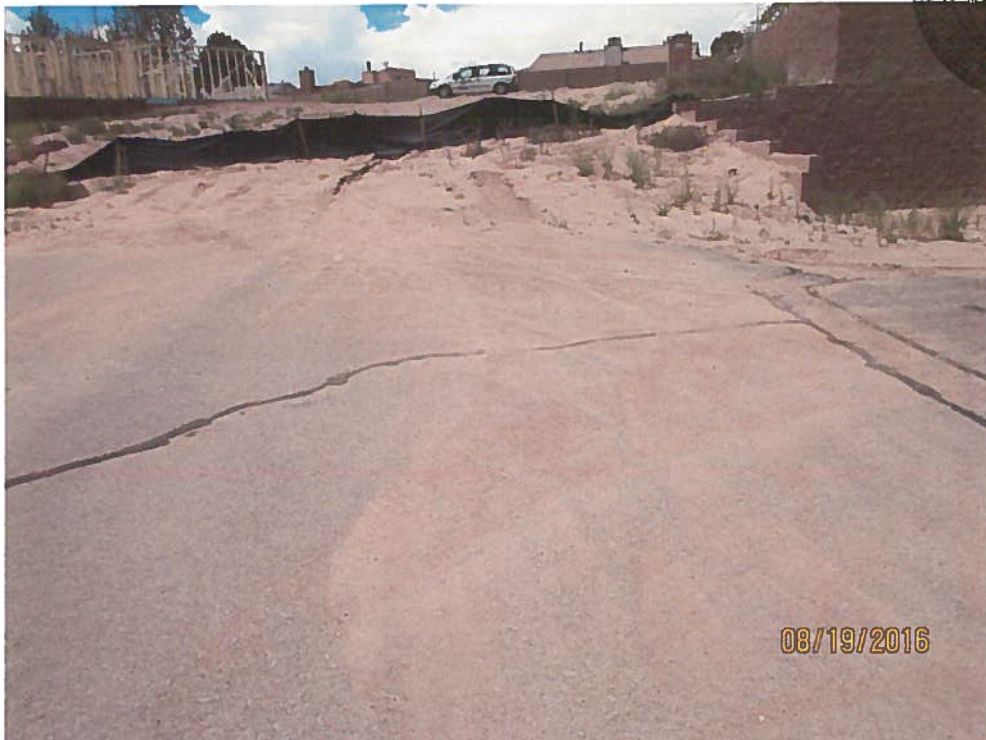
Sediment in Mill Rd. from ineffective BMP not per approved plan.

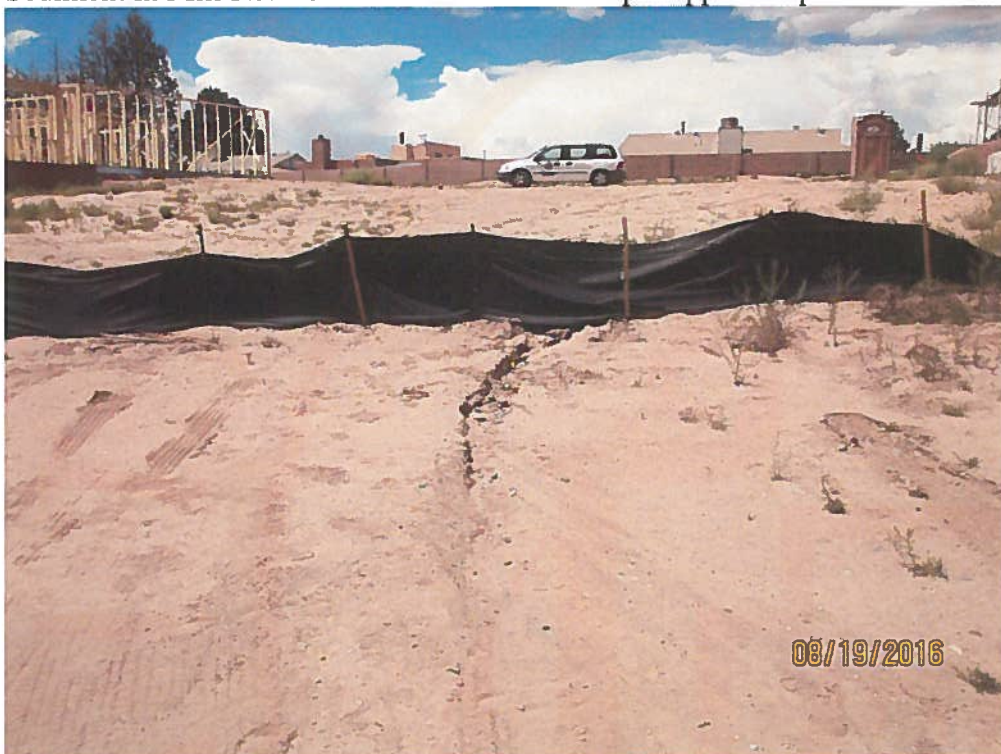
Erosion from ineffective BMP not per plan.

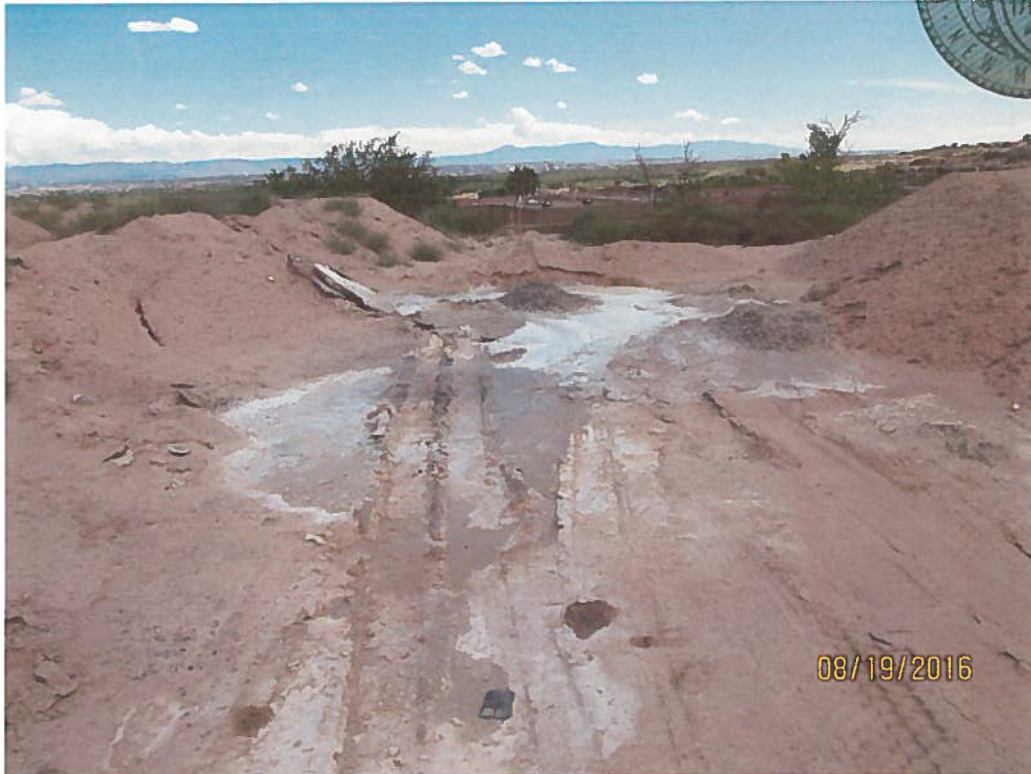
Large are of cement pollution.

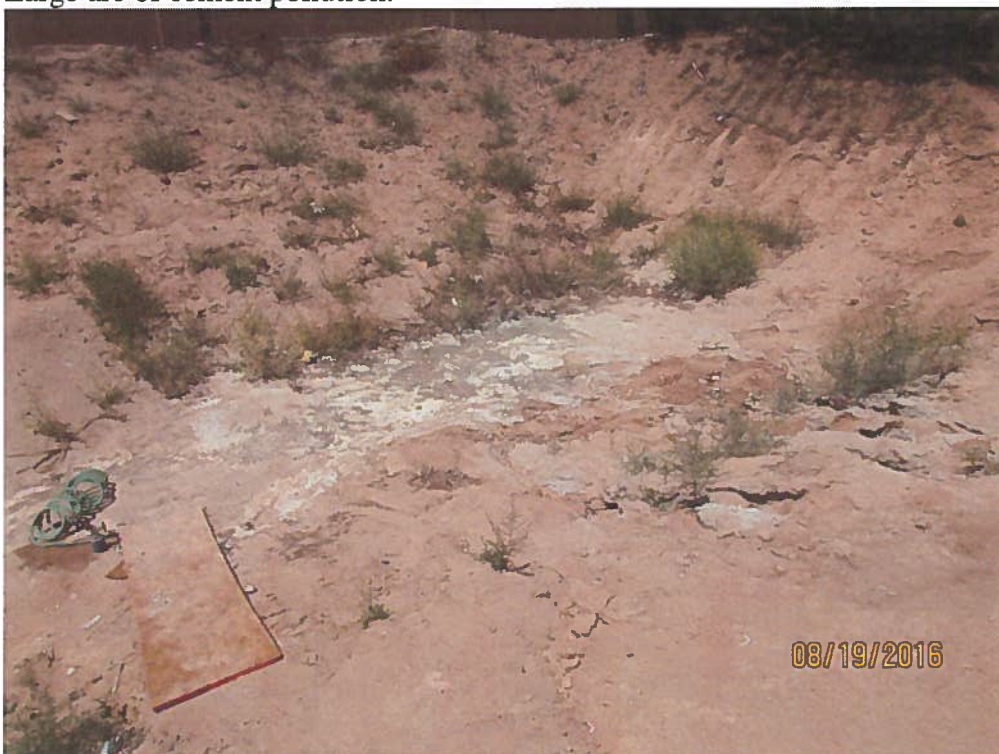
Cement pollution in ponding area.
