August 19, 2016

Re: Drainage Control Ordinance (14-5-2-1) and NPDES CGP Violations for Erosion and Sediment Control and Pollution – La Luz Del Oeste Unit 4

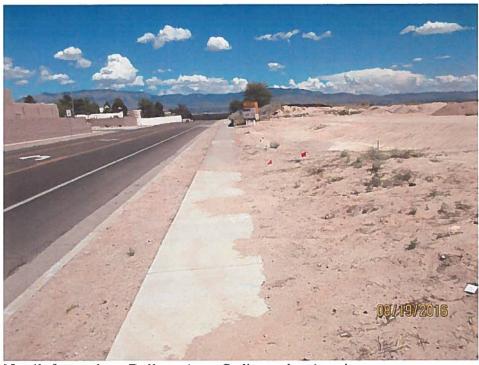
- 1. Missing silt fence along Dellyne Ave. Sediment was observed leaving the site.
- 2. The construction entrance needs maintenance.
- 3. The sediment BMP across road to Mill Rd needs improvement. Sediment observed in Mill Rd.
- 4. In addition to the repeat violations listed above, numerous instances of cement pollution were observed. See photos with descriptions.

No silt fence along Dellyne Ave. Sediment leaving site.

1. Install silt fence along project boundary along Dellyne Rd and remove sediment from the sidewalk.

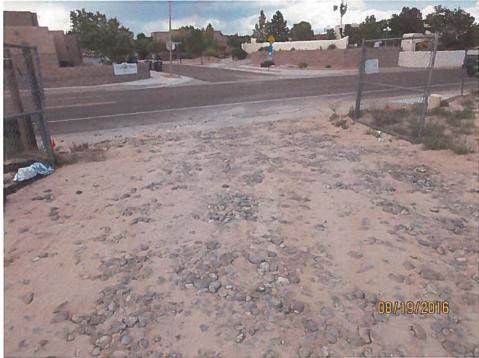
Construction entrance not maintained.

- 2. Improve the construction entrance to Erosion Control Plan specifications.
- 3. Install the series of wattles across the road to Mill Rd. per the Erosion Control Plan.

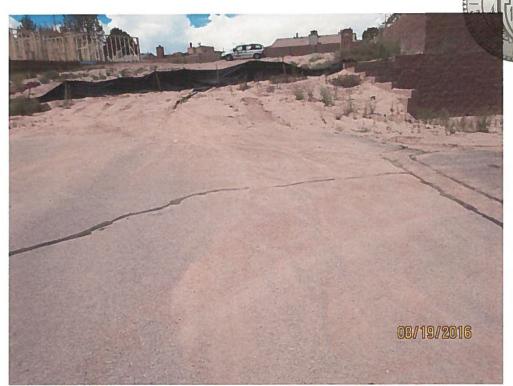
Sediment in Mill Rd. from ineffective BMP not per approved plan.

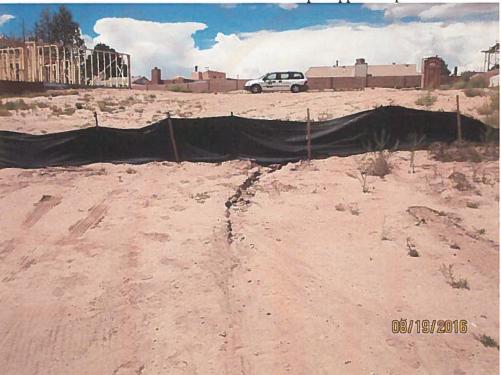
Erosion from ineffective BMP not per plan.

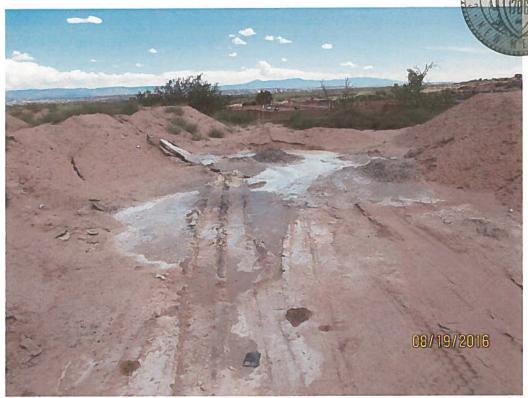
Large are of cement pollution.

4. Remove cement pollution material and have an acceptable concrete wash-out on site.

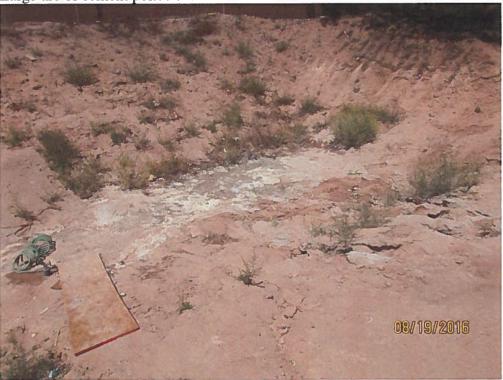
Cement pollution in ponding area.
