**From:** Cherne, Curtis  
**Sent:** Friday, September 04, 2015 9:04 AM  
**To:** nancybelen25@yahoo.com; 'davisbelen@aol.com'  
**Subject:** erosion at Vista De La Luz

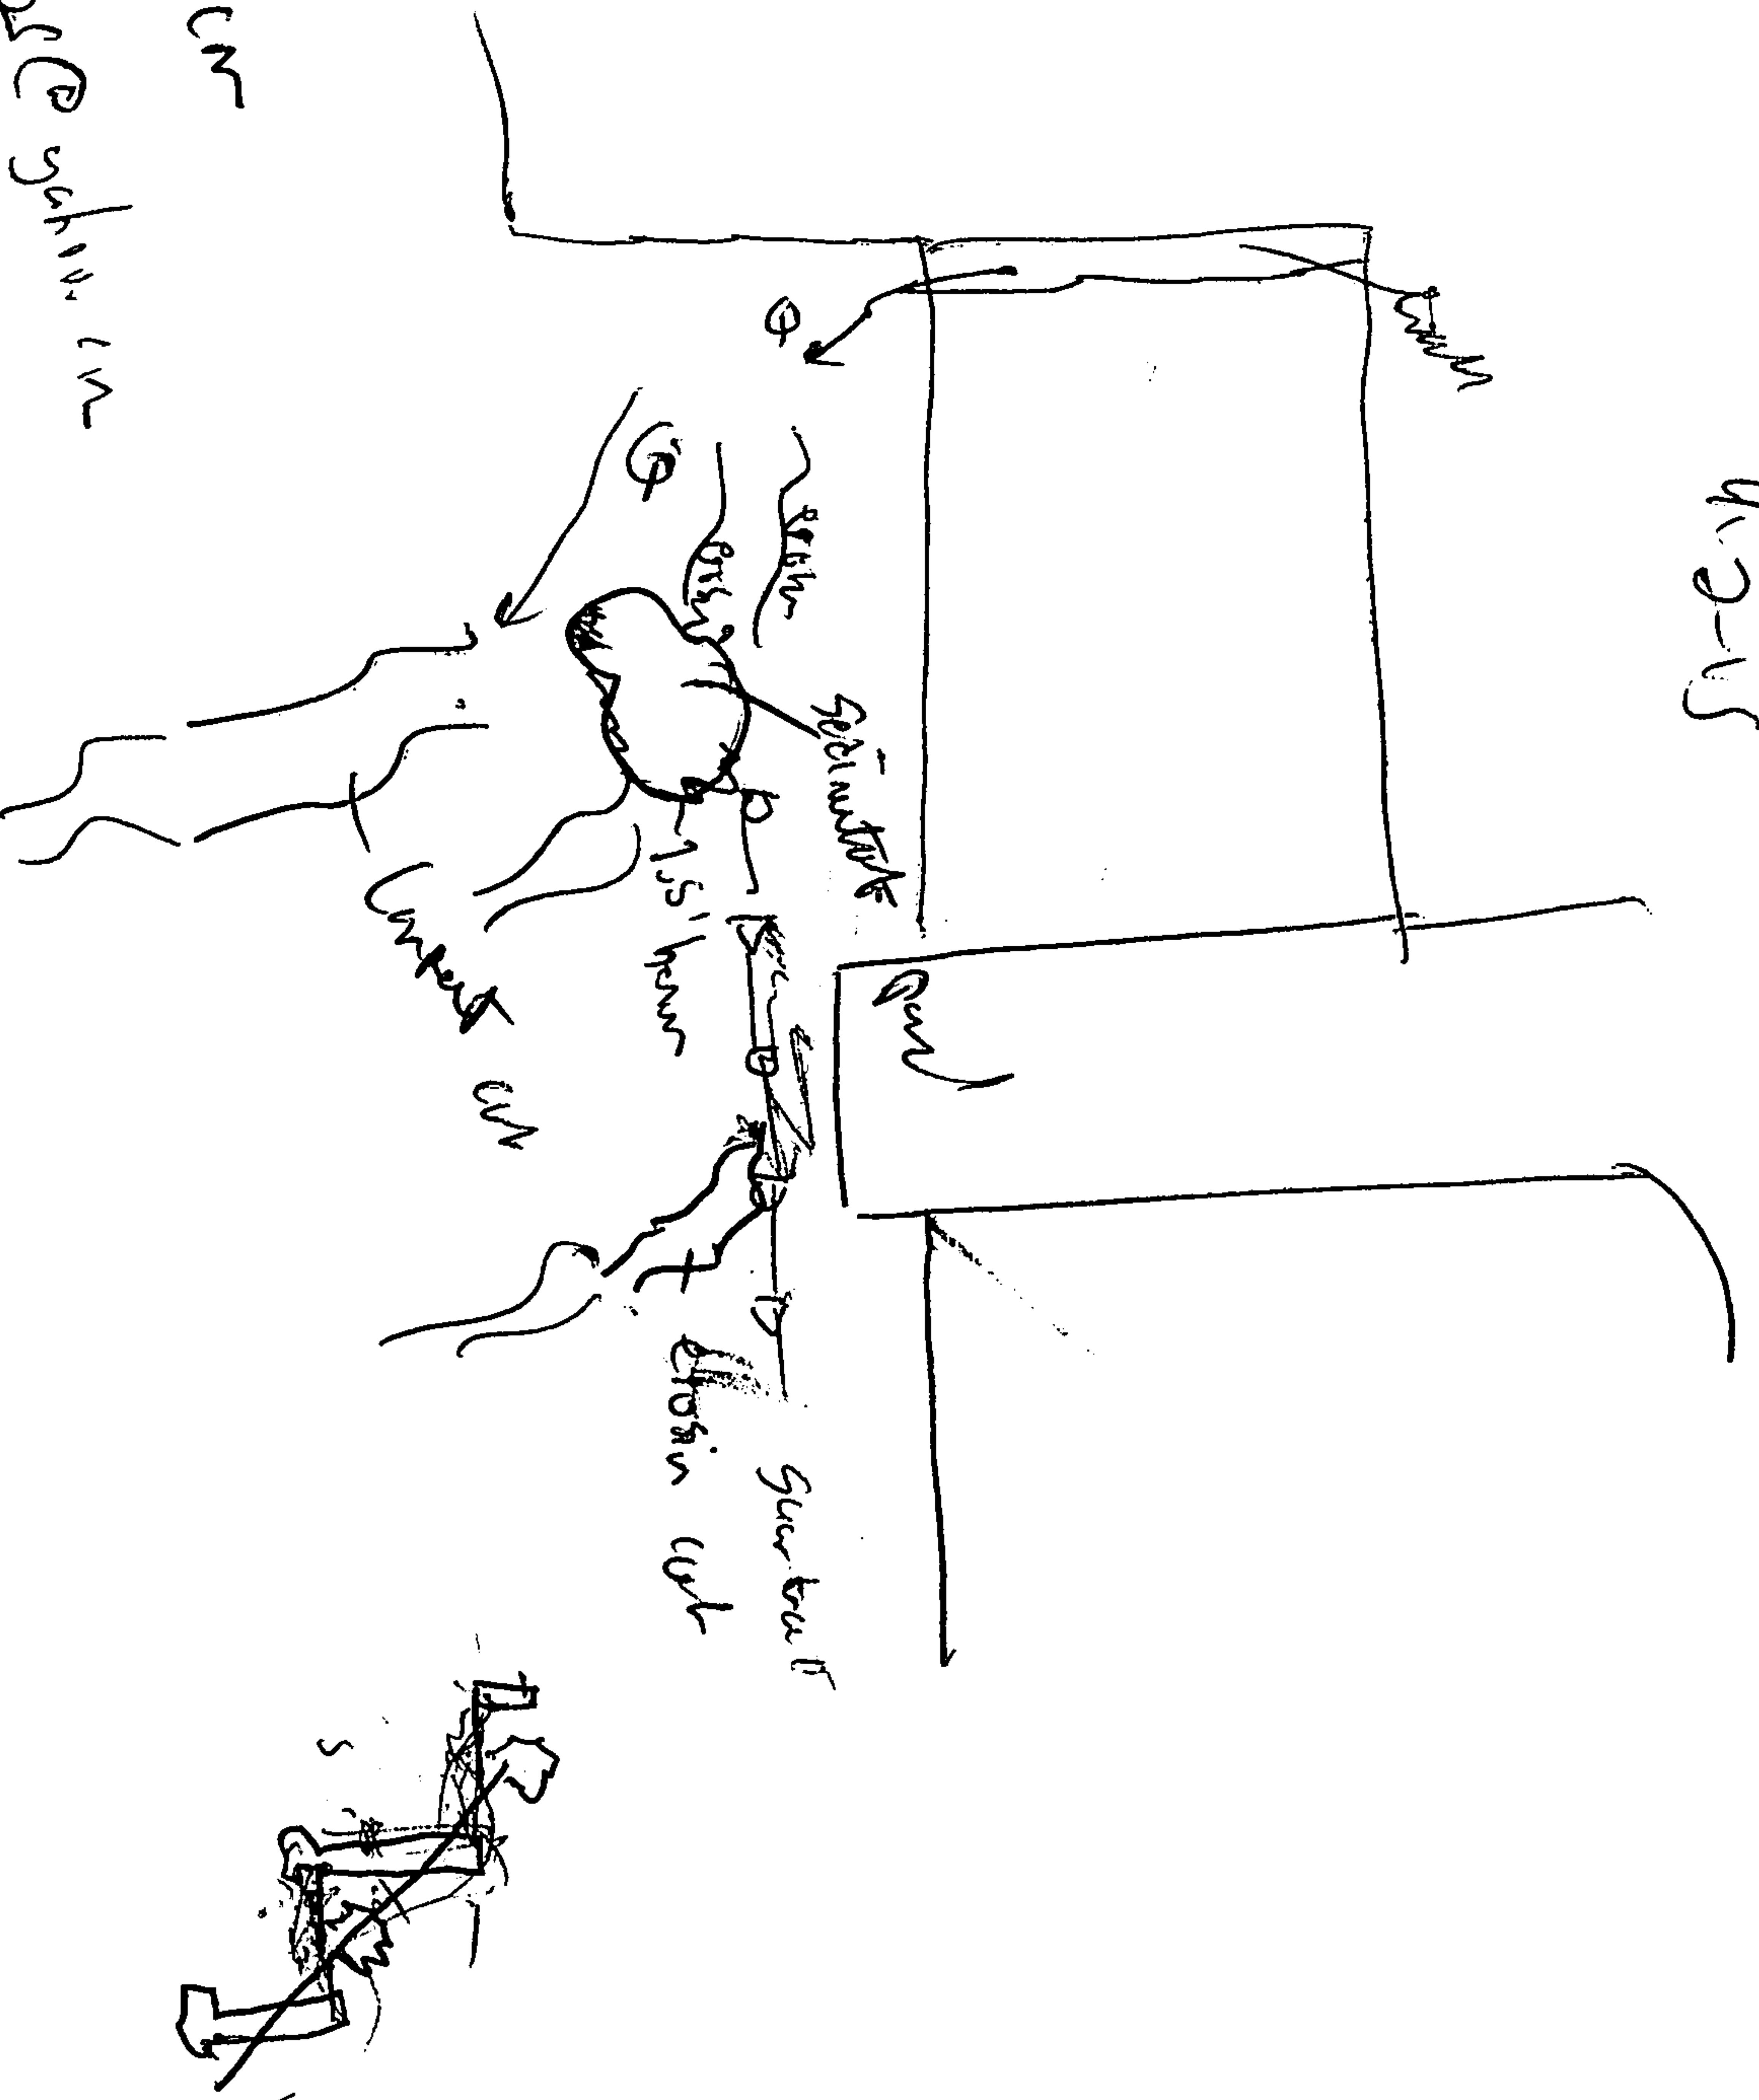
4-2-15

Ditch 1/2 m @ 0.5 m

Part 1 hole 2.5 @ 0.5 m

due to slope
