City of Albuquerque Stormwater Construction Site Inspection Report

Project Name and Location	Sevilla at Andalucia Sevilla & cons		
Site Contact Name & Agency	Kenin Patten Pulte Homes	Contact Phone #/ E-mail	505 238-2855
Date of Inspection	12-14-16	Start/End Time	1:00/
Inspector Name, COA Dept.	Curtis Cherne, Stormwater Quality		
Inspector Phone / E-mail	505-924-3420/ccherne@cabq.gov		
Inspector Qualifications	Qualified Compliance Inspector of Stormwater- Stormwater One		
Describe Present Phase of Construction	Stabilized		
Type of Inspection:			
<input checked="" type="radio"/> Regular <input type="radio"/> During storm event <input type="radio"/> Post-storm event (> 0.5 inch) <input type="radio"/> 311 / Complaint Response <input type="radio"/> Follow-Up

**Re: Drainage Control Ordinance Violations for Erosion and Sediment Control-
Rinsing Street into Storm Drain System - Sevilla at Andalucia Subdivision**

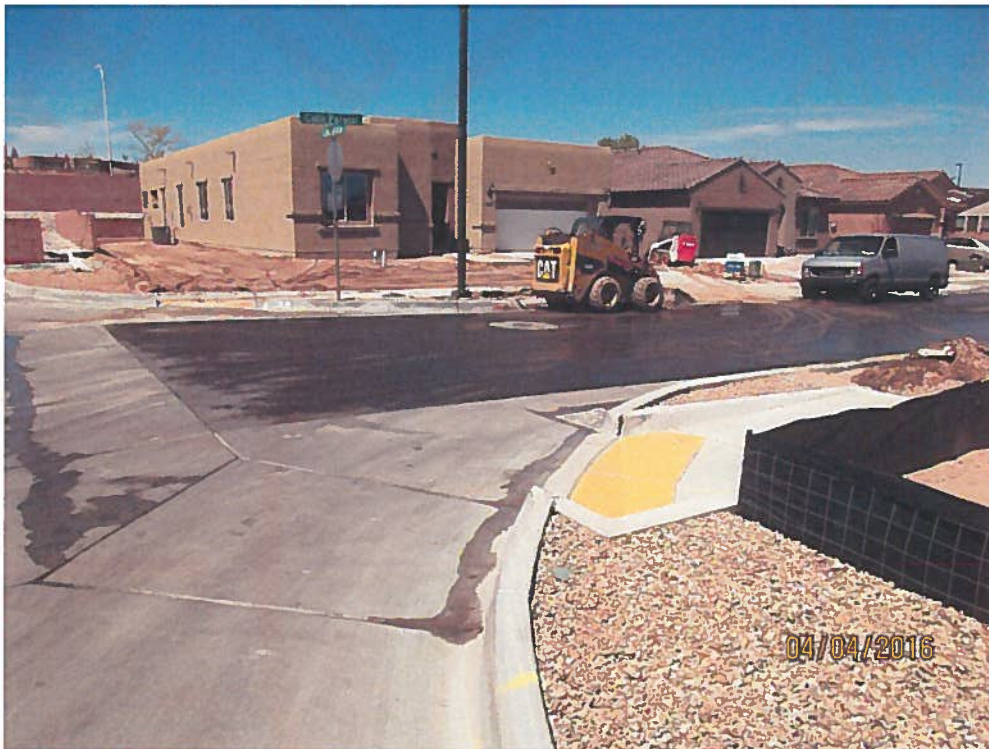
On April 4th, 2016, a water truck was spraying water onto Calle Parasol St. The water picked up sediment and debris and transported them into the storm drain system in Calle Espana NW. Photos of the violation are included in this letter.

Water release location; 5001 Calle Parasol NW

The activity of rinsing the street(s) is to cease. In addition, the inlet protection in Calle Espana was ineffective and should be evaluated.

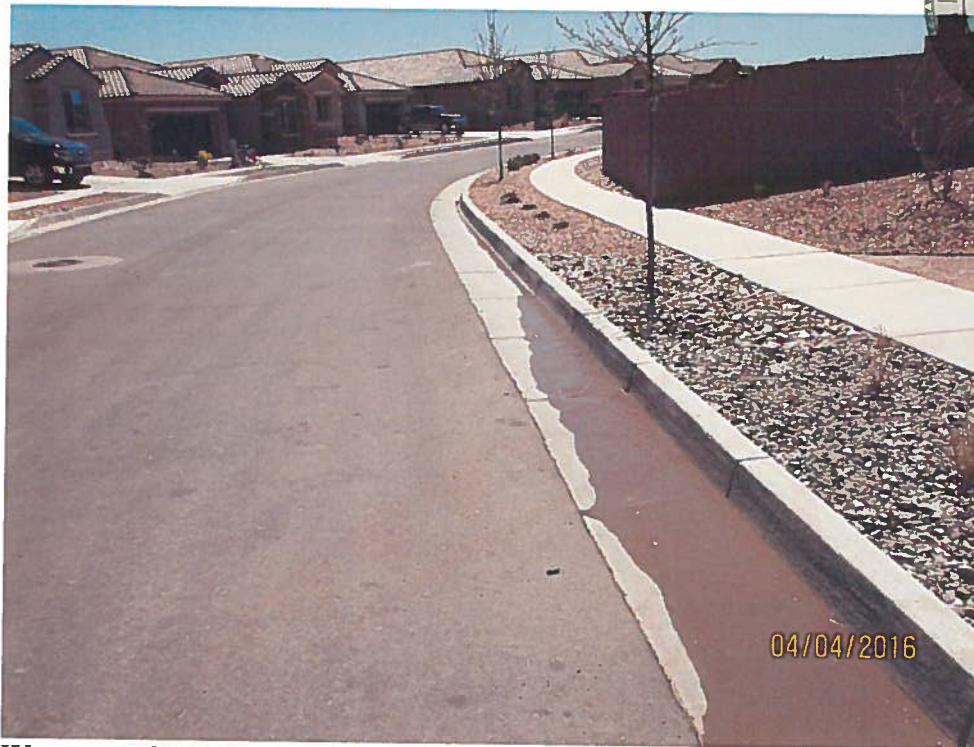
Water was followed around the corner. This is the beginning of the hydrograph.

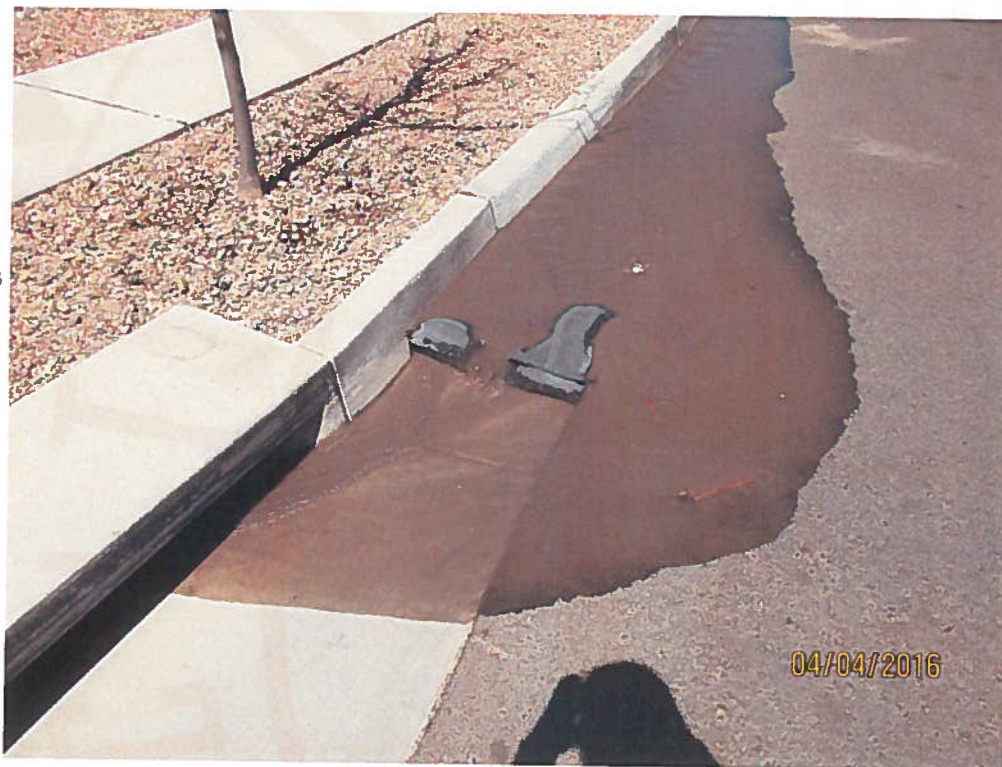
Rinse water flowing into inlet in Calle Espana NW. Inlet protection not filtering water.

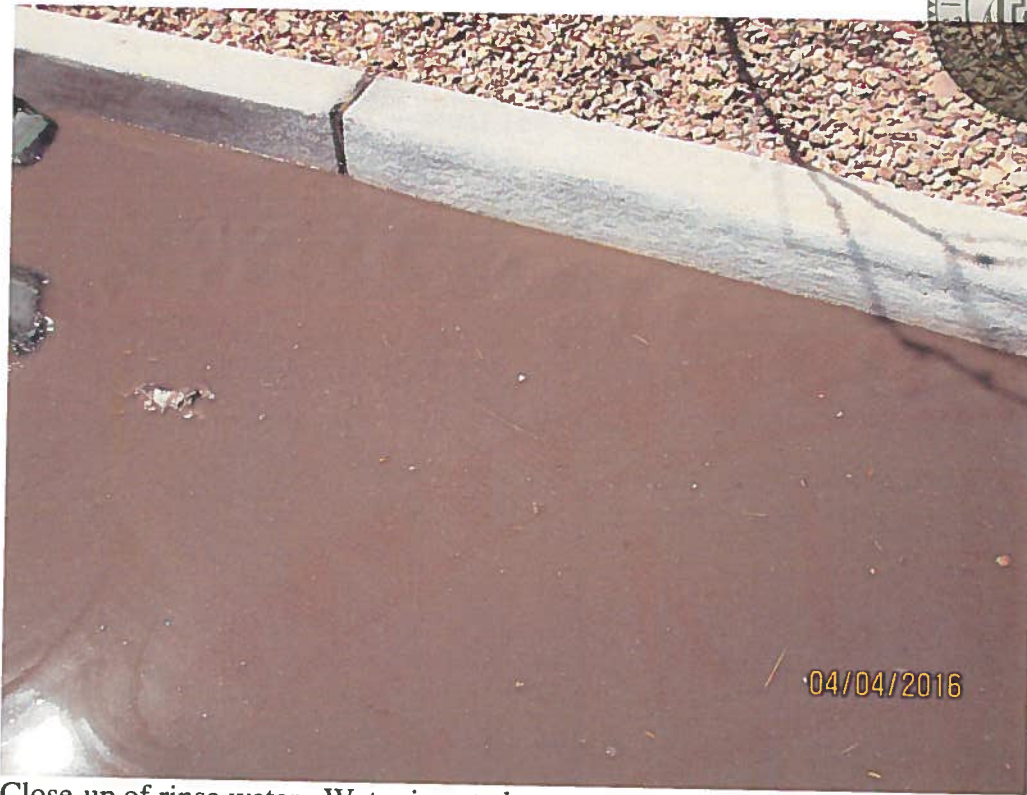
Close-up of rinse water. Water is not clean.
