### **SWPPP Rain Event Inspection Report**

General Information				
Project Name	Top Golf Albuquerque			
NPDES Tracking No.	NMR 1001XF/NMR	Location	1600 Desert Surf Loop	
	1001XJ			
Date of Inspection	7-26-19	Start/End Time	Overnight 7-25-19	
Inspector's Name(s)	Brad Frosch			
Inspector's Title(s)	SWPPP Compliance Inspector			
Inspector's Contact Information	bfrosch@tierrawestllc.com 505-263-5808			
Inspector's Qualifications	Qualified SWPPP Preparer and Inspector of Stormwater Controls			
Weather Information				
Has there been a storm event since the last inspection? X Yes □No Reporting Weather Station- Albuquerque International Airport Storm Start Date & Time: 7-25-19 Storm Duration (hrs): 5 Approximate Amount of Precipitation (in): 1.05 Site rain gauge recorded 1.5"				
Weather at time of this inspection?  X Clear □Cloudy X Rain □ Snowing □ High Winds □ Other: Temperature: 78° F				
Have any discharges occurred since the last inspection? X Yes  No  A discharge occurred with a sediment release to Desert Surf Drive. The sediment pond breached and discharges occurred at both north and south entrance areas and at segmental wall open areas. Crews had begun to remove sediment from the

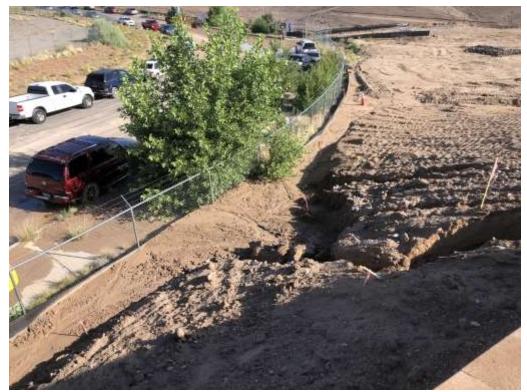
Discharge between walls

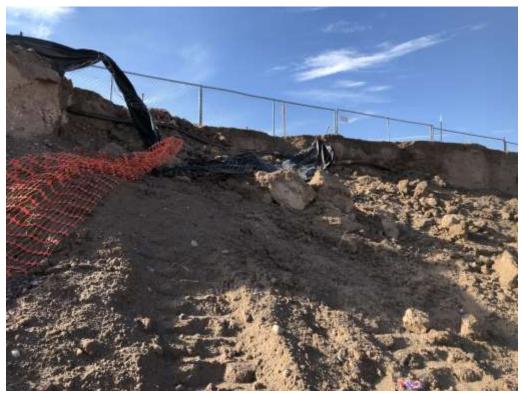
Area of Site Run-on

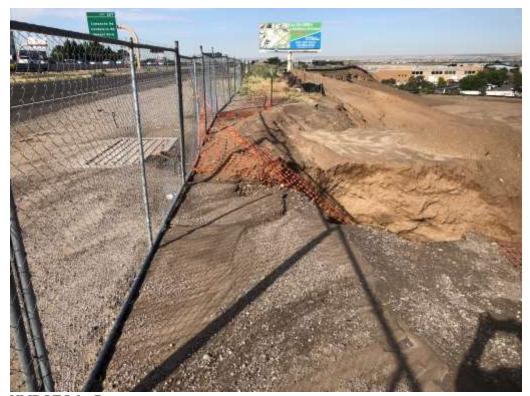
Primary source of runoff discharge was due to the NMDOT inlet not having the required controls in place due to wall construction issues and recent SD pipe/MH work. Additional controls should include replacement of silt fencing and berm at NMDOT inlet to direct the potential run off towards the inlet.

NMDOT Inlet By -pass

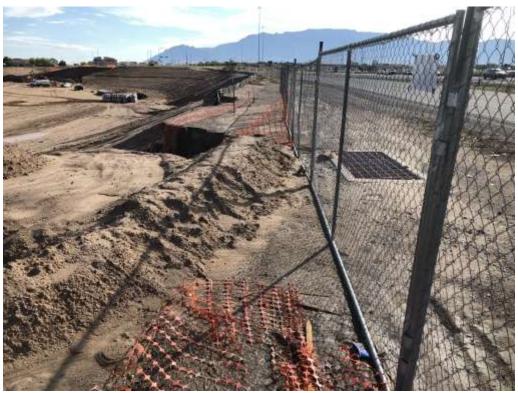
NMDOT Inlet Uncontrolled Run-On

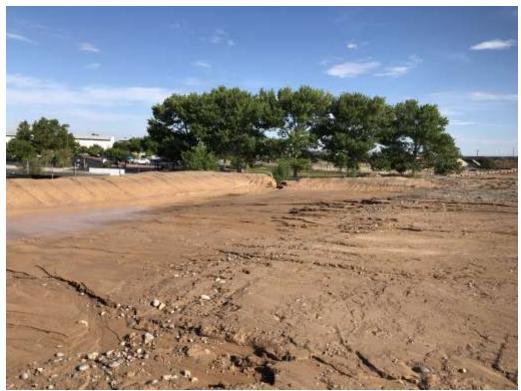
**Sediment Trap Breach**

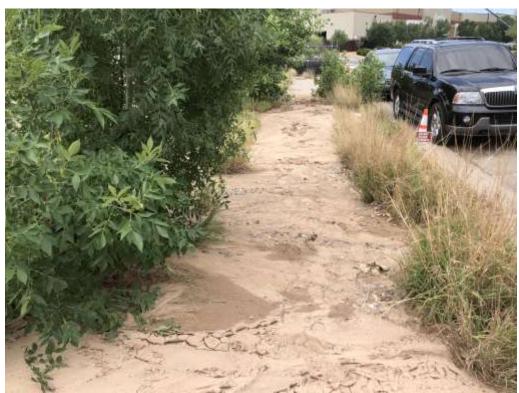
**Sediment remains on Desert Surf Sidewalk**

Perimeter silt fencing should have sediment removed where sediment exceeds 50% capacity to insure proper retainage of sediment and filtration of runoff. Sediment is present at City sidewalk on Desert Surf and remains to be cleared. Desert Surf inlets need to be cleared of sediment and controls replaced. Grading has removed north entrance sediment traps and new traps should be installed out of proposed work area.

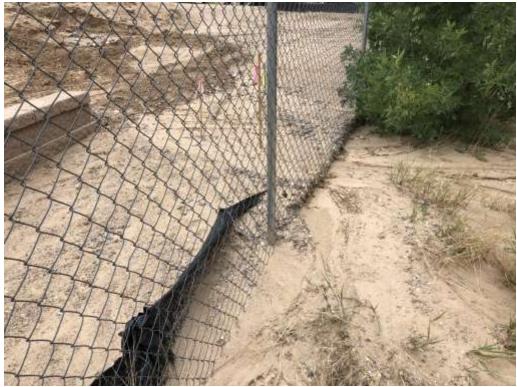
Silt fencing over capacity

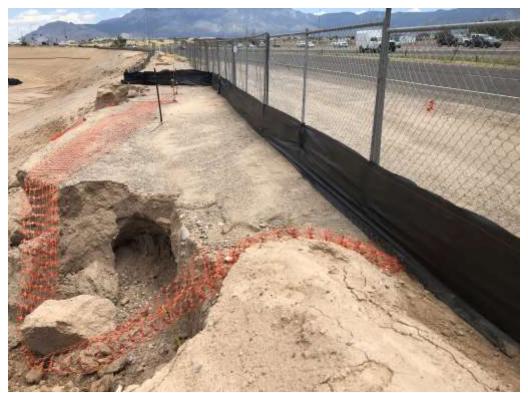
Silt fencing recently installed at NMDOT inlet is not keyed into substrate. A diversion berm or other should be placed to direct offsite flows towards NMDOT inlet.

New silt fencing not keyed into sub-grade

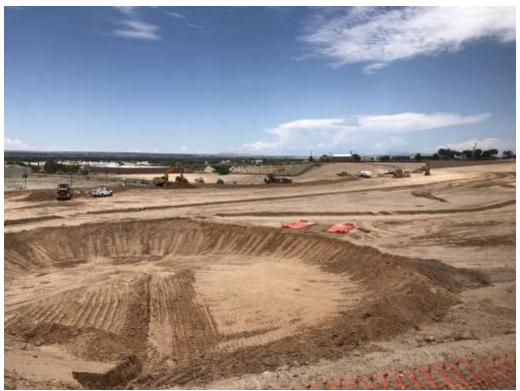
Run-on receiving pond requires dedicated emergency overflow
