<b>Project Name and Location</b>	Bishop's Compound Rio Grande and Candelaria		
<b>Site Contact Name &amp; Agency</b>	Scott Ashcraft Las Ventanas Homes	<b>ESC File No. NPDES ID No.</b>	G12E032
<b>Date of Inspection</b>	11/01/18	<b>Start/End Time</b>	3:10pm 3:15pm
<b>COA Inspector Name</b>	Cassandra Durkin, Stormwater Quality		
<b>Describe Present Phase of Construction</b>	Stabilized		
<b>Type of Inspection:</b>			
<input checked="" type="checkbox"/> Regular <input type="checkbox"/> During storm event <input type="checkbox"/> Post-storm event (> 0.25 inch) <input type="checkbox"/> 311 / Complaint Response <input type="checkbox"/> Follow-Up

City of Albuquerque  
Stormwater Construction Site  
Inspection Report

### Stormwater Control Permit for Erosion and Sediment Control

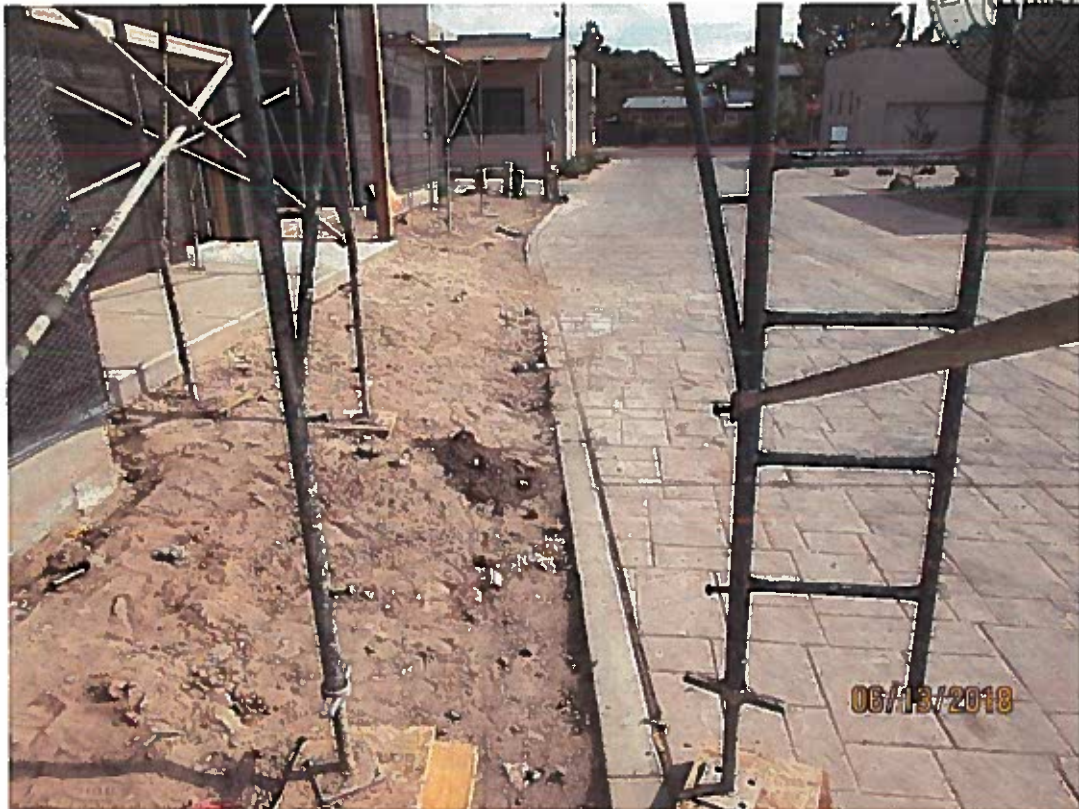
No sediment BMP.

1. Install a sediment BMP (cutback/ mulch sock/wattle) on lots under construction.
2. Remove the wash-out from one of the lots and prevent this from occurring in the future.
3. Remove the sediment from Calle Obispo Lane.

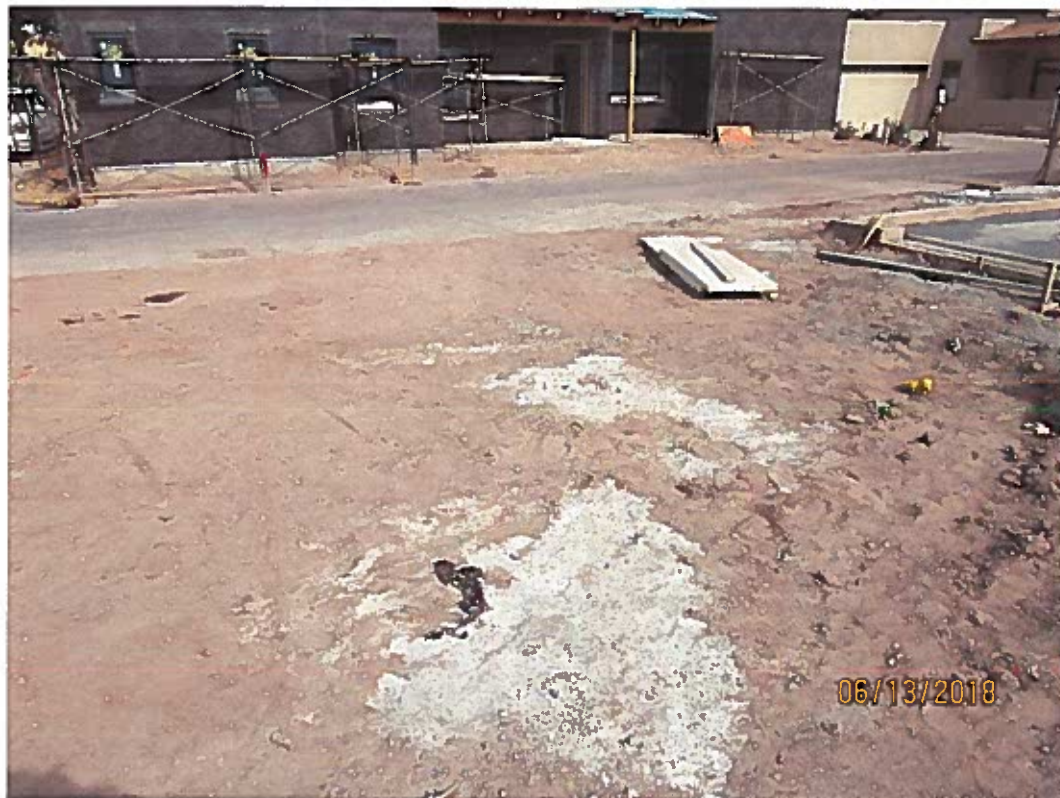
Wash-out on a lot.

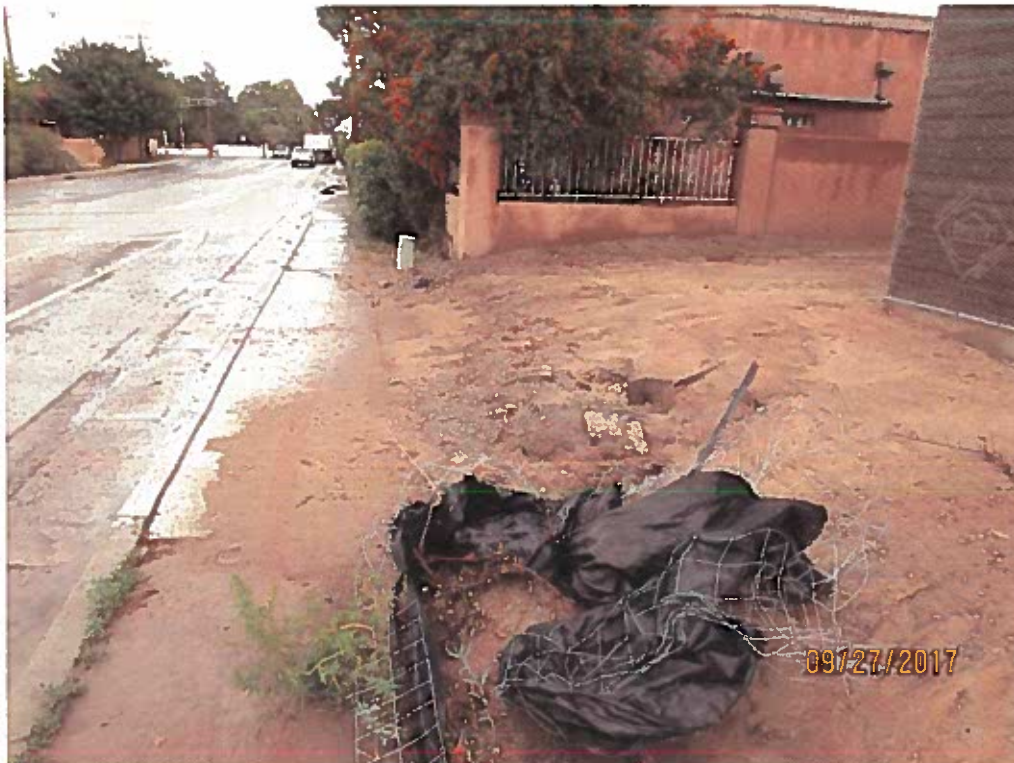
No sediment BMP.

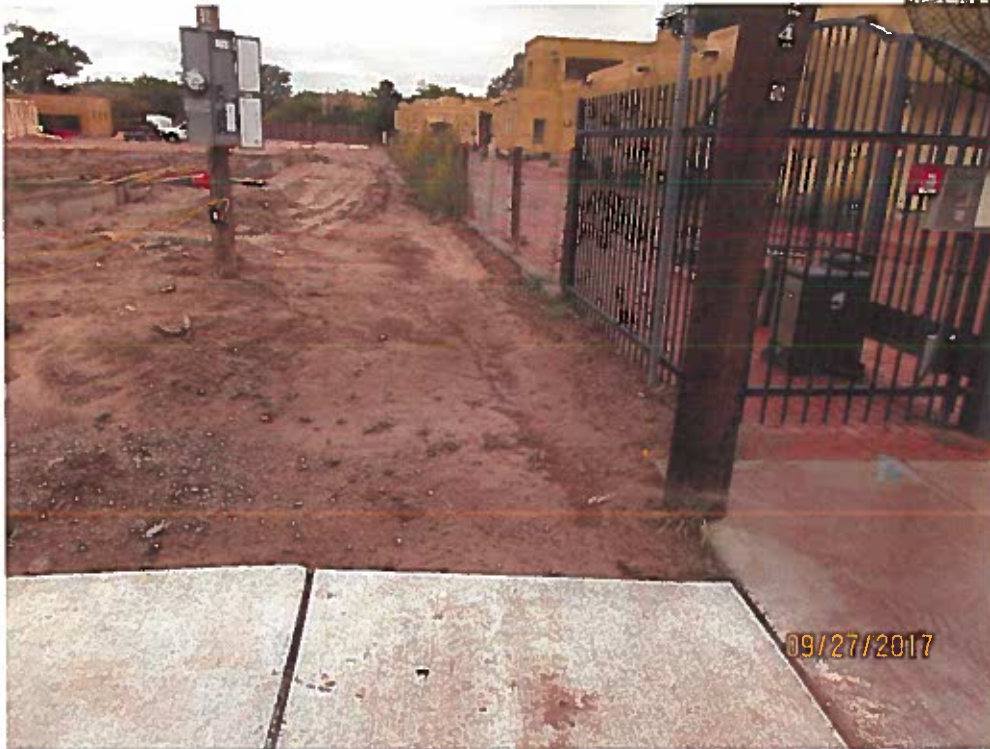
No sediment BMP.

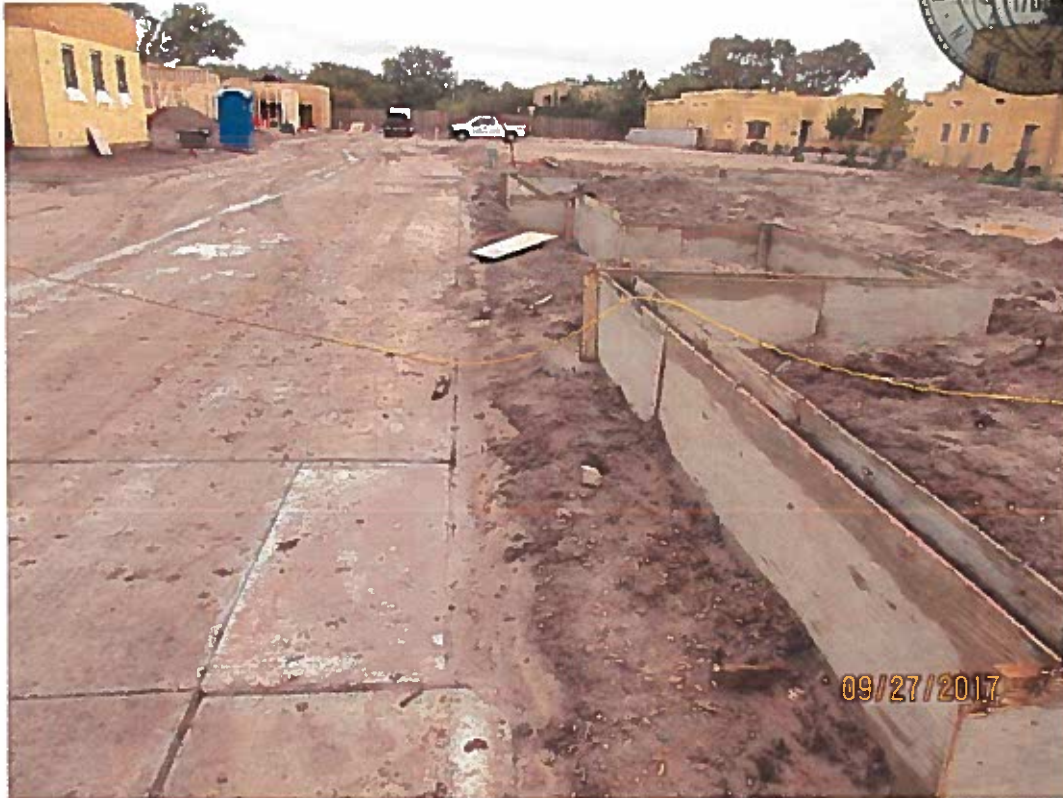
No sediment BMP.

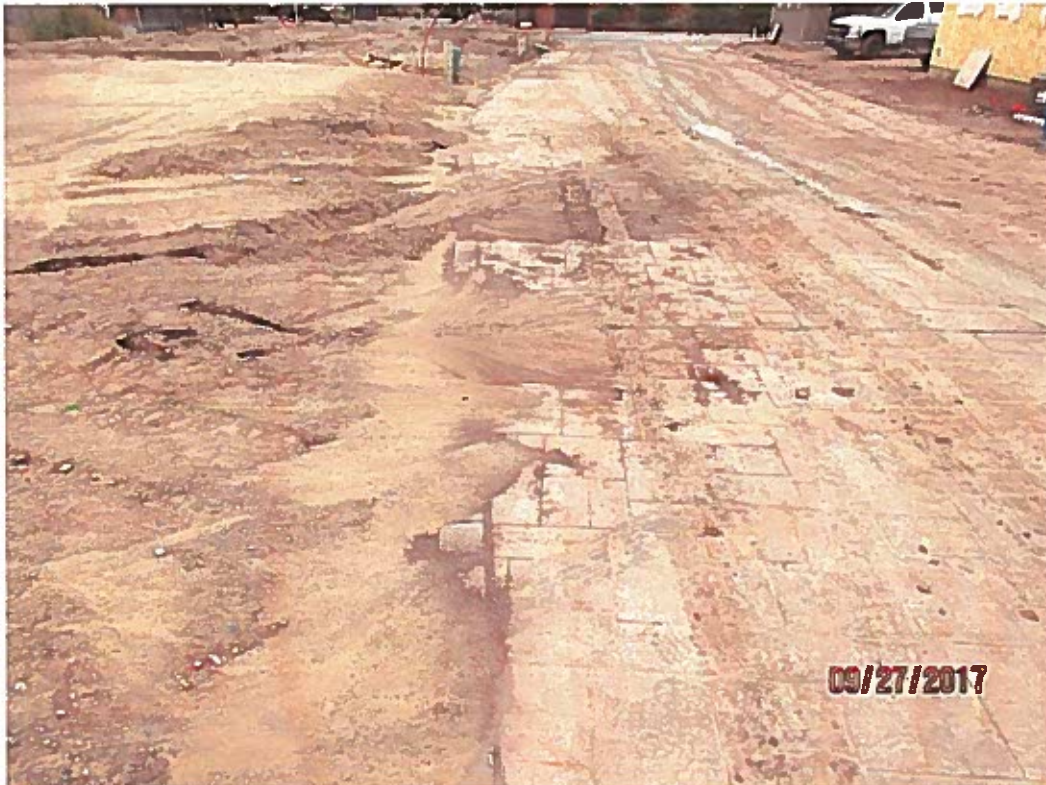
No sediment BMP.

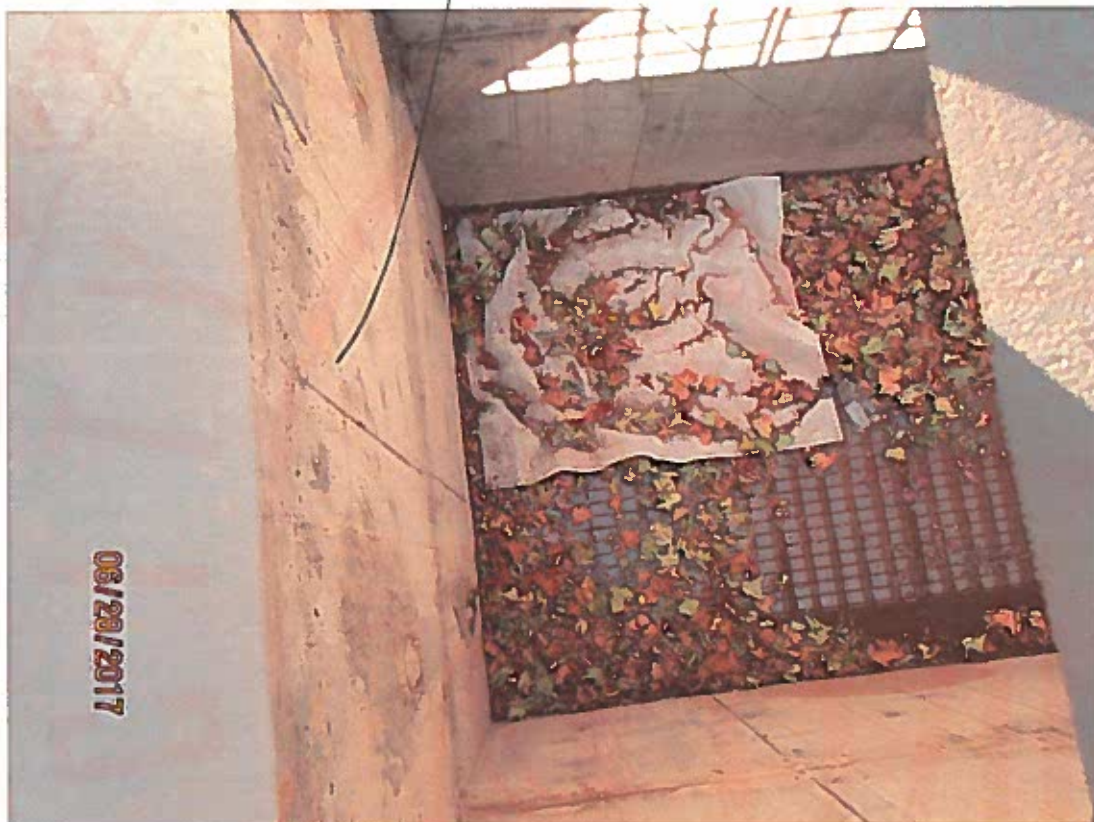
Large piece of trash in inlet at the northwest corner of the site. Most likely there during construction as it is too big to fit through the grate.

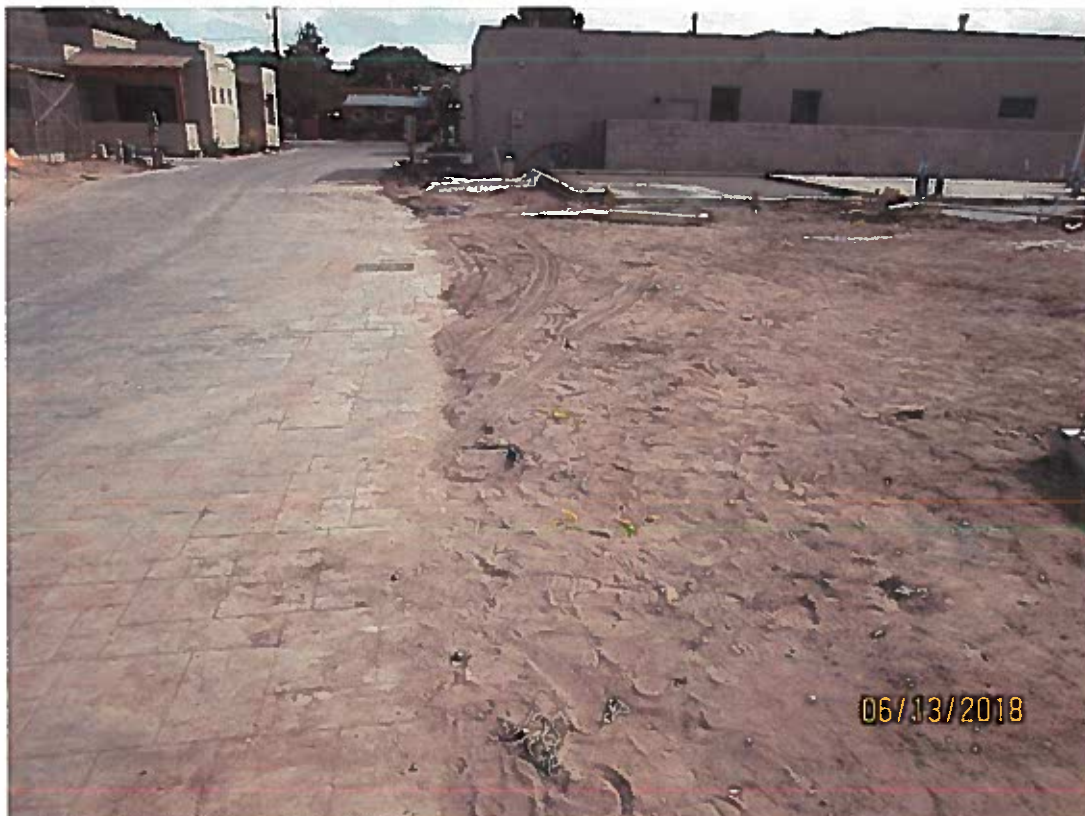
No sediment BMP and sediment in the street.
