April 28, 2017

Del Webb at Mirehaven

## **Drainage Ordinance (14-5-2-1) Violations for Erosion and Sediment Control** Re: and Pollutants in Drainage System

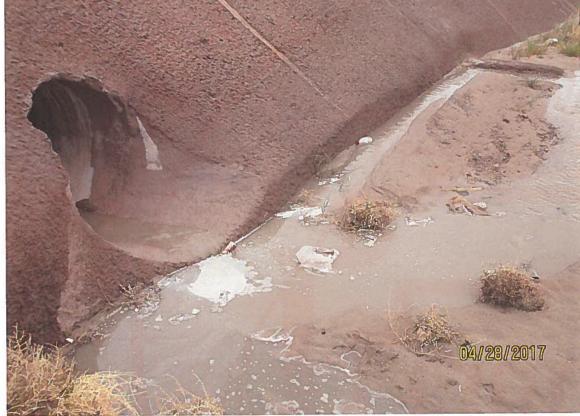
White foam and trash in Mirehaven Arroyo.

- 1. Remove trash from the arroyo.
- 2. Install more effective inlet protection. At this stage of development (all dirt and streets) and with the amount of sediment that was present in the streets; a more restrictive type of inlet protection should be used.
  - 3. Prevent foam from entering the storm drain system and arroyo.

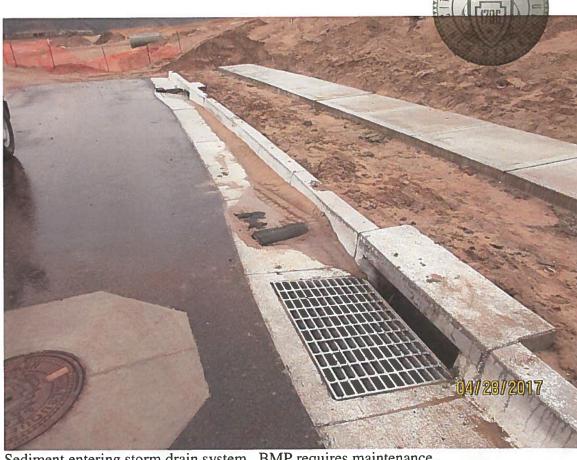
Sediment entering storm drain system. BMP requires maintenance.

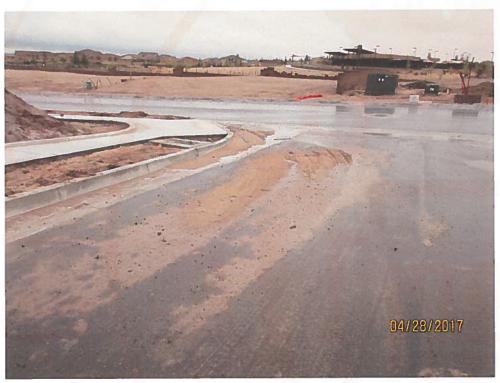
Sediment in street.

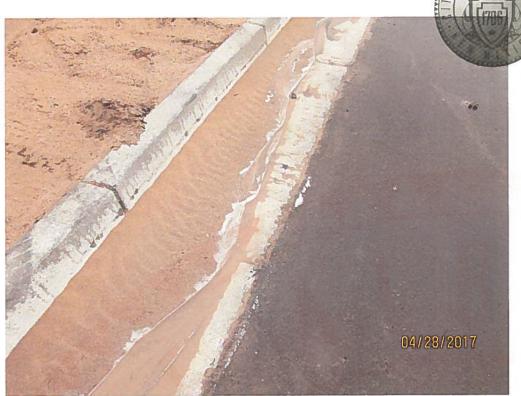
Sediment and foam in gutter.

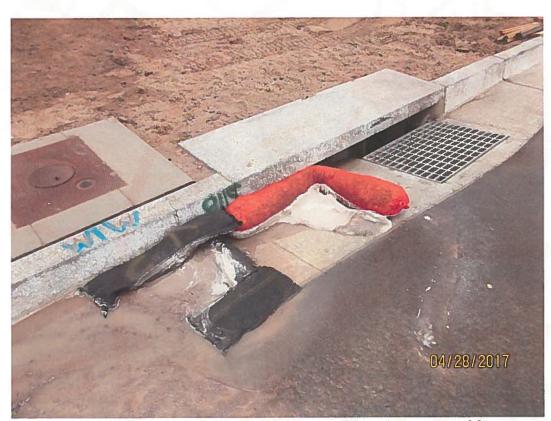
The City placed a rock filter bag and filter sock to reduce the amount of foam entering the arroyo.
