CITY OF ALBUQUERQUE

Site: Del Webb@Mirehaven Phase 3 and 4

Re: Drainage Ordinance (14-5-2-1) Violations for Erosion and Sediment Control

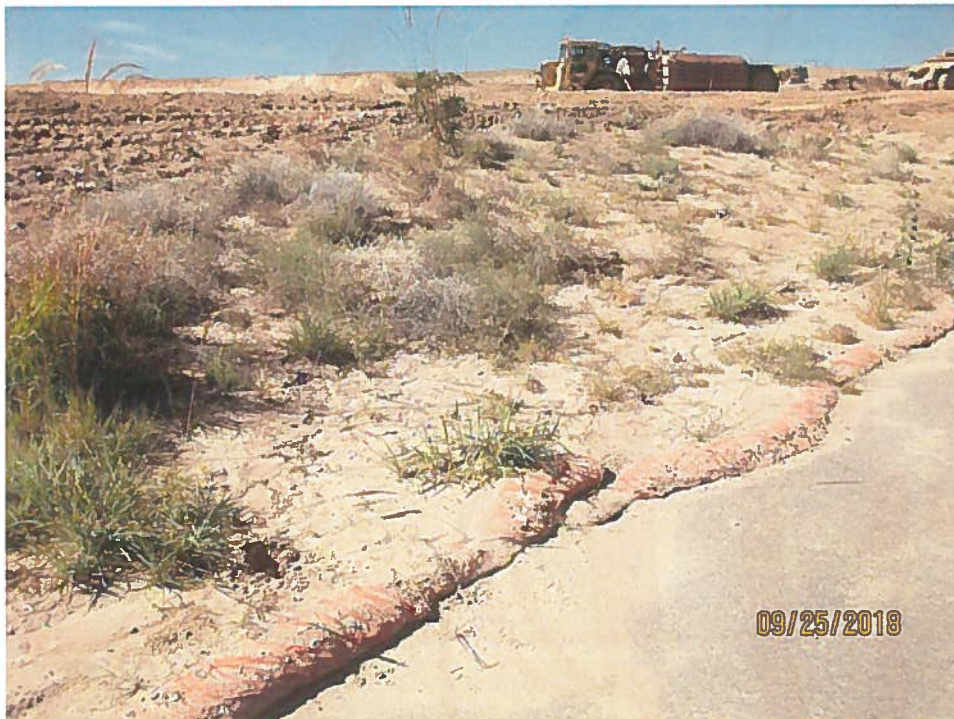
North edge of site showing ineffective sediment BMP.

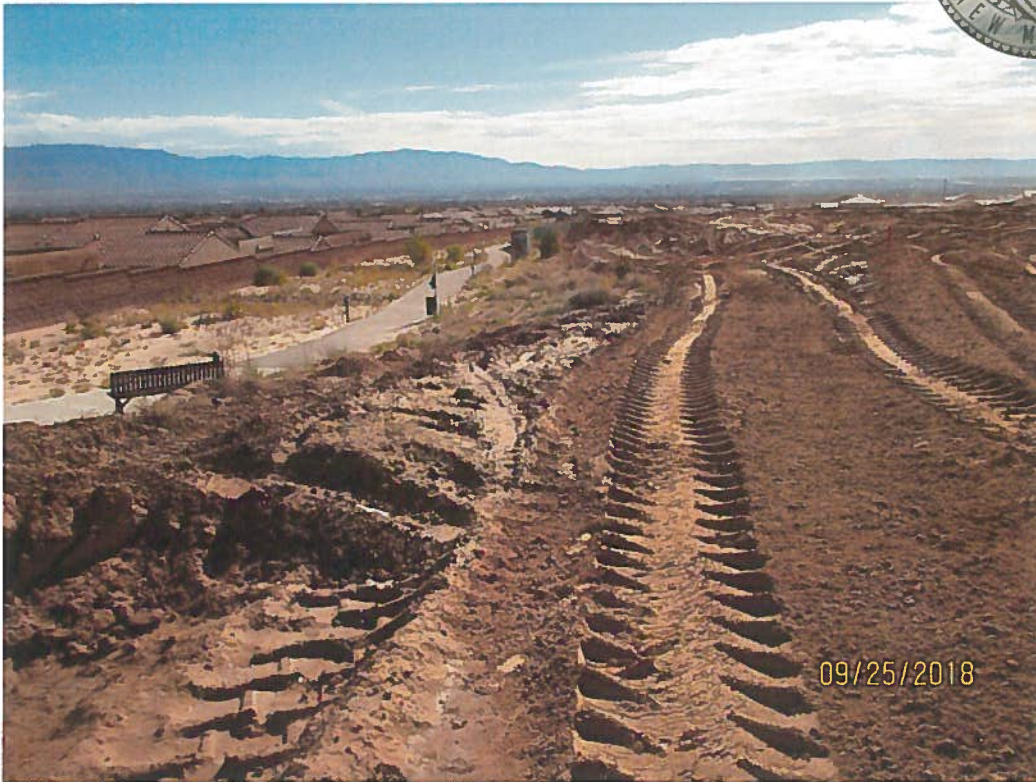
Drainage basin for ineffective BMP shown in photo above.

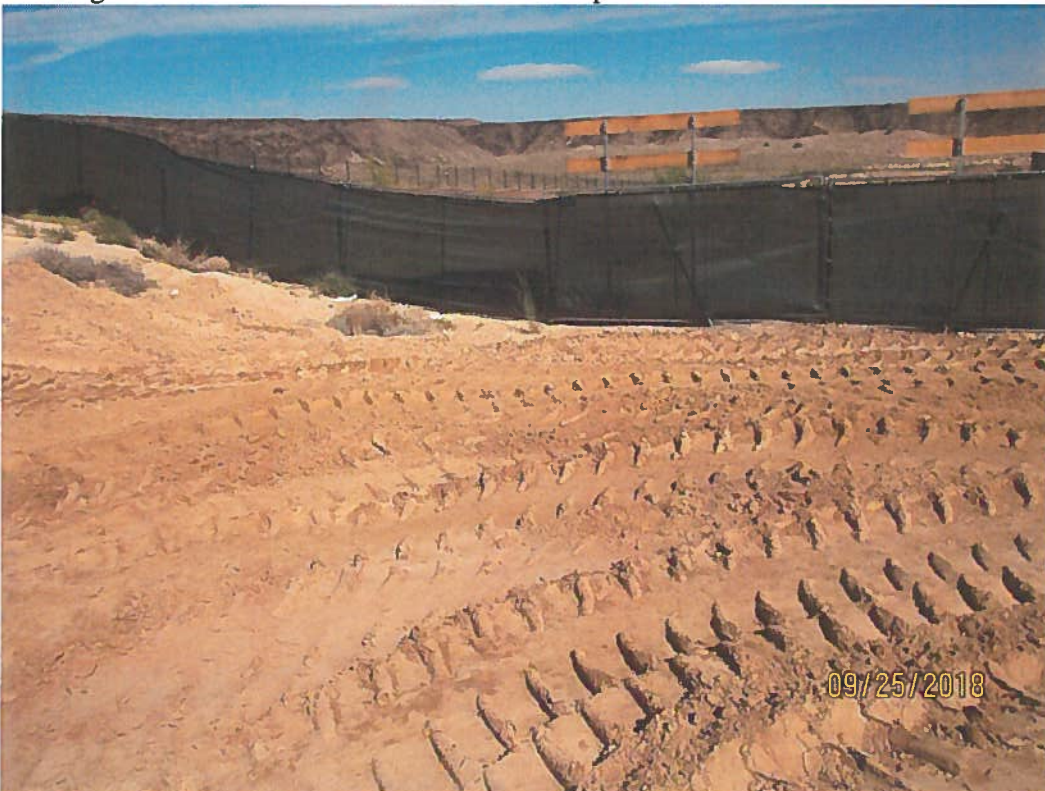
NW corner where pond was filled in. No sediment BMP.

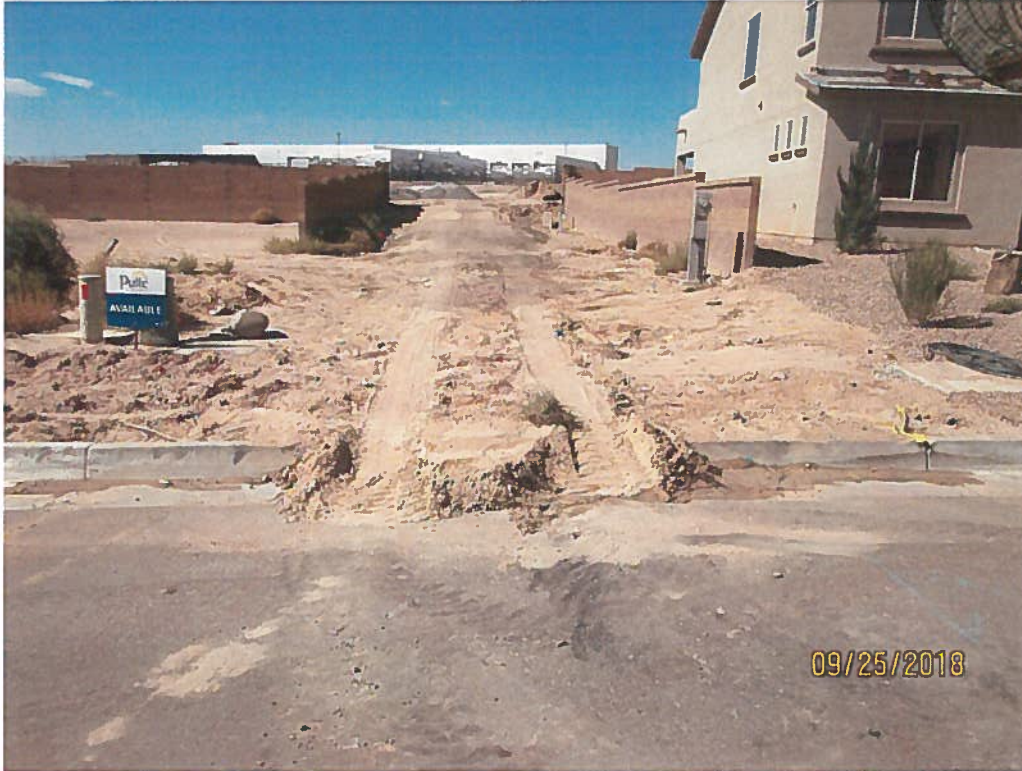
Dirt ramp in street, drainage conveyance with no sediment BMP and no track-out pad.

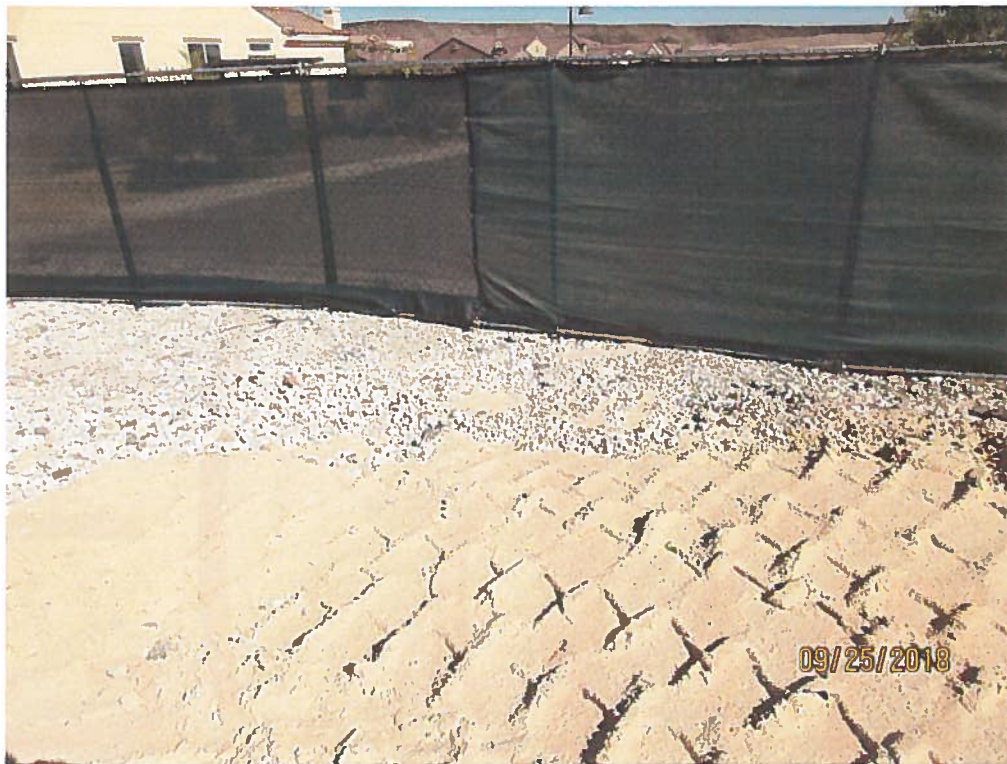
Outfall location for medium sized basin with no sediment BMP. Location is south of Willow Canyon Trail.

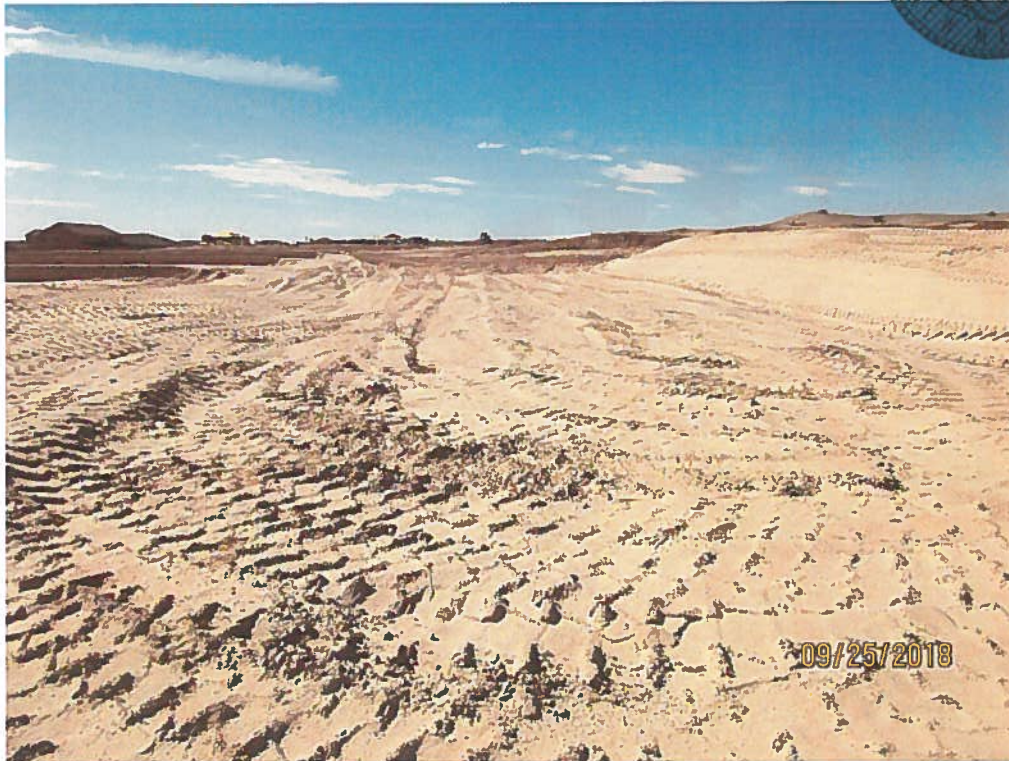
Drainage basin draining to area with no sediment BMP.

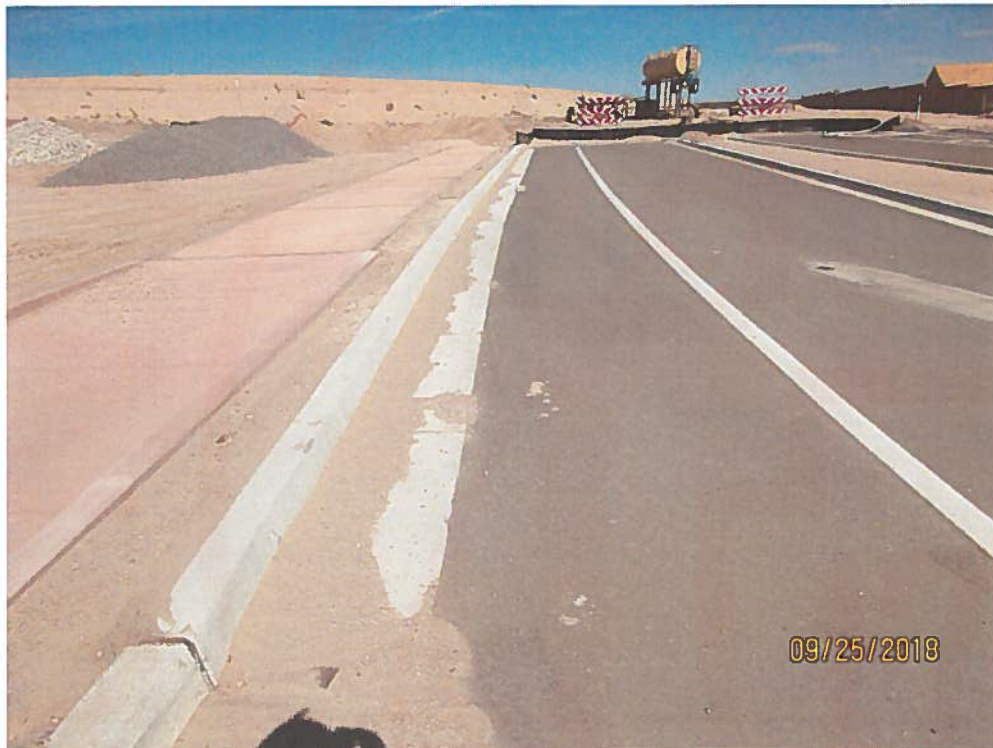
Sediment in Mirehaven Parkway at the south end. South gutter.

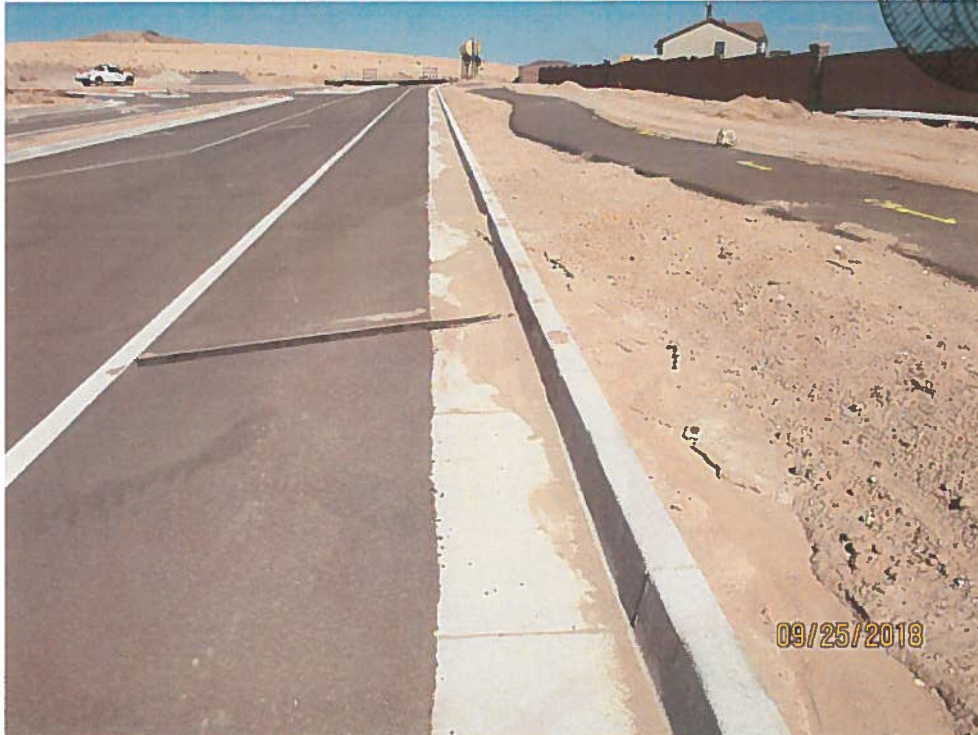
Sediment in Mirehaven Parkway at the south end. North gutter.

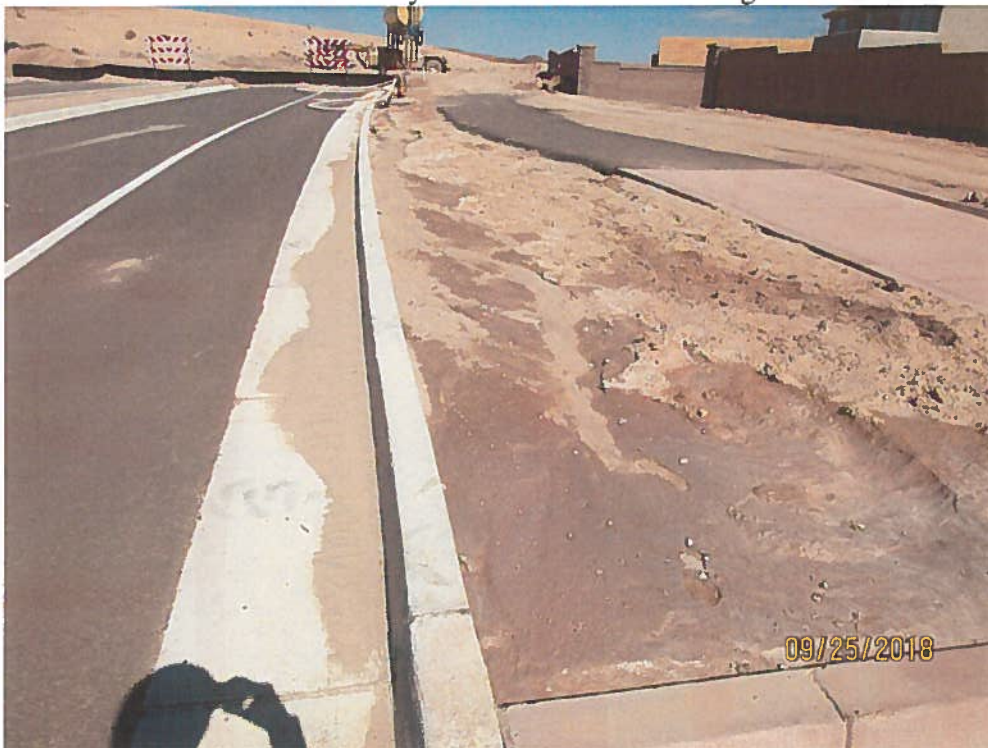
Sediment and/or erosion BMP required in this location at downhill end.

1. Provide a sediment BMP along the north edge where there is not a wall.
2. Provide a sediment BMP in the northwest corner where the pond has been filled-in that was graded for offsite flows.
3. Remove the dirt ramp (Abo Canyon and Red Butte) and do not build dirt ramps in the future. If egress onto the paved street is desired in this location, install vehicle tracking control. Divert drainage from dirt road towards a sediment BMP.
4. Provide a sediment BMP at the drainage outfall location south of Willow Canyon Trail.
5. Remove sediment from the gutters of Mirehaven Parkway at the south end of the project. Prevent sediment from accumulating to this amount in the gutters in the future.
6. Provide a sediment and/or erosion BMP on the north side of Mirehaven Parkway at the south end of the project between the curb and the path at the downhill end. See photo.
