Date & Time: <u>07-08-2021 at 4:56 PM</u>

# NATIONAL STORM WATER QUALITY PROGRAM SITE INSPECTION REPORT (SIR)

Community Name:		PulteGroup-MS-1026:	PulteGroup-MS-1026:Mirehaven, 9043 Fenton Lake Road NW, Albuquerque, NM 87120 NPDES: NMR1000C1								
		(Include Site Name, Ci	ty, State, Zip Code and NPDES/0	Construction Storm Water Perm	it Number)						
Master Site List ID:		369	Inspection performed by: Mario Alderete, Inspector, Green Globe Environmental								
				(Print N	ame, Company, and Title / Qual	lifications )					
Stages	of Construction:	(check all that apply)	Land Development	Inactive	Vertical Construction	Post-Construction					
Type of	Inspection:	(check all that apply)	☐ Land and Vertical ☐ Routine Inspection ☐ Other:	Storm-Event Related	Final Site Inspection

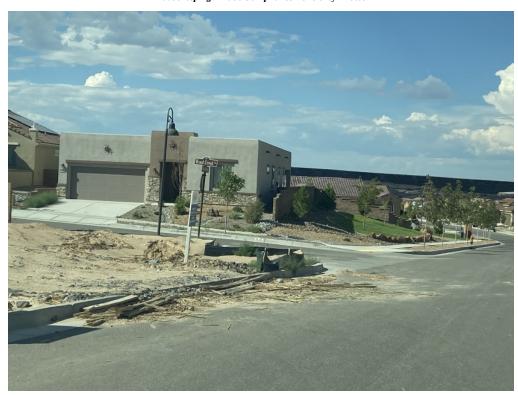
**Deficiency Name:** Wood creek & willow canyon **Corrective Actions:** Need to sweep street

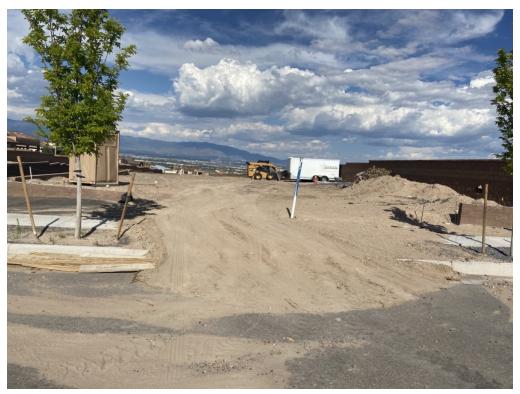
Deficiency Name: Cebolla creek

$\textbf{Corrective Actions:} \ \ \text{Sweep street and remove dirt ramp}$

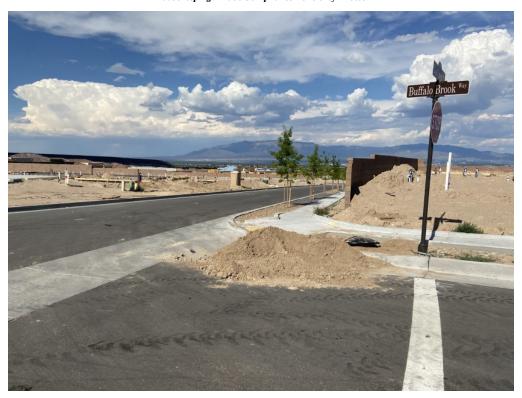
**Deficiency Name:** Buffalo brook & Lost creek **Corrective Actions:** Clean up dirt on the street

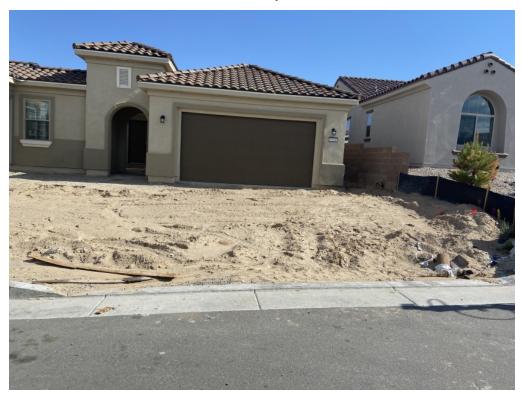
**Deficiency Name:** 9316 wood creek **Corrective Actions:** Cut curb back
