From: Carrillo, Abiel X.
To: ["Yolanda Padilla Moyer"](#)
Cc: [Biazar, Shahab](#)
Subject: ROFG - Del Webb Phase I @ Mirehaven - H019D017C
Date: Friday, August 26, 2016 2:07:00 PM
Attachments: [Mirehaven Del Webb 1 ROFG Comments.pdf](#)

Based on the information provided in your Certification dated 7-6-2016, and a field visit of the completed improvements, the following comments will need to be addressed before we approve the submittal for Release of Financial Guarantee:

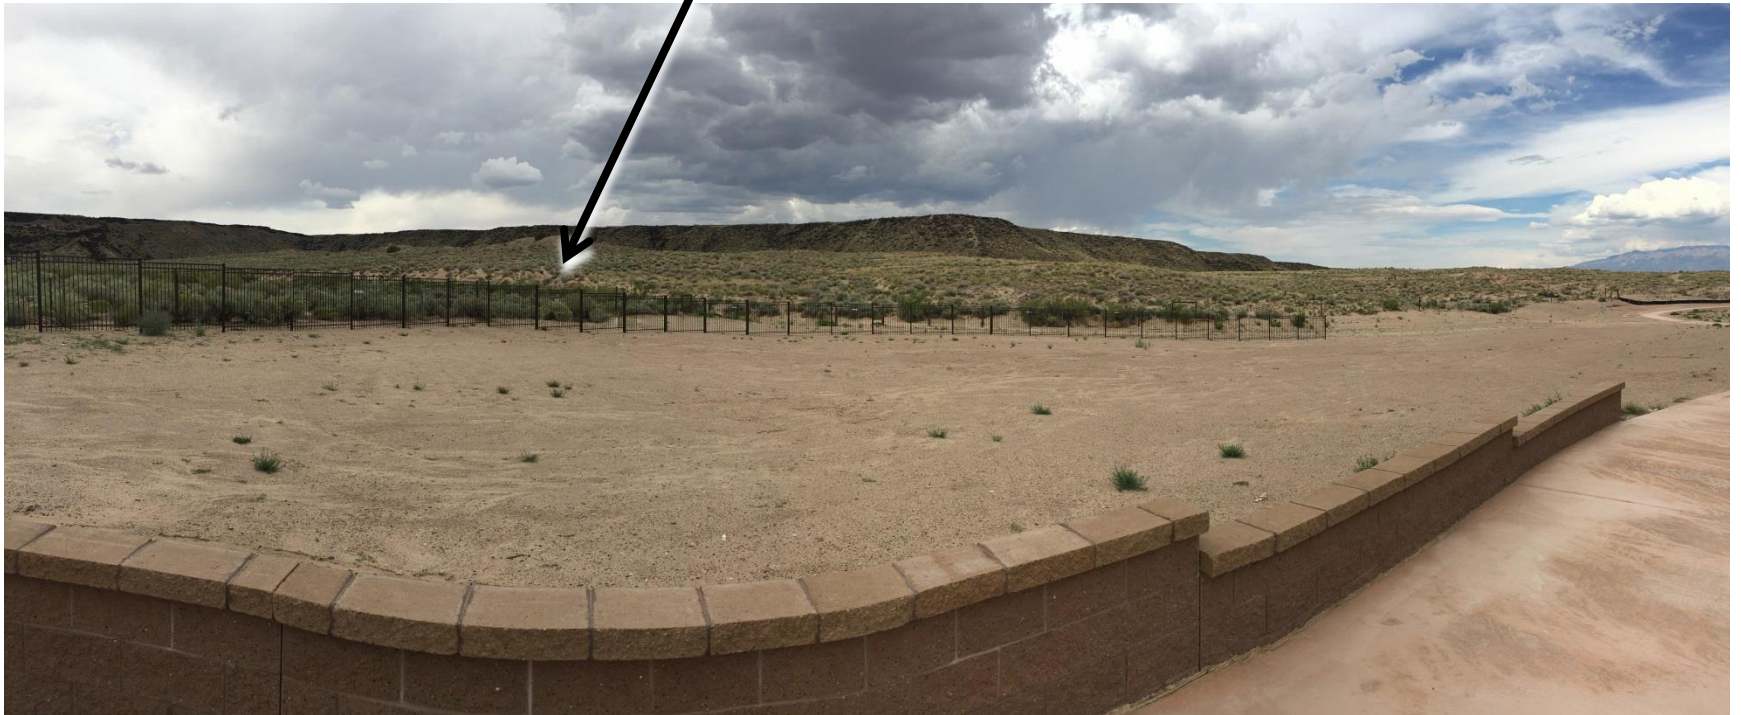
Comment # 1

1. There is a wrought iron fence that is encroaching into the Mirehaven Arroyo Floodplain. It's not clear that it offers additional protection then the existing wire strand fence, but it can trap debris and it affects the limits of the floodplain. This fence may not be able to remain if it is impacting the floodplain. See attached.

Fence in the arroyo floodway/plain

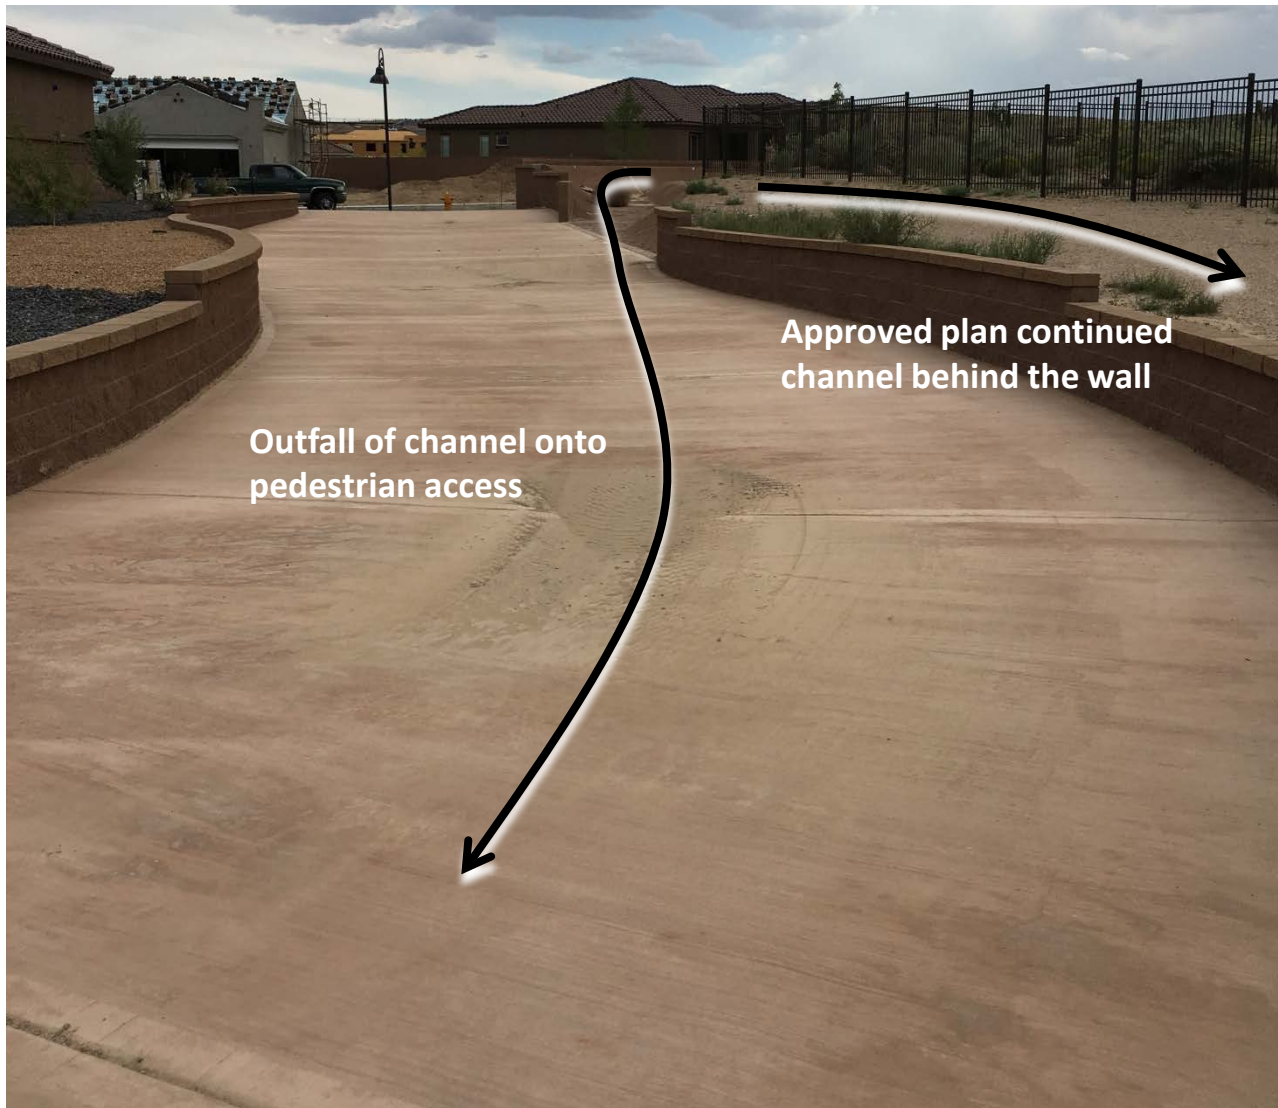
Comment # 2

2. Sheet 2B shows a change to the approved plans which re-directs the diversion channel onto the pedestrian trail/sidewalk connection behind lots 172 through 177. It is not acceptable to discharge the channel directly onto the pedestrian trail. It is clear that the intent for the colored concrete segment was to provide a pedestrian connection. As a corrective measure, a swale could be constructed behind the wall of the concrete pedestrian path and connect to the Arroyo (may not need to be shotcrete/concrete if the energy can be dissipated).

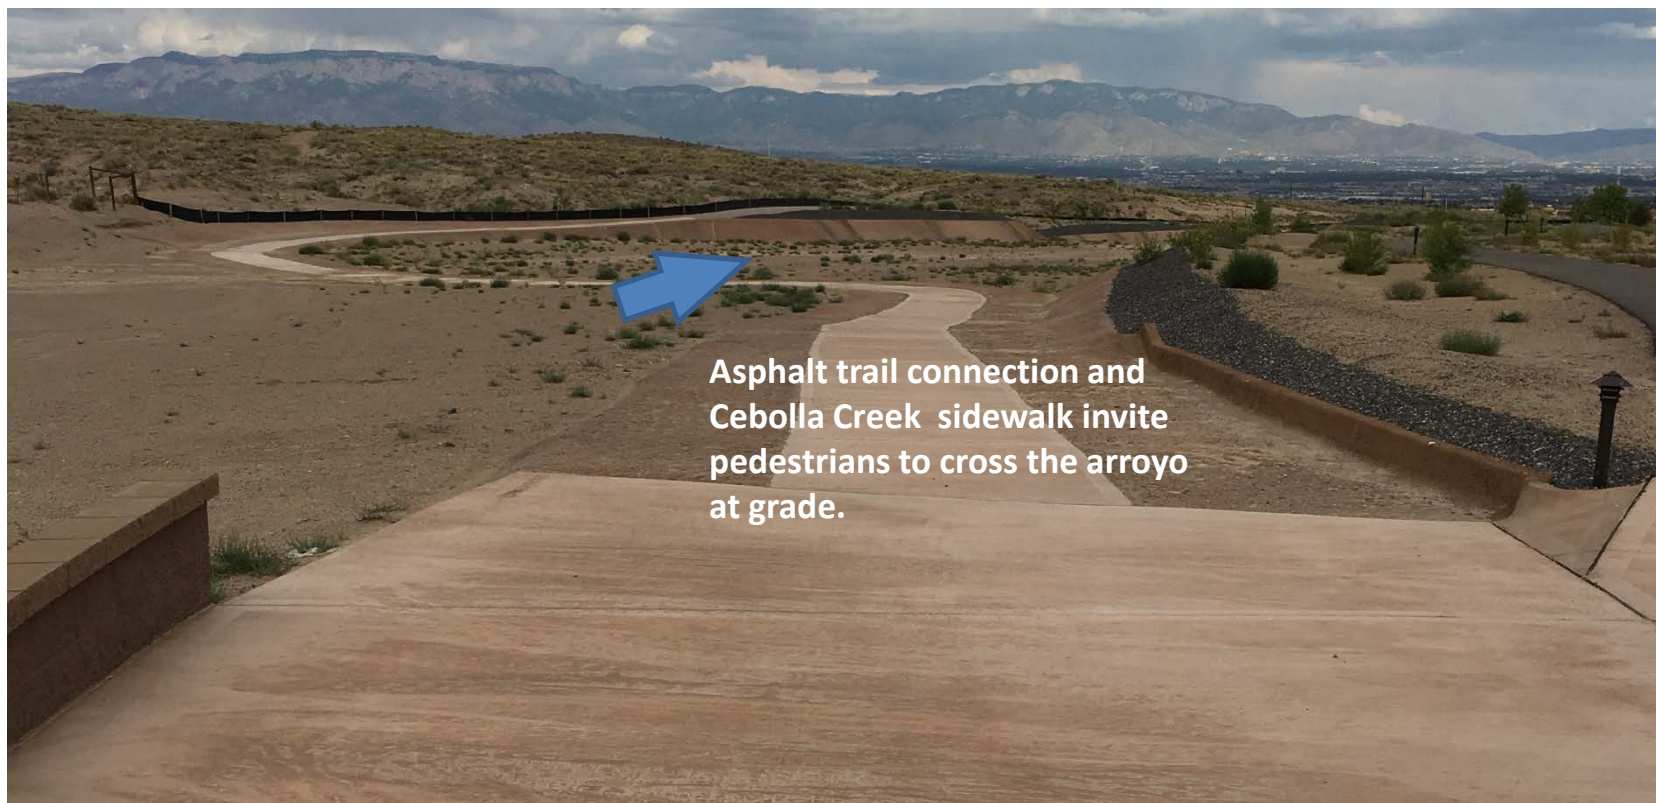
Comment # 3

3. At the same location as the previous comment, the widened concrete transitions behind Lot 177 to a shotcrete-like surface with a pedestrian sidewalk aligned on center. The sidewalk/access then extends into the arroyo at-grade and terminates on the northern bank. To my knowledge there is no authorization for such a crossing.

Asphalt trail connection and Cebolla Creek sidewalk invite pedestrians to cross the arroyo at grade.

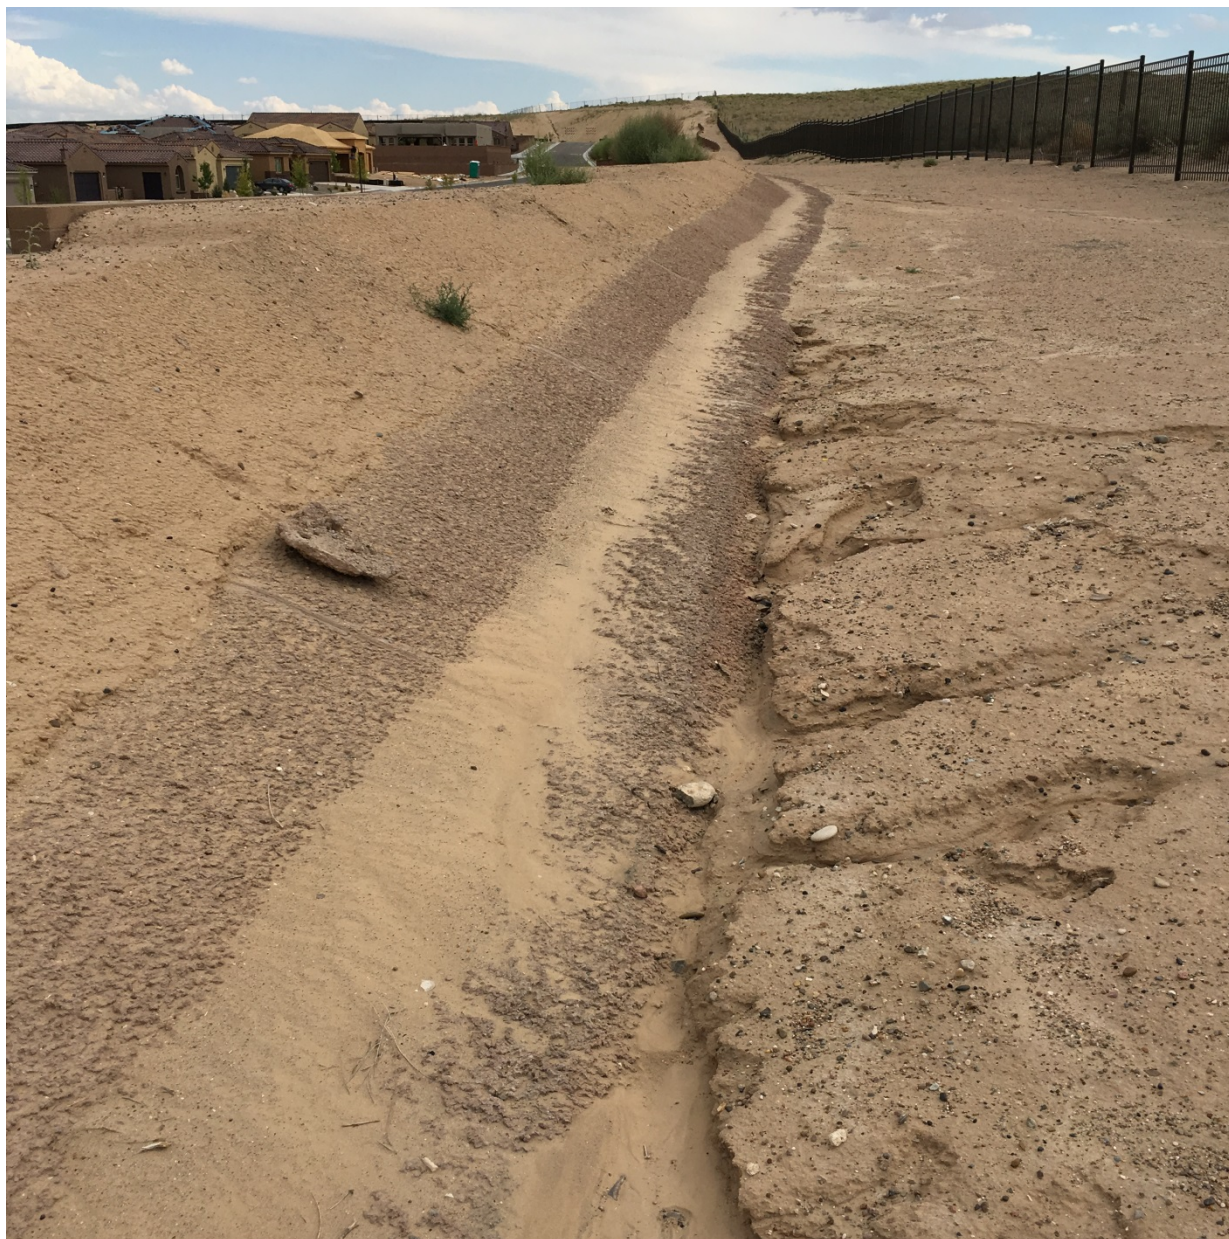
Comment # 4

4. The reinforced concrete diversion channel was substituted with a shotcrete trapezoidal section. I understand this may have been coordinated with the City Engineer. However, the segment behind Lot 203-Cebolla Creek is only a half section, apparently to protect the toe of the berm. The lip of the L-shaped edge is subject to erosion, and we are concerned that Stormwater can pipe under the structure and undermine the berm. Erosion control/scour protection should be installed.

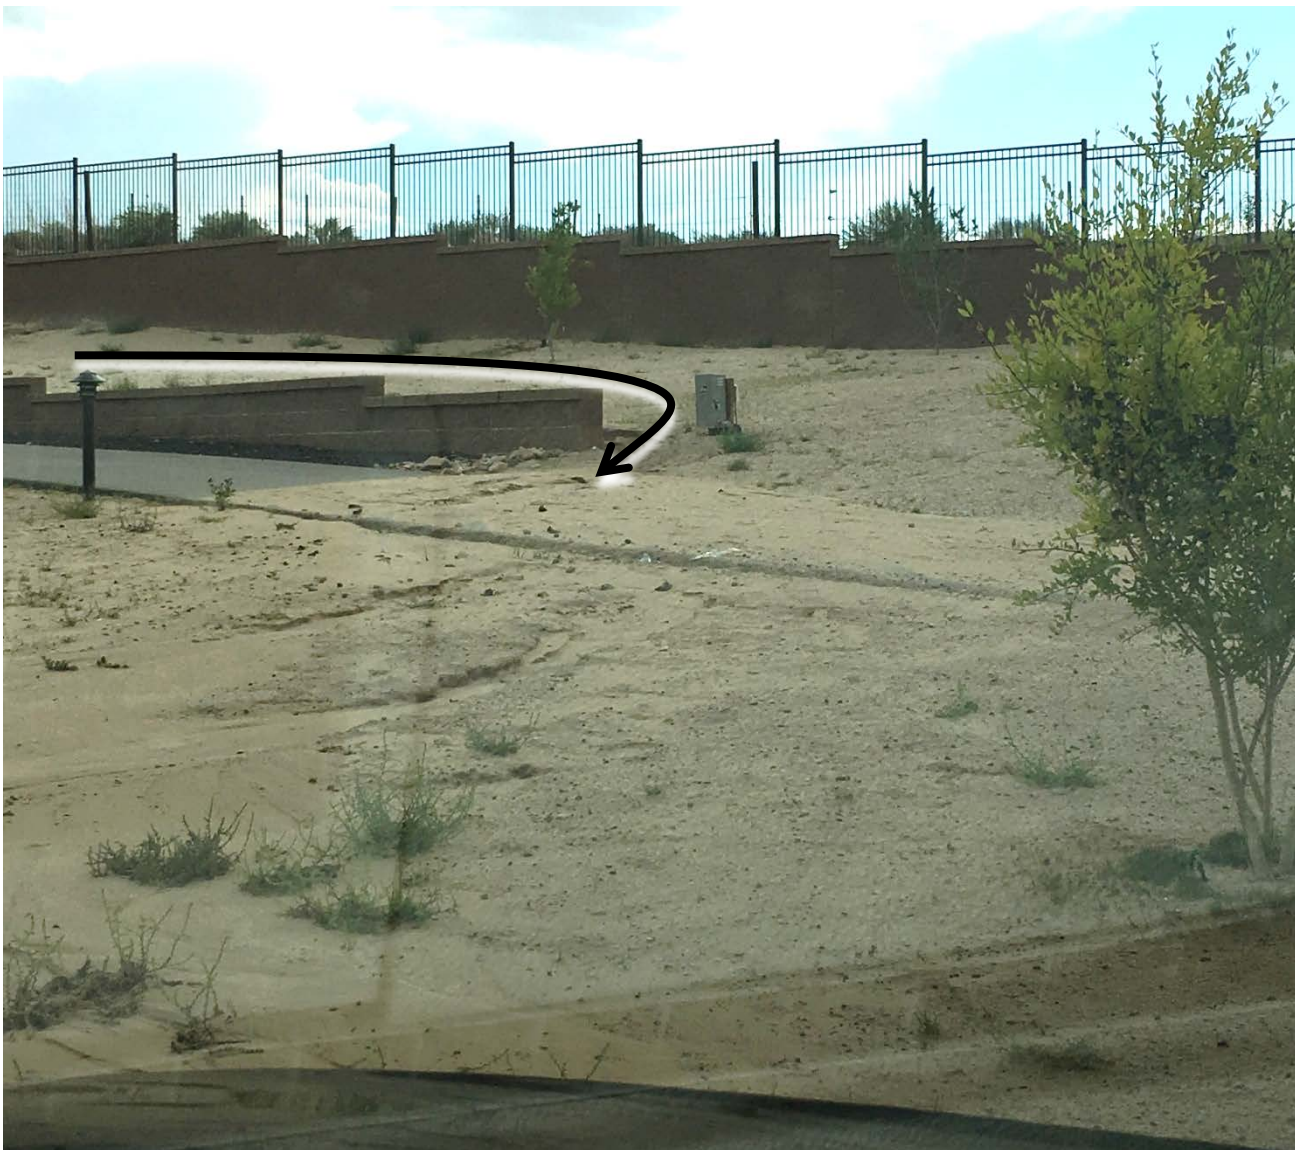
Comment # 6

6. Provide erosion control for the end of the retaining wall between lots 108 and 98 – Cebolla

Creek, flows coming from the top of the hill are concentrating along the wall and depositing sediment across the sidewalk.

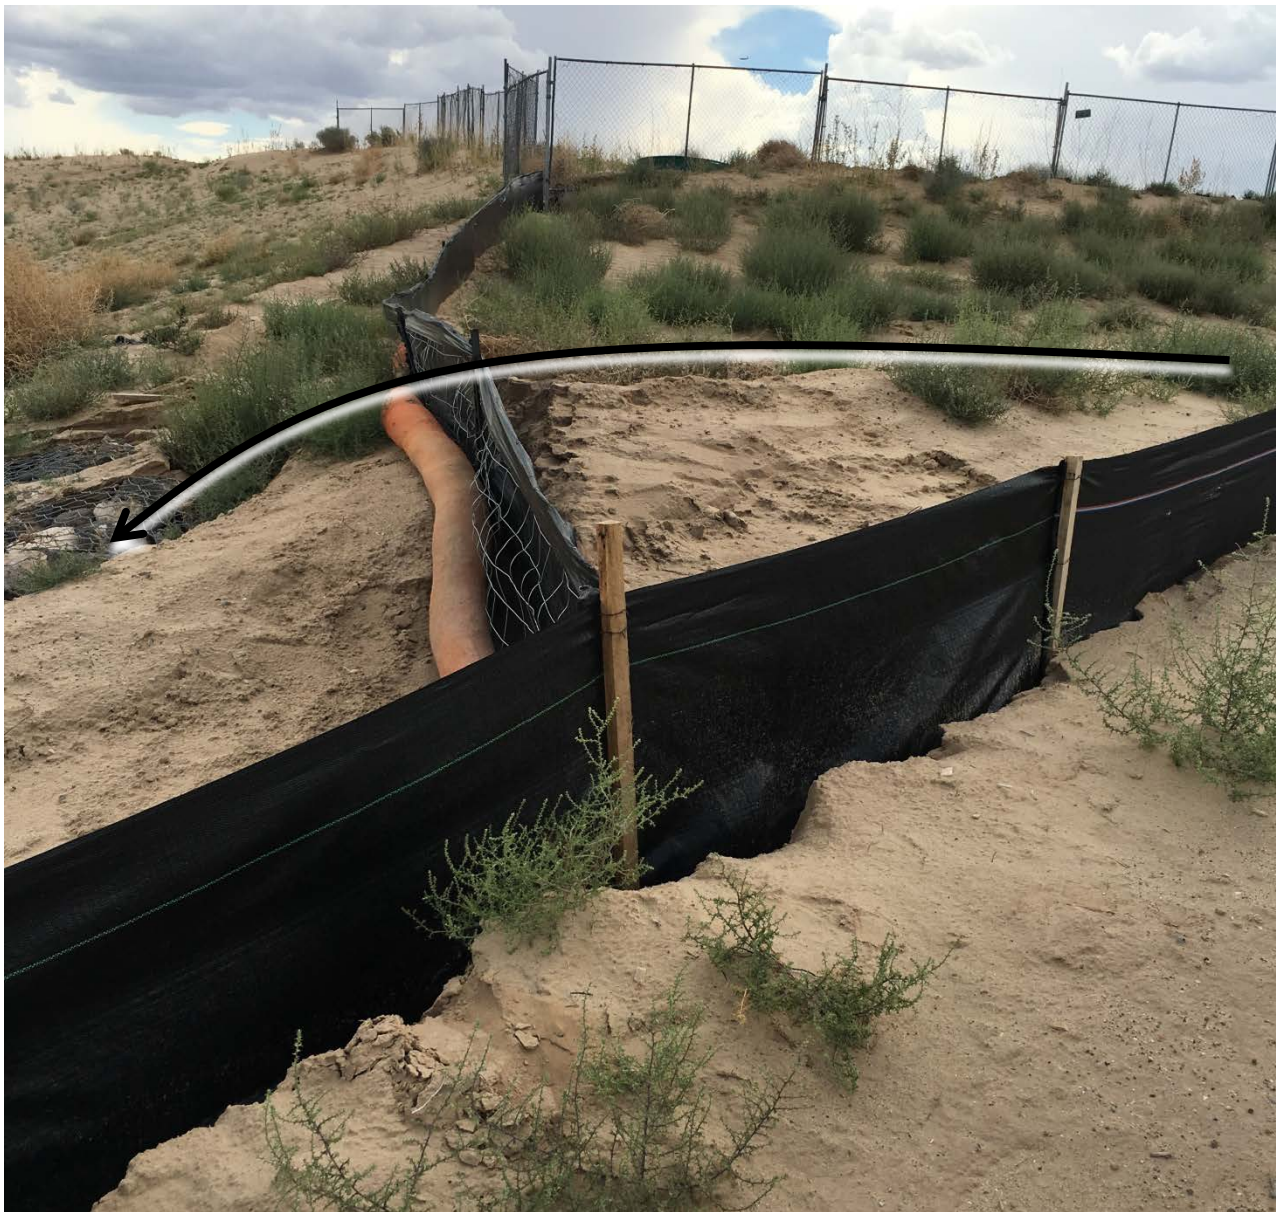
Comment # 7

7. Sheet 6 shows an inflow channel and rip rap swale for the large temporary pond. A silt fence is placed perpendicular to the flow into the pond. It should be removed and the channel should be shaped to allow unobstructed flow into the pond. The berm that is forming is redirecting sediment onto the trail and behind lot 135-Bear Lake Way.
8. Additional erosion control is needed beyond the existing rip rap over the steep slope behind Lots 120 and 121-Bear Lake Way.
9. There is edge cracking along the asphalt trail behind Lots 130-135-Bear Lake Way, possibly due to erosion of the trailside surface.
10. The tie slope between the pond and Mirehaven Parkway is missing the rock mulch called out on the plans (Sheet 7).
