April 26th, 2019

Site: Del Webb at Mirehaven Ph 3 and 4

Re: Drainage Ordinance (14-5-2-1) Violations for Erosion and Sediment Control and Construction Site Waste(s)

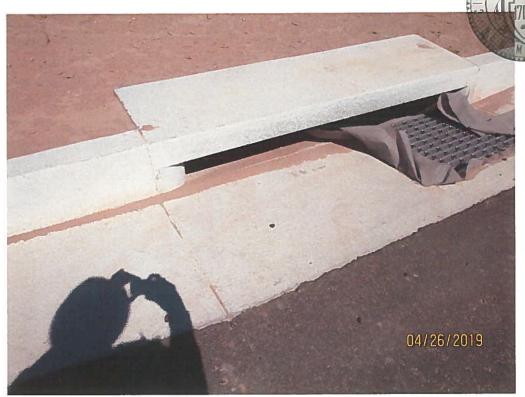
Sediment entering throat of inlet.

- 1. The project has 37.9 acres of disturbance minus the small area that is paved. At this stage of development rock bags and grate covers are inadequate for inlet protection. The throats of the inlets are also to be protected.

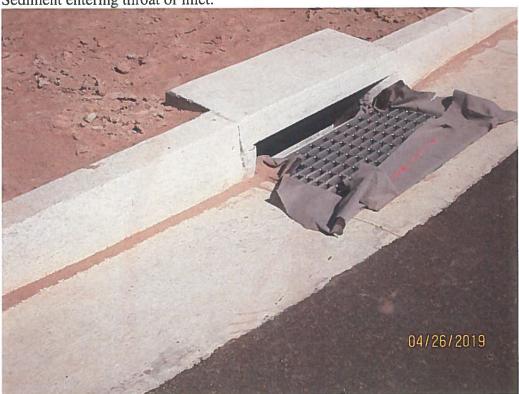
Sediment entering throat of inlet.

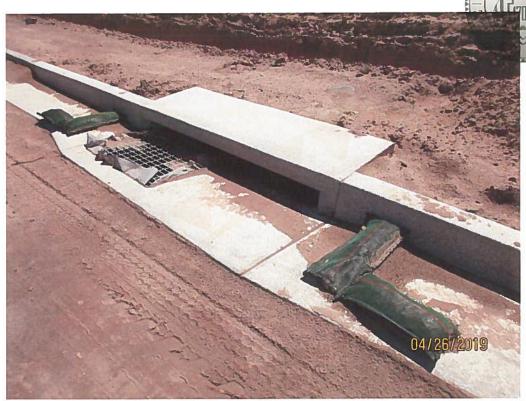
Sediment entering throat of inlet.

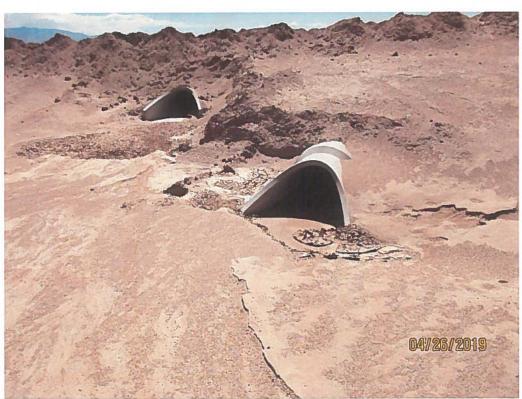
Sediment entering storm drain system. Pond to be re-established.

- 3. Remove sediment from storm drain openings and provide a sediment BMP at the storm drain. The pond in this area is to be reestablished.
- 4. Remove sediment from the street(s) and gutters.

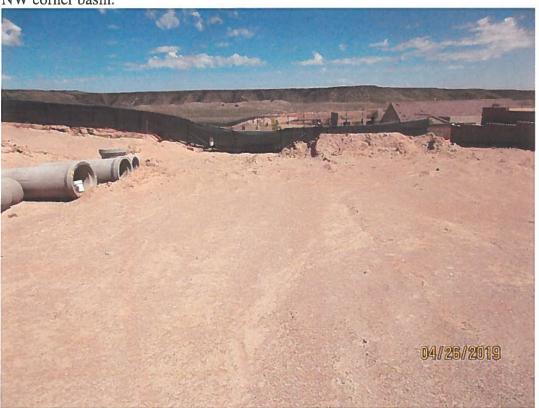
NW corner. A temporary sediment pond is to be built here.

- 2. Some of the streets are relatively steep (e.g. Sugar Creek Lane 3.43%, Wood Creek Lane 4.85%). Stormwater will achieve an erosive velocity at these grades. Provide BMPs to minimize velocity and provide temporary sediment ponds. Per the CGP the ponding area is 3600 cu. ft per acre drained.

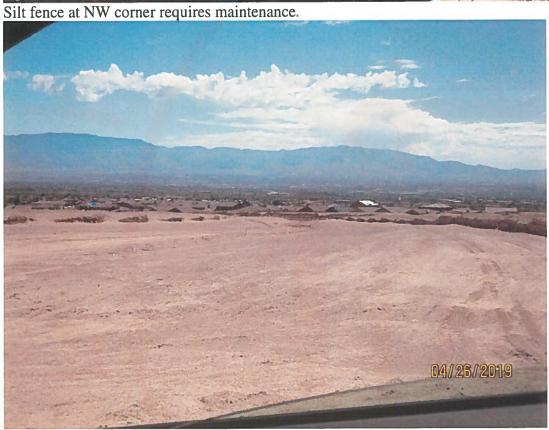
Typical east-west street with no BMP to minimize velocity.

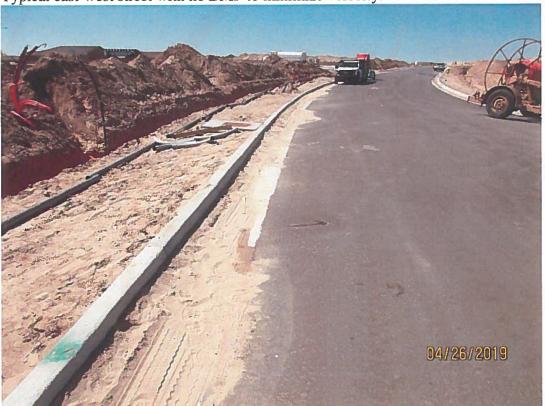
Sediment in the street.

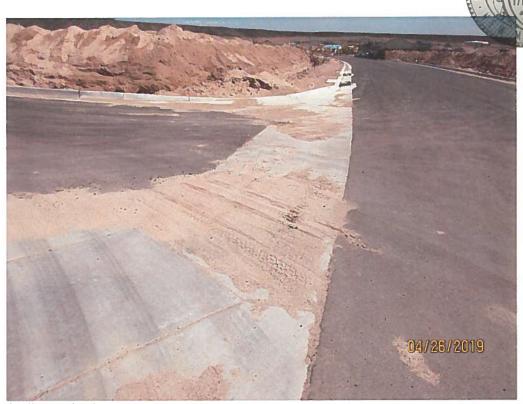
Sediment in the street.

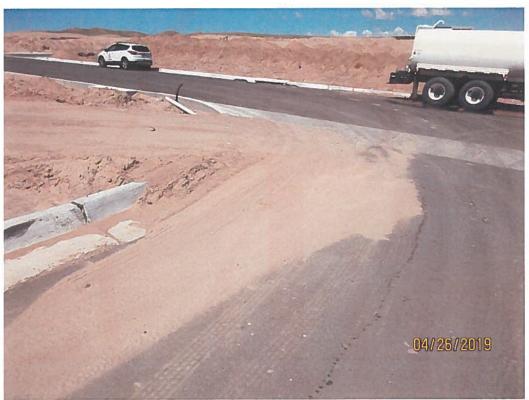
Sediment in the street.

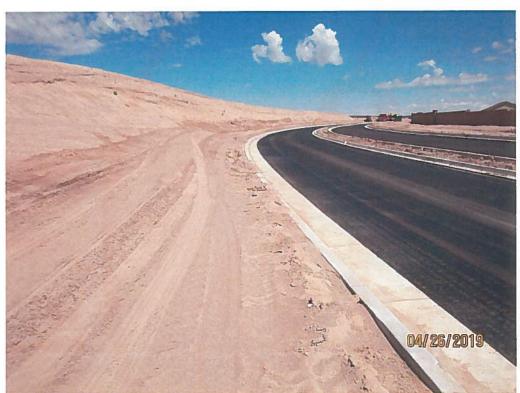
No sediment BMP along Mirehaven Parkway.

- 7. Provide a BMP to minimize the velocity along the western edge of Mirehaven Parkway and provide a sediment BMP.
