Date & Time: 04-23-2020 at 10:45 AM

NATIONAL STORM WATER QUALITY PROGRAM SITE INSPECTION REPORT (SIR)

Community Name:		PulteGroup-MS-1026:Mirehaven, 9043 Fenton Lake Road NW, Albuquerque, NM 87120 NPDES: NMR1000C1									
		(Include Site Name, Ci	(Include Site Name, City, State, Zip Code and NPDES/Construction Storm Water Permit Number)								
Master Site List ID:		369	In	Inspection performed by: Mario Alderete, CESSWI CISEC, Green Globe Environmental							
				(Print Na	ame, Company, and Title / Qua	lifications)					
Stages	of Construction:	(check all that apply)	Land Development	Inactive	Vertical Construction	Post-Construction					
			X Land and Vertical								
Type of	Inspection:	(check all that apply)	Routine Inspection Other:	Storm-Event Related	Final Site Inspection

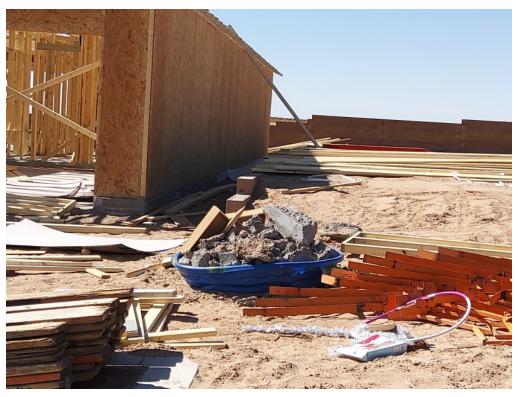
Item	Location and Responsive Action to be taken		Date Noted Date of Completion								
	Deficiency Name: Granite mountain										
9	Corrective Action: Need to stabilize dirt piles			04-09-2020							
	Deficiency Name: 2319 komate										
11	Corrective Action: Trash ans stucco washout need to be cleaned	04-09-2020									
	Concerve rection. This is and studed washout need to be created										
	Deficiency Name: 2223 chuckwalla spring										
14	Corrective Action: Concrete washout pool needs to be cleaned	04-09-2020									
	Confective Action. Confecte washout poor needs to be created										
	Deficiency Name: 1904 cebolla creek										
14	Corrective Action: Concrete washout pool needs to be emptied		04-23-2020								
	Confective Action. Concrete washout poor needs to be empired	out									
	Deficiency Name: 9324 wood creek										
14	•		04-23-2020								
	Corrective Action: Concrete washout pool needs to be emptied

Corrective Actions: Concrete washout pool needs to be emptied out

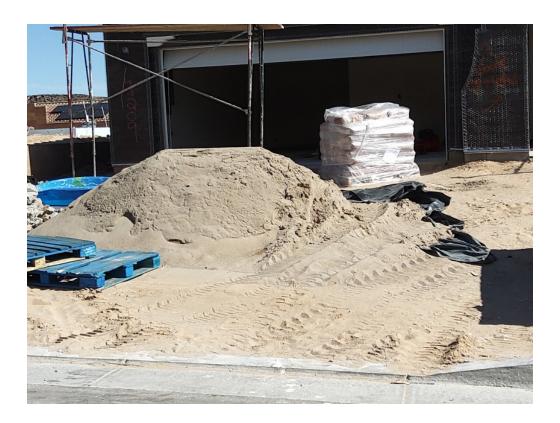
Deficiency Name: 9209 sugar creek **Corrective Actions:** Curb cut back

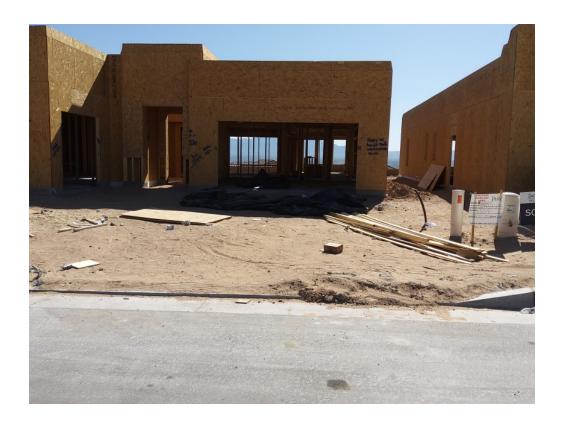
Deficiency Name: 1804 pebble **Corrective Actions:** Curb cut back
