From: michael farrell <michael@superiorstormwater.com>
Sent: Tuesday, July 10, 2018 6:46 AM
To: Cherne, Curtis
Cc: Kevin Patton (Kevin.Patton@PulteGroup.com); Tim Slatunas W Green Globe (tim@greenglobenm.com)
Subject: Re: Stormcloud Unit 4 construction site inspection

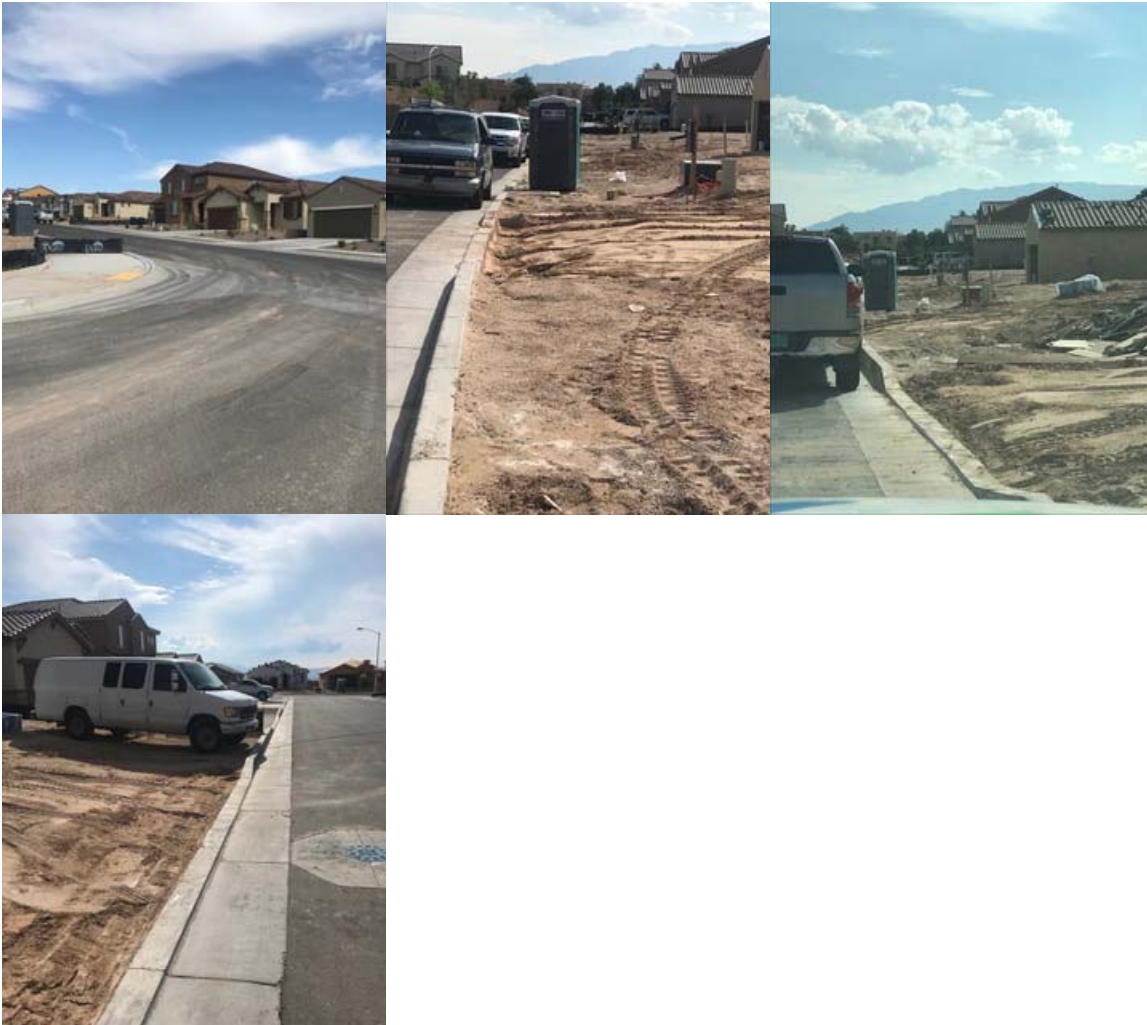
1. Lots 8540 Animas, 8535 Animas and 8715 Jet Stream could use a better cutback behind the curb. Looks like the curbs were cut recently.
2. The track-out pad from 4B to 4A could use some maintenance. The track-out was making it out to Jet Stream.
3. Please send the last two self-inspection reports.

Here are the pics of those coercive actions you had in you inspection. I don't have one of the trackout pad yet. I will get that today and send it over to you as soon as I get it. Let me know if there is anything else you need.
Thanks
