City of Albuquerque  
Stormwater Construction Site  
Inspection Report

Project Name and Location	2400 Marix Park Same		
Site Contact Name & Agency	Jason Buchanan Jason@FandSBuilders.com	ESC File No.	H22E026
Date of Inspection	12-13-17	Start/End Time	10:05 / 10:15
Inspector Name, COA Dept.	Curtis Cherne, Stormwater Quality		
Describe Present Phase of Construction	Stabilized		
Type of Inspection:	<input checked="" type="radio"/> Regular • During storm event • Post-storm event (> 0.5 inch) • 311 / Complaint Response • Follow-Up

**Re: Drainage Control Ordinance (14-5-2-1) Violations for Erosion and Sediment Control**

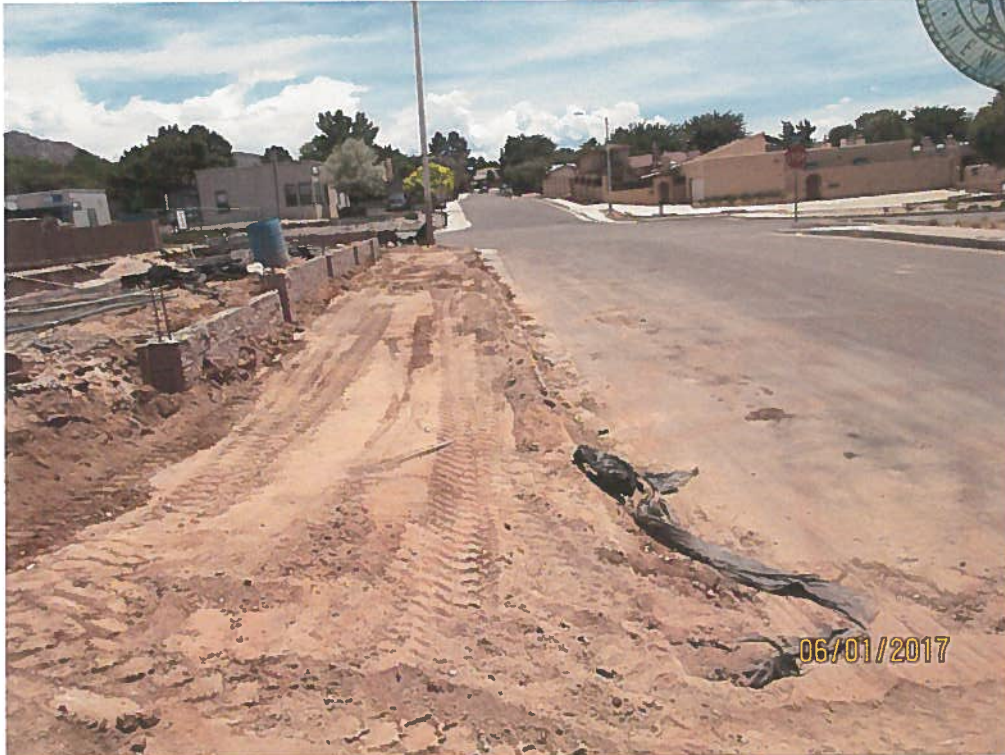
1. The silt fence was not installed along Marie Park Dr.
2. Silt fence was not installed from Marie Park Dr. to the wall shown in the last photo.
3. Sediment was observed in Marie Park Dr due to lack of sediment BMP/silt fence.
4. A large dirt ramp was placed in the street.
5. Cement pollution in the soil.
6. An acceptable concrete wash-out facility was not observed.
7. Silt fence and dirt covering a portion of the public sidewalk.

No sediment BMP/silt fence.

1. Remove sediment from Marie Park.
2. Install a sediment BMP/silt fence along Marie Park Dr.
3. Install silt fence in the northwest corner from Marie Park Dr to the wall.
4. Remove dirt ramp from the street and use approved access point.

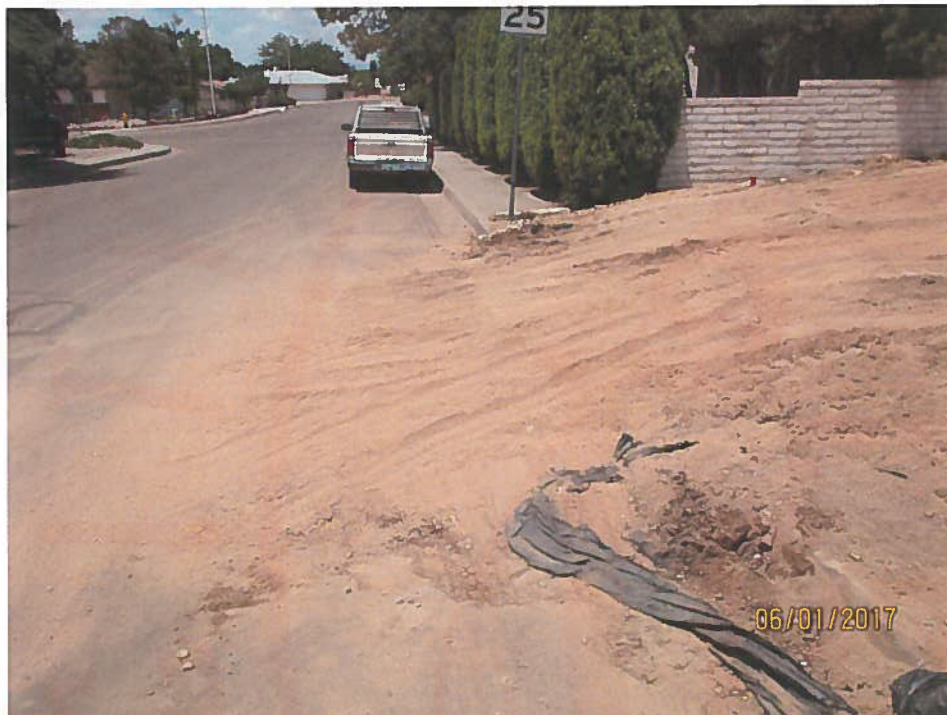
No sediment BMP and large dirt ramp in the street.

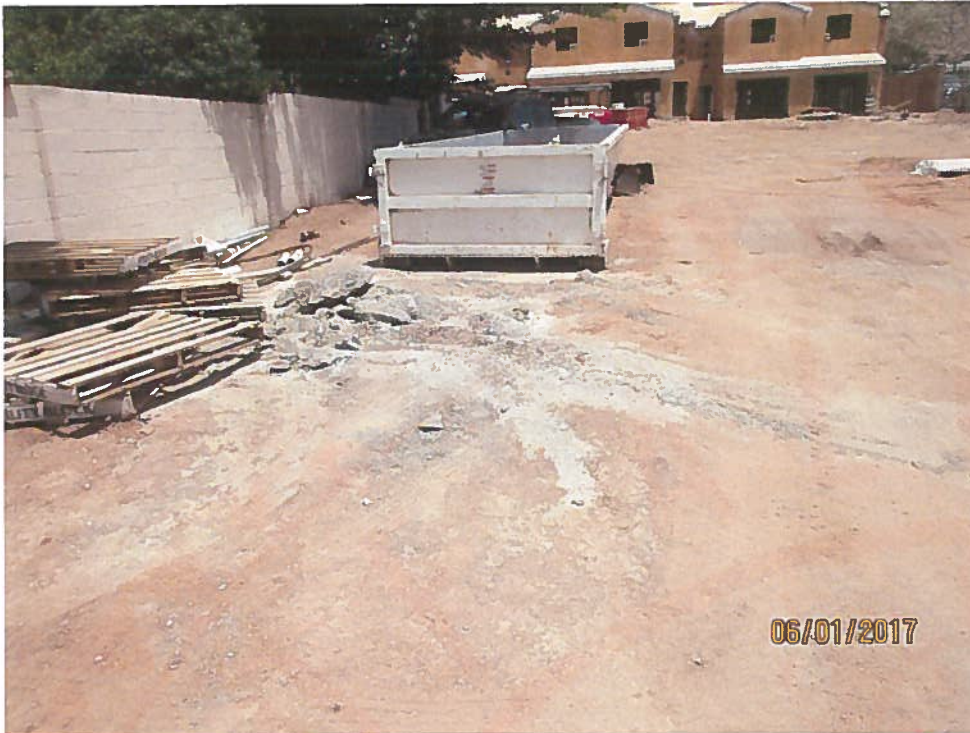
Cement pollution.

1. Remove cement pollution.
2. Have an acceptable concrete wash-out facility on site and use it.
3. Remove silt fence and dirt form public sidewalk on Menaul Blvd.

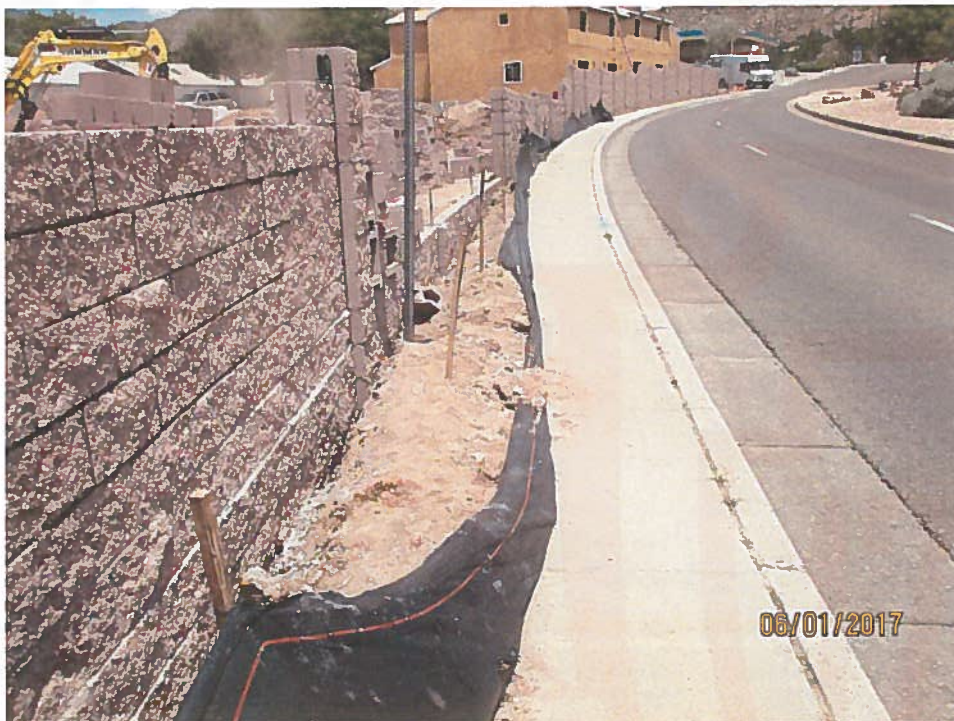
Silt fence and dirt on public sidewalk.

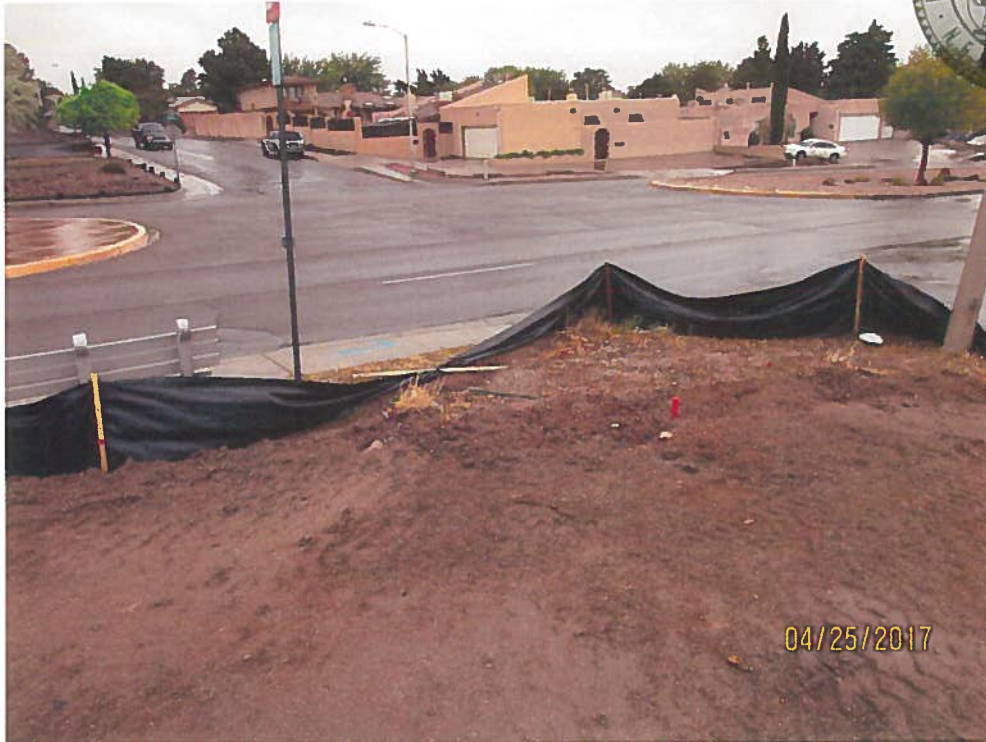
Silt fence in southwest corner. No berm.

Per telephone conversation with Jason Buchanan on 4-18-17, he stated that he started building the wall and should be done in two weeks and therefore requested to not have to replace the silt fence. We agreed that he would construct berms in the locations where the fence was not buried or there were gaps.

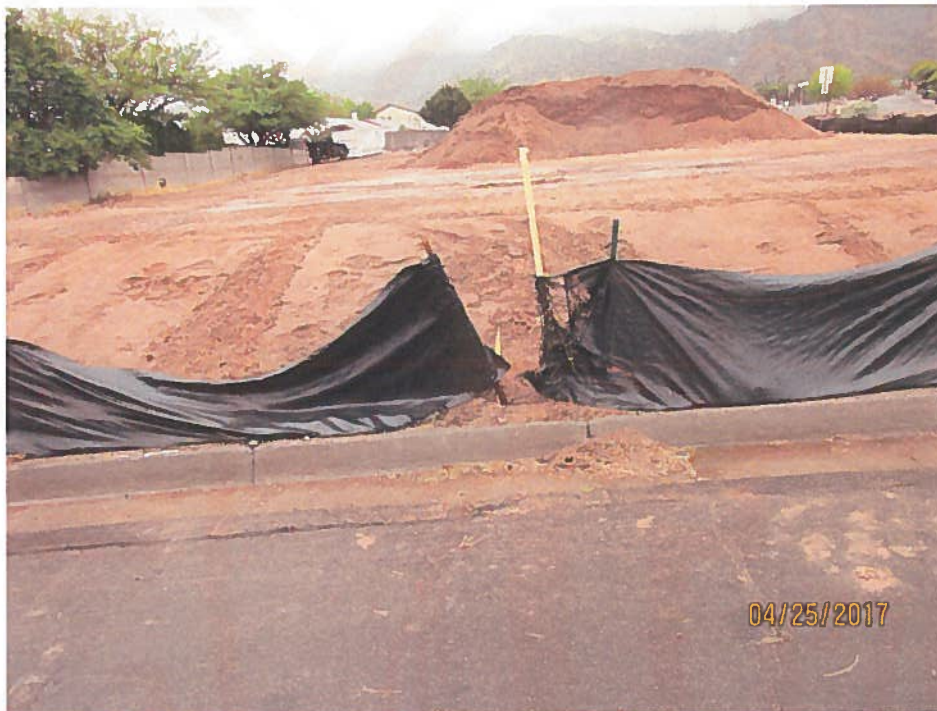
Gap in silt fence and silt fence falling down along Marie Park Dr. Dirt straight-graded to edge and no berm. Sediment observed in street.

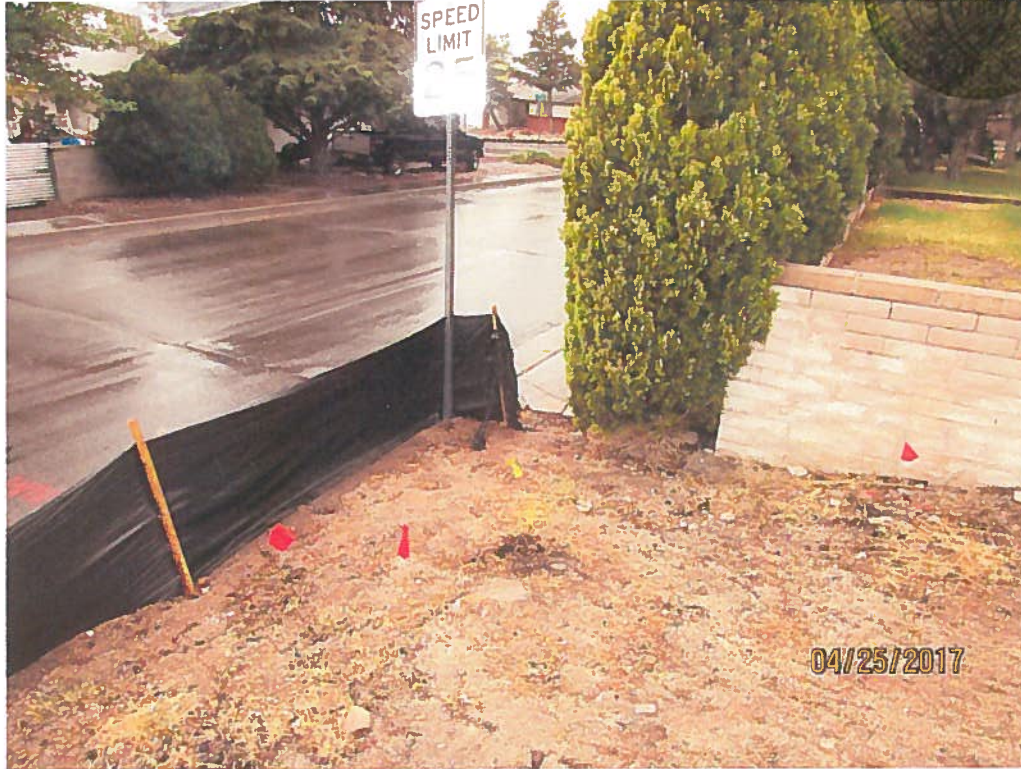
Gap in NW corner. No berm.
