CITY OF ALBUQUERQUE

Site: Inspiration Subdivision at Arroyo Vista Blvd/ 118th St. NW – J08E005

Re: Drainage Ordinance (14-5-2-11) Violations for Erosion and Sediment Control

This Notice of Violation #2 pertains to observation during City Follow-up inspections on 9/1/22 and 9/15/22.

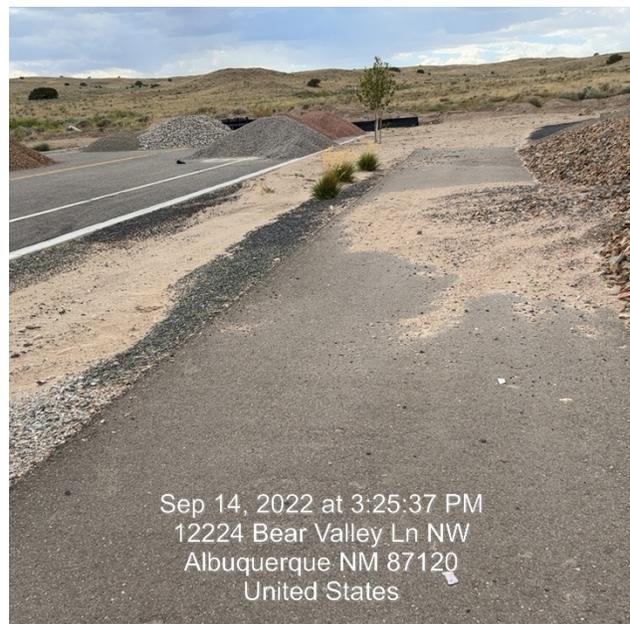
1. Sediment was on the AC Trail at the west end of Arroyo Vista Blvd.

1. Where sediment has been washed or tracked out onto paved roads, sidewalks, and parking lots remove the deposited sediment by the end of the same business day CGP 2.2.4.d. Most of the existing instances of sediment in the street have been there longer than 7 days so they must be escalated from Routine Maintenance to Corrective Actions.

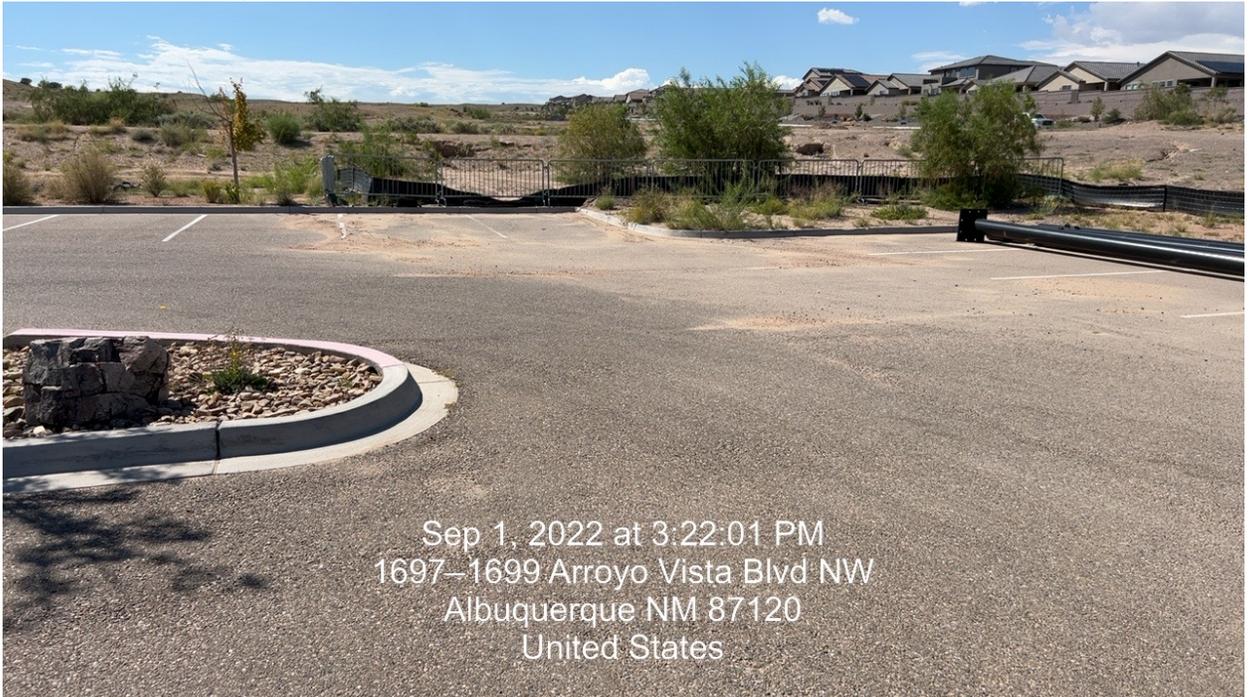
and in the Albuquerque Regional Sports Complex parking lot (Previously reported 7/14/22 and 8/8/22).

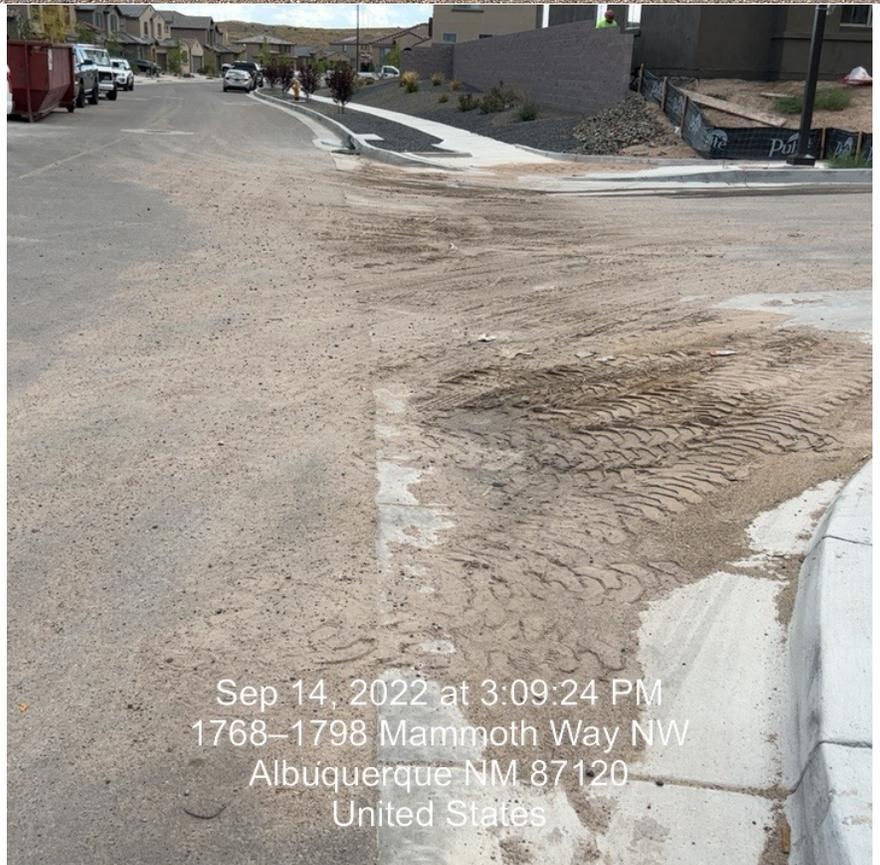
Sediment was also on several onsite streets and sidewalks throughout the site. (Previously reported 4/21/21, 7/14/22, and 8/8/22) All of the street and utility construction is complete and is serving the public. Housing construction is about 60% complete and the houses are occupied. The onsite streets discharge stormwater runoff into the City's MS4 system.

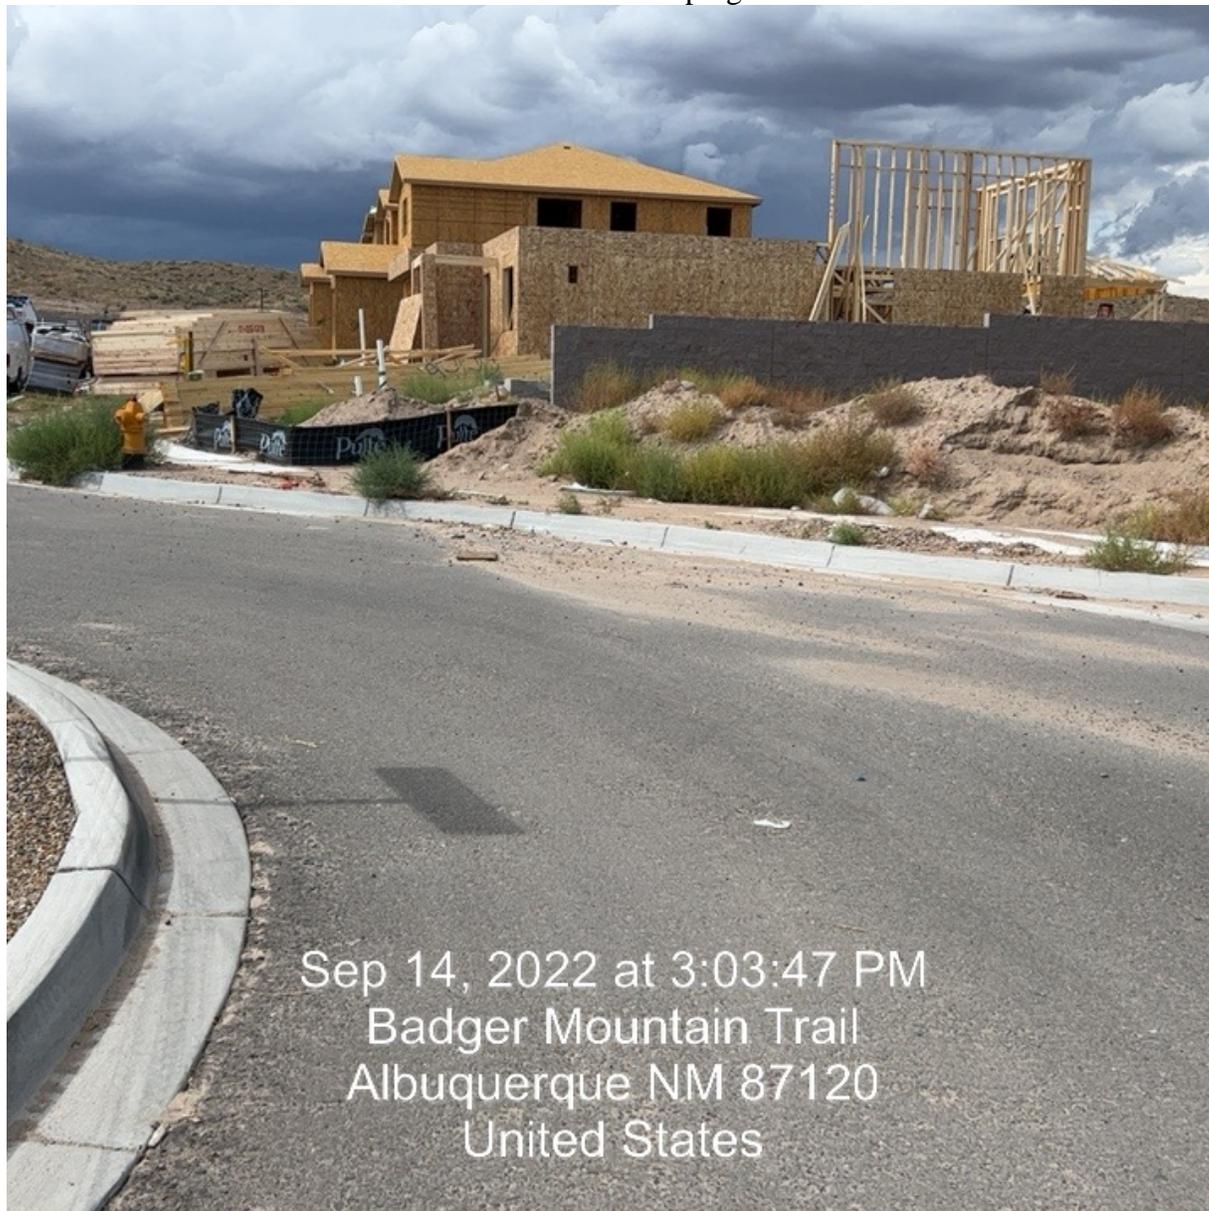
2. BMPs –Cut-back swales behind the curbs are not keeping sediment out of the streets.

Silt Fence repairs, replacement, and additions are needed in several locations along the northern perimeter. Additional Silt fence is needed at the above photo of Badger Mountain Trail.

- a. Better perimeter controls need to be established per CGP 2.2.3.c.ii around each lot and block to keep sediment out of the streets and off of the sidewalks. The City standard cut-back detail says to use check dams or silt fences to slow stormwater runoff down on steep (>2%) streets. Modify the SWPPP accordingly.

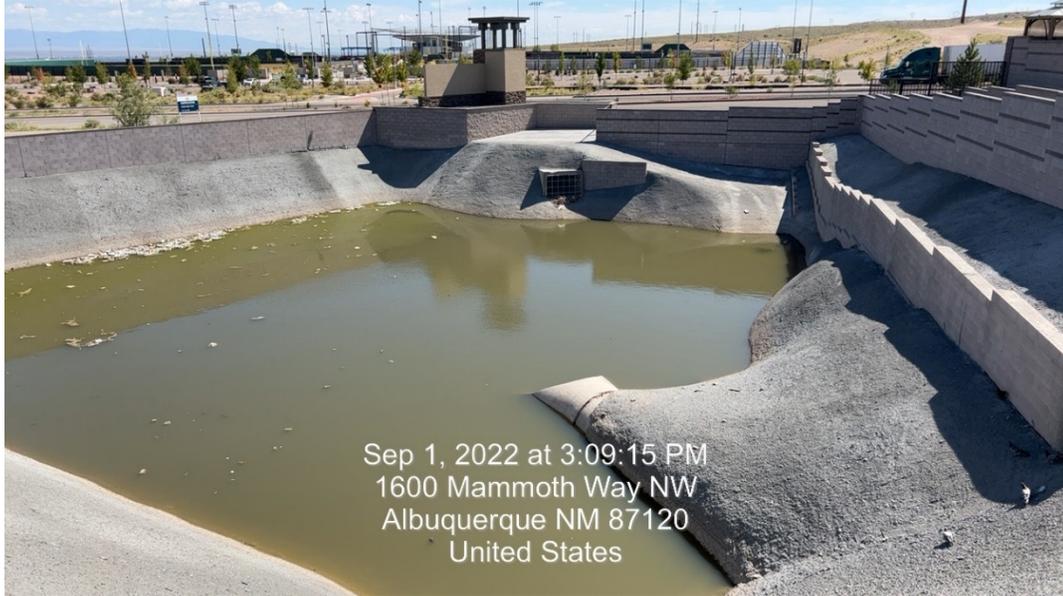
Two sediment basins are identified on the SWPPP map, but the SWPPP doesn't provide any criteria for inspection or a maintenance schedule for these BMPs, as required by CGP 9.6.1.c.i, so it isn't clear how to remedy the waste floating on top of the brackish water the First Flush Pond in the south east corner of the subdivision. It has an as-built retention volume of 0.93 ac-ft which is less than 1/3 of the volume required for Sediment Basins

by CGP 2.2.12. The pond has had standing water in it during every inspection since 7/6/22. Infiltration is prevented by shotcrete lined sides and a dirt bottom that is sealed with fine sediment. The pond owner, Inspiration Community Association Inc., doesn't have an NOI. They also own another dirt pond on a 1.1 acre tract along the north edge of the subdivision that needs to be stabilized per CGP 2.2.14. So permit coverage is required for the Association and the transfer must be shown on Pulte's SWPPP. Severe erosion at two of the rip-rap rundowns needs repaired and the tumble weeds in the picture to the right violate the City's weed control ordinance § 9-8-4 https://codelibrary.amlegal.com/codes/albuquerque/latest/albuquerque_nm/0-0-0-97141 which prohibits weeds wider or taller than 4".

- c. Repair and prevent erosion at the 118th St. discharge point on Arroyo Vista Blvd. per CGP 2.2.11. This shouldn't be a discharge point.
 - d. Inspect and maintain the sediment basins in accordance with standard procedures and modify the SWPPP accordingly.

- i. Monitor the sediment accumulations in both basins and remove sediment when it reaches half capacity per CGP 2.2.12.f
 - ii. Remove and dispose of construction and domestic waste.

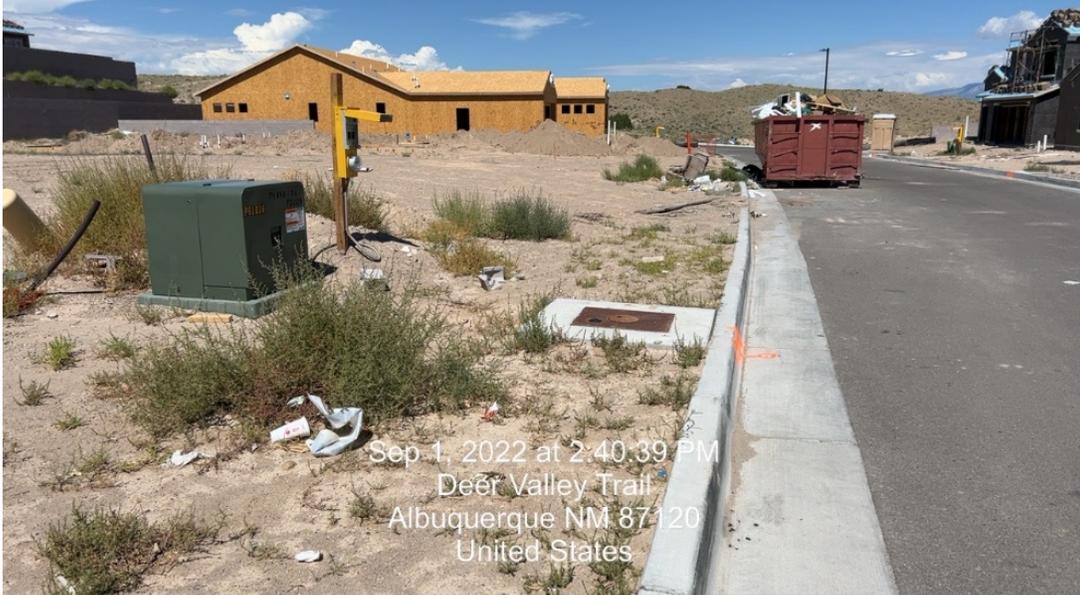
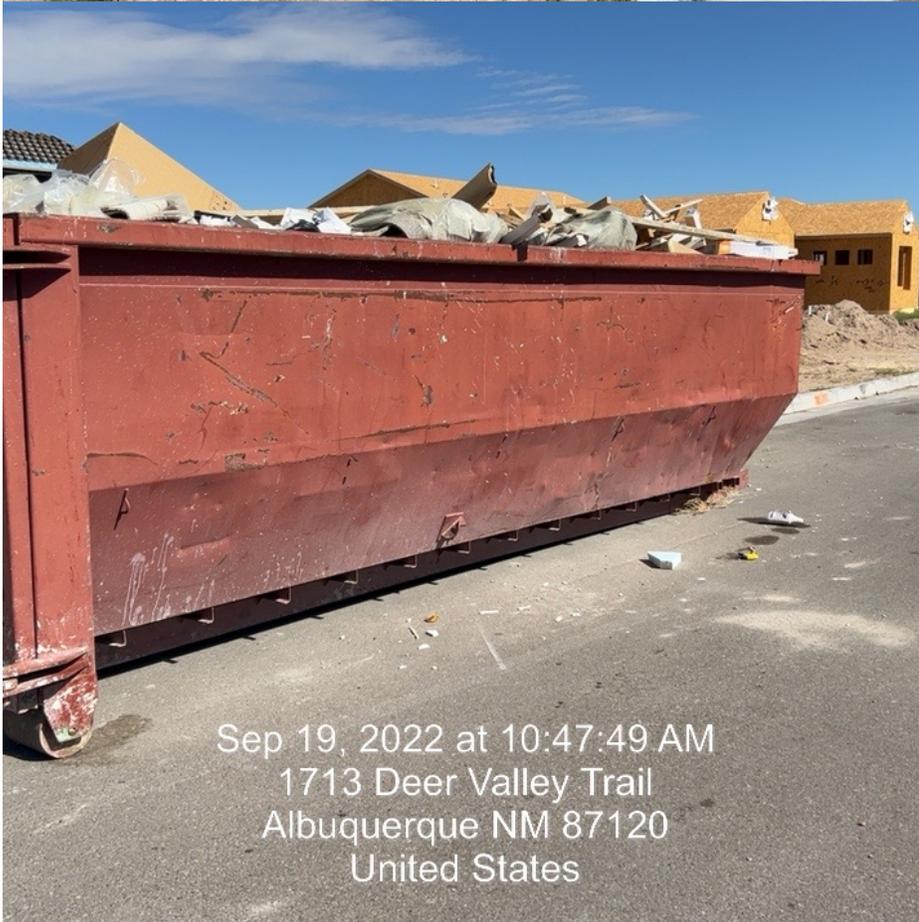
3. Construction and domestic waste is overflowing dumpsters and is strewn about the site.

- iii. Provide temporary and permanent stabilization in accordance with CGP 2.2.14.
 - iv. Repair severe erosion at two rundowns in the north
3. Dispose of construction and domestic waste in acceptable containers daily and use lids or tarps to cover waste containers when not in use per CGP 2.3.3.e

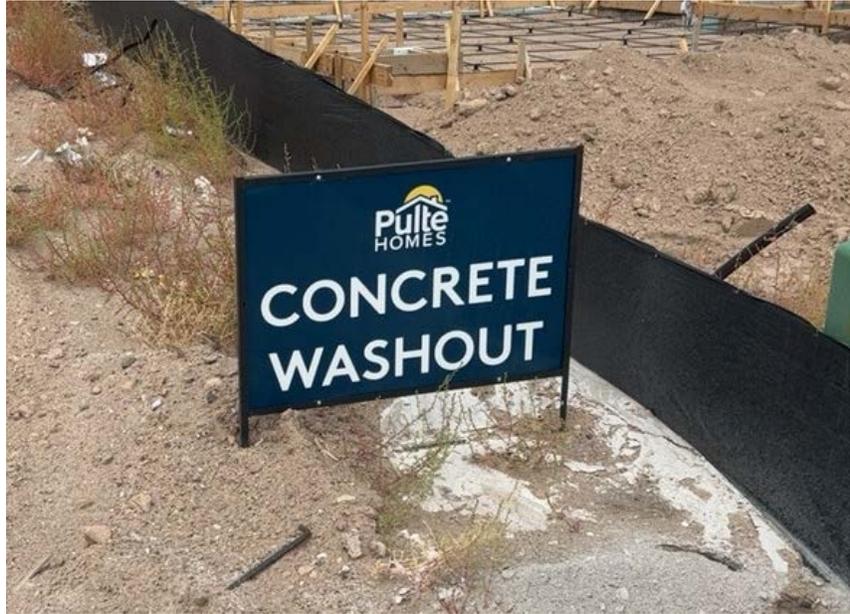
5. Washout of concrete, stucco, and paint is on the ground at many of the houses under construction and at the concrete washout in the northeast corner of the subdivision. Lined containers were absent. Washout had overflowed and was still sitting on the ground at the sign.

- b. Permit coverage is required for the Inspiration Community Association, LLC., and the transfer must be shown on Pulte's SWPPP map. Their NOI should either be added to the Pulte SWPPP or another SWPPP will be required for the Association.
5. Direct wash water from concrete, paint, and stucco into a leak-proof container and never onto the ground per CGP 2.3.4. Provide lined containers at the primary washout location and at convenient locations for each house during such construction. Remove and dispose of hardened concrete with other waste in per CGP 2.2.3.
6. Support all portable toilets to prevent tipping per CGP 2.2.3.f.

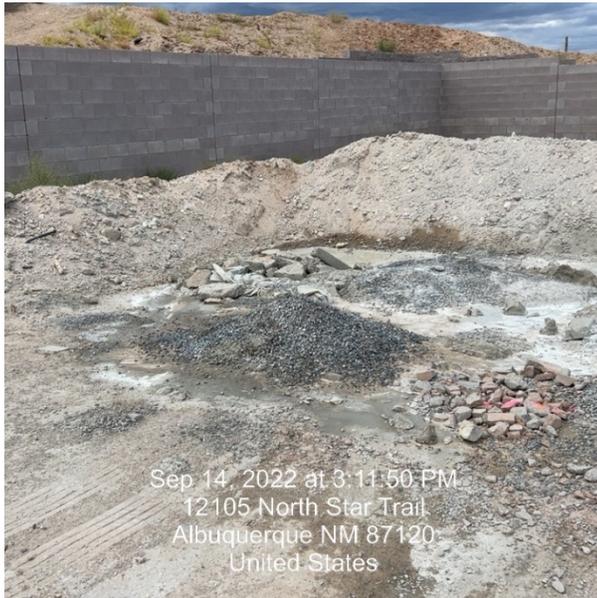
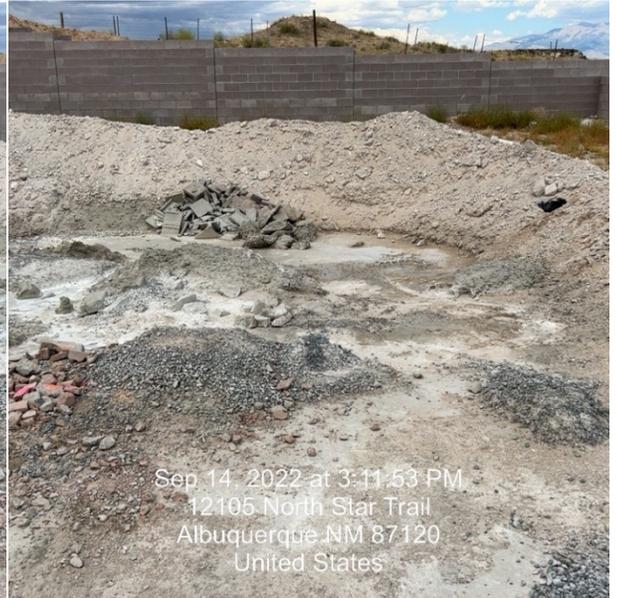
No liner could be found at the main washout or anywhere else.

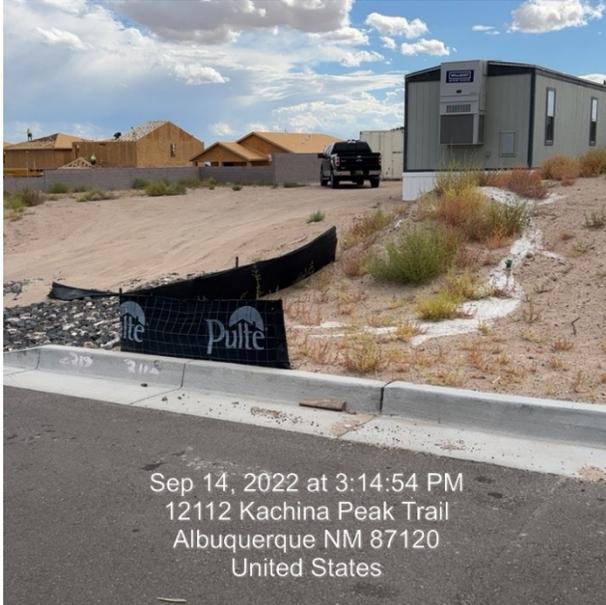
Washout by the construction trailer.

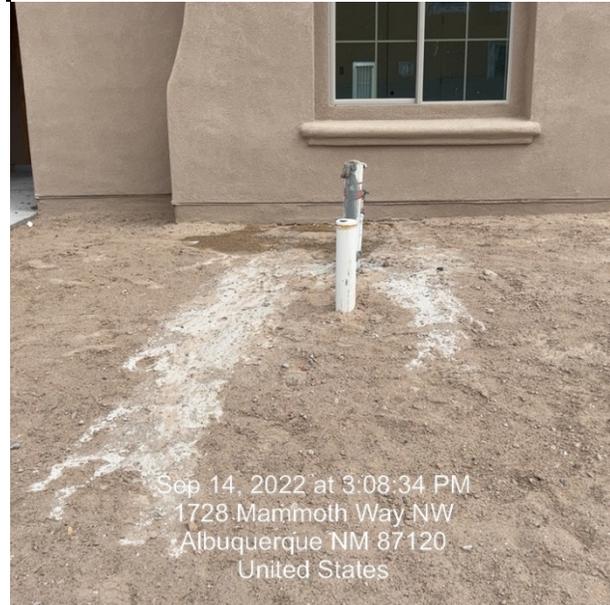
Washout on Mammoth Way.

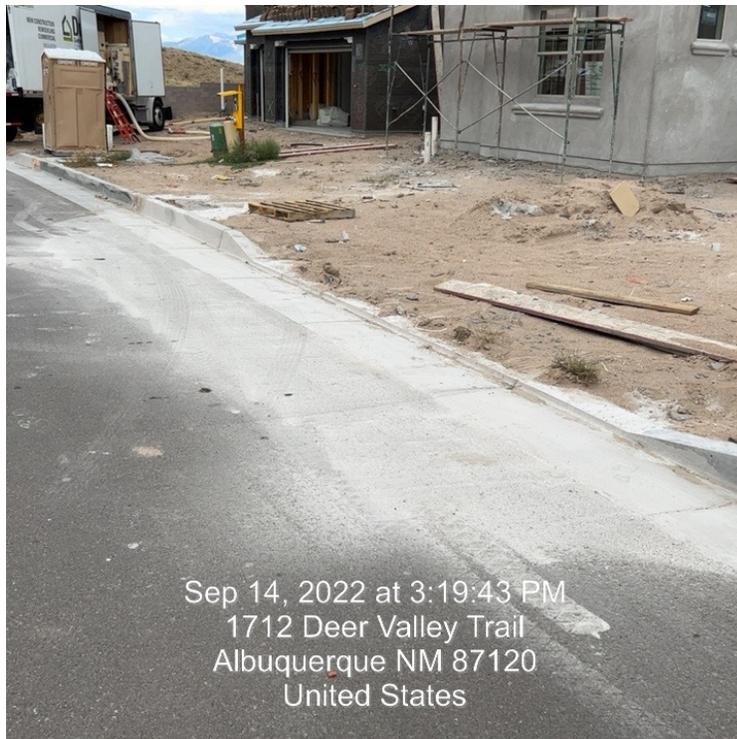
Curb cut is another form of concrete wash water.
