NATIONAL STORM WATER QUALITY PROGRAM SITE INSPECTION REPORT (SIR)

Commu	nity Name:	Pulte: Inspiration, Arr	oyo Vista Blvd and Mesa Drive,	Albuquerque, NM 87120 NPDE	S: NMR10024T				
		(Include Site Name, Ci	ty, State, Zip Code and NPDES/	Construction Storm Water Perm	iit Number)				
Master	Site List ID:	A1414	In	spection performed by: Joshua A	Armijo , Inspector, Green Globe	Environmental			
				(Print N	ame, Company, and Title / Qual	ifications)			
Stages	of Construction:	(check all that apply)	Land Development	Inactive	Vertical Construction	Post-Construction			
			Land and Vertical						
Type of	Inspection:	(check all that apply)	Routine Inspection	Storm-Event Related	Final Site Inspection				
	_		Other:

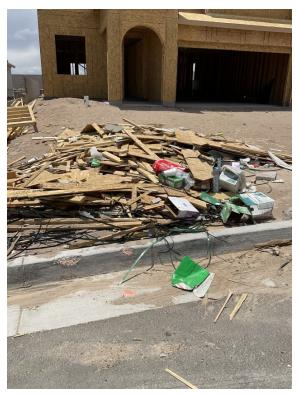
Deficiency Name: 11908 echo valley **Corrective Actions:** Construction debris
