Date & Time : 07-08-2021 at 4:29 PM

**NATIONAL STORM WATER QUALITY PROGRAM  
SITE INSPECTION REPORT (SIR)**

Community Name: Pulte: Inspiration, Arroyo Vista Blvd and Mesa Drive, Albuquerque, NM 87120 NPDES: NMR10024T  
(Include Site Name, City, State, Zip Code and NPDES/Construction Storm Water Permit Number)

Master Site List ID: A1414 Inspection performed by: Mario Alderete, Inspector, Green Globe Environmental  
(Print Name, Company, and Title / Qualifications )

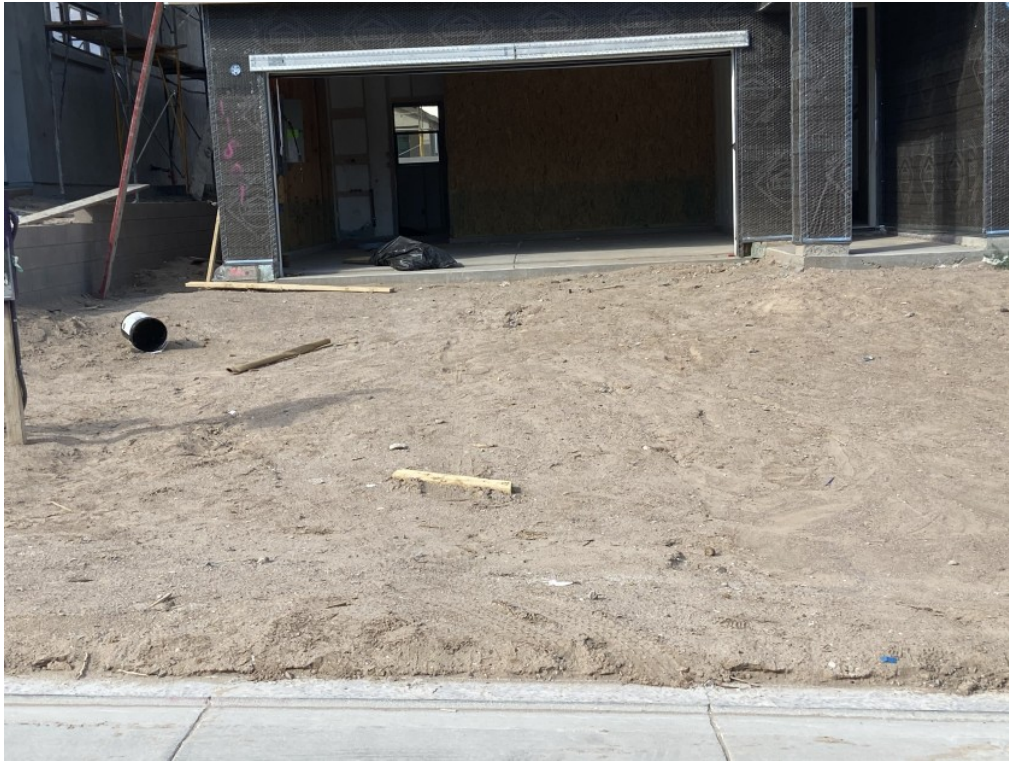
**Deficiency Name:** 11502 echo valley

**Sediment Control Deficiency Photos**

**Corrective Actions:** Cut curb back

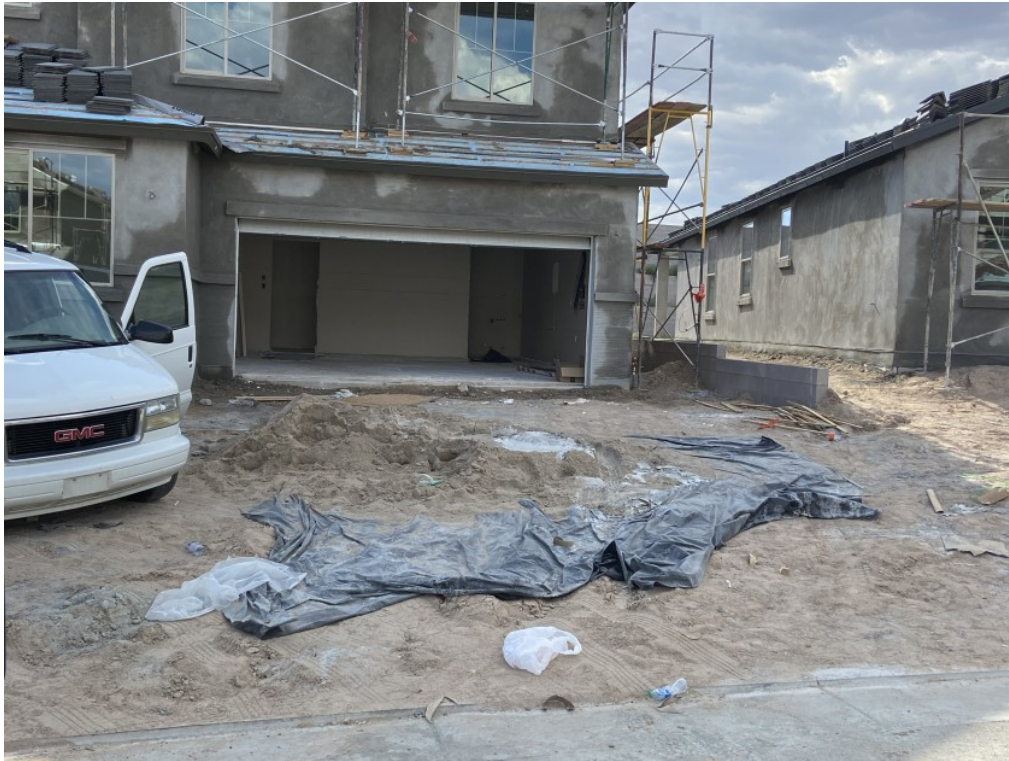
**Deficiency Name:** 1605 Taos mountain

**Sediment Control Deficiency Photos**

**Corrective Actions:** Cut curb back

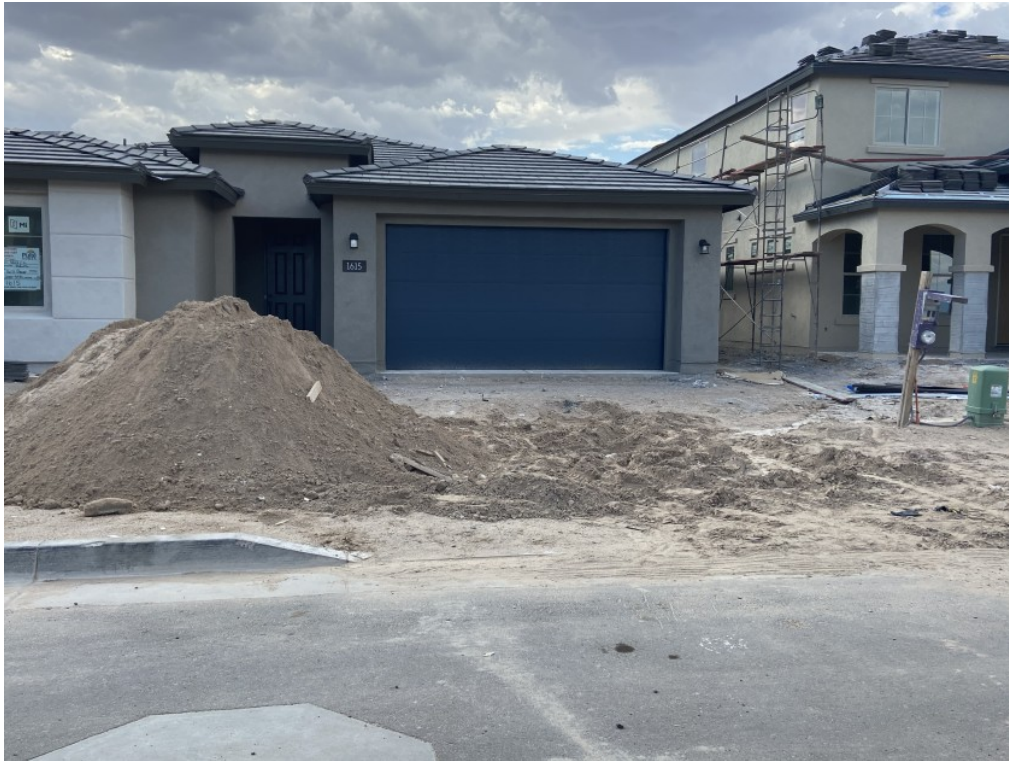
**Deficiency Name:** 1615 beaver creek

**Sediment Control Deficiency Photos**

**Corrective Actions:** Cut curb back

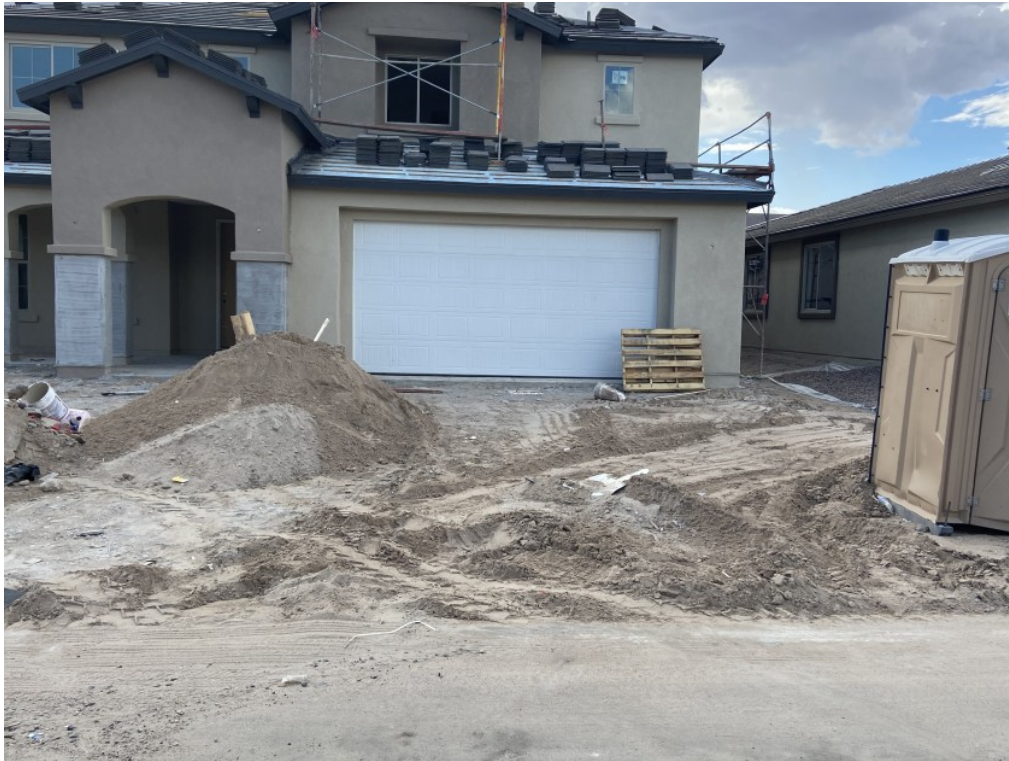
**Deficiency Name:** 1619 beaver creek

**Sediment Control Deficiency Photos**

**Corrective Actions:** Cut curb back

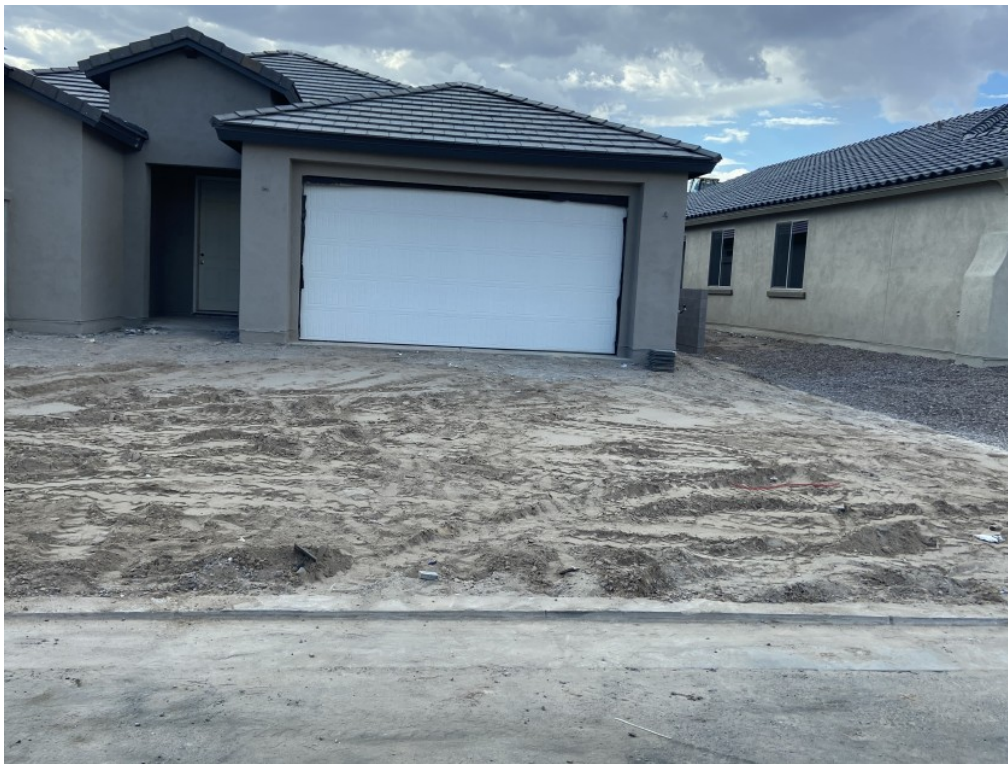
**Deficiency Name:** 1701 beaver creek

**Sediment Control Deficiency Photos**

**Corrective Actions:** Cut curb back

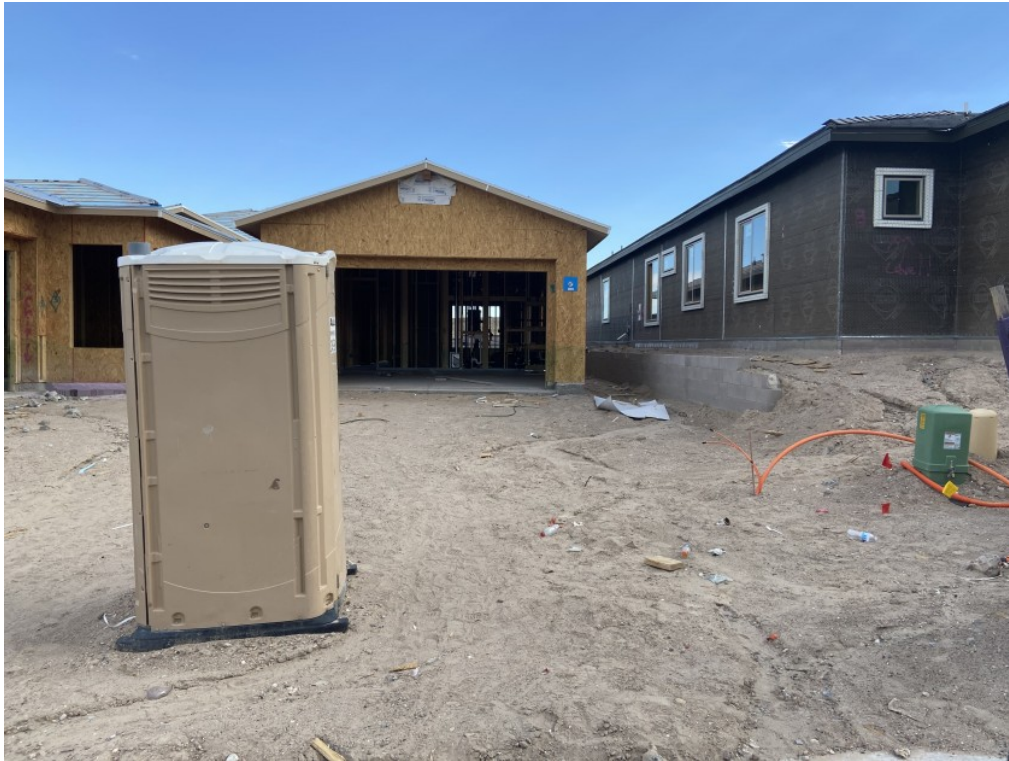
**Deficiency Name:** 12210 bear

**Sediment Control Deficiency Photos**

**Corrective Actions:** Cut curb back

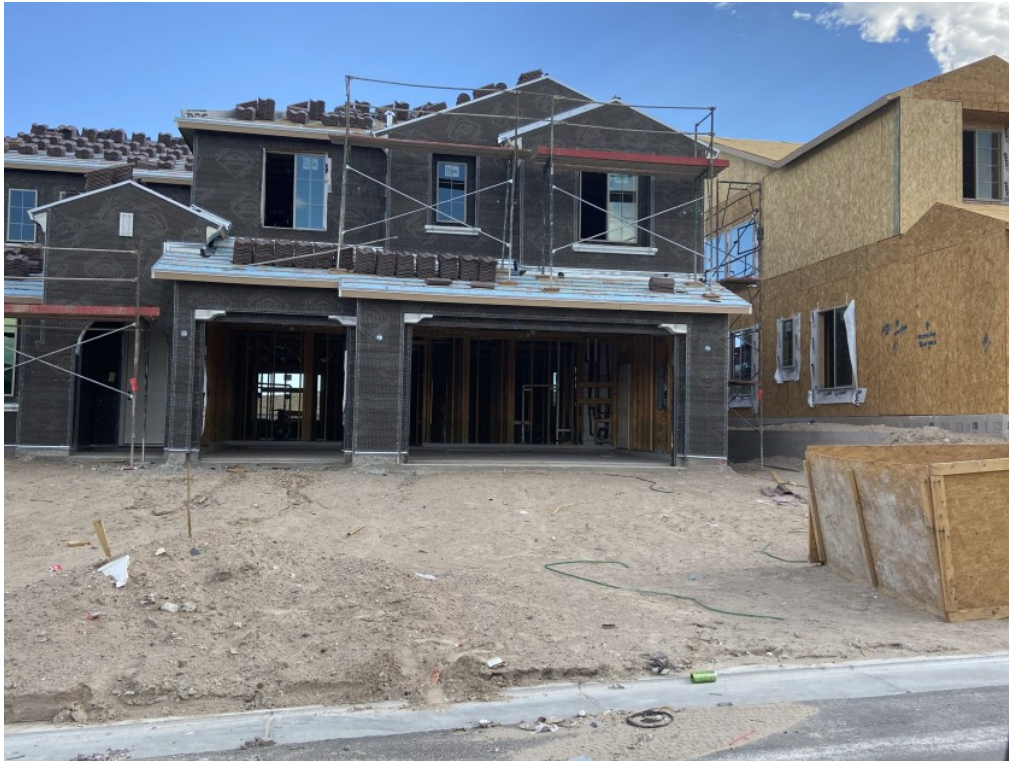
**Deficiency Name:** 12204 bear

**Sediment Control Deficiency Photos**

**Corrective Actions:** Cut curb back
