ENGINEER'S CERTIFICATION:

GRADING & DRAINAGE PLAN

A BUILDING FOR CLARK SANCHEZ

ALBUQUERQUE, NEW MEXICO

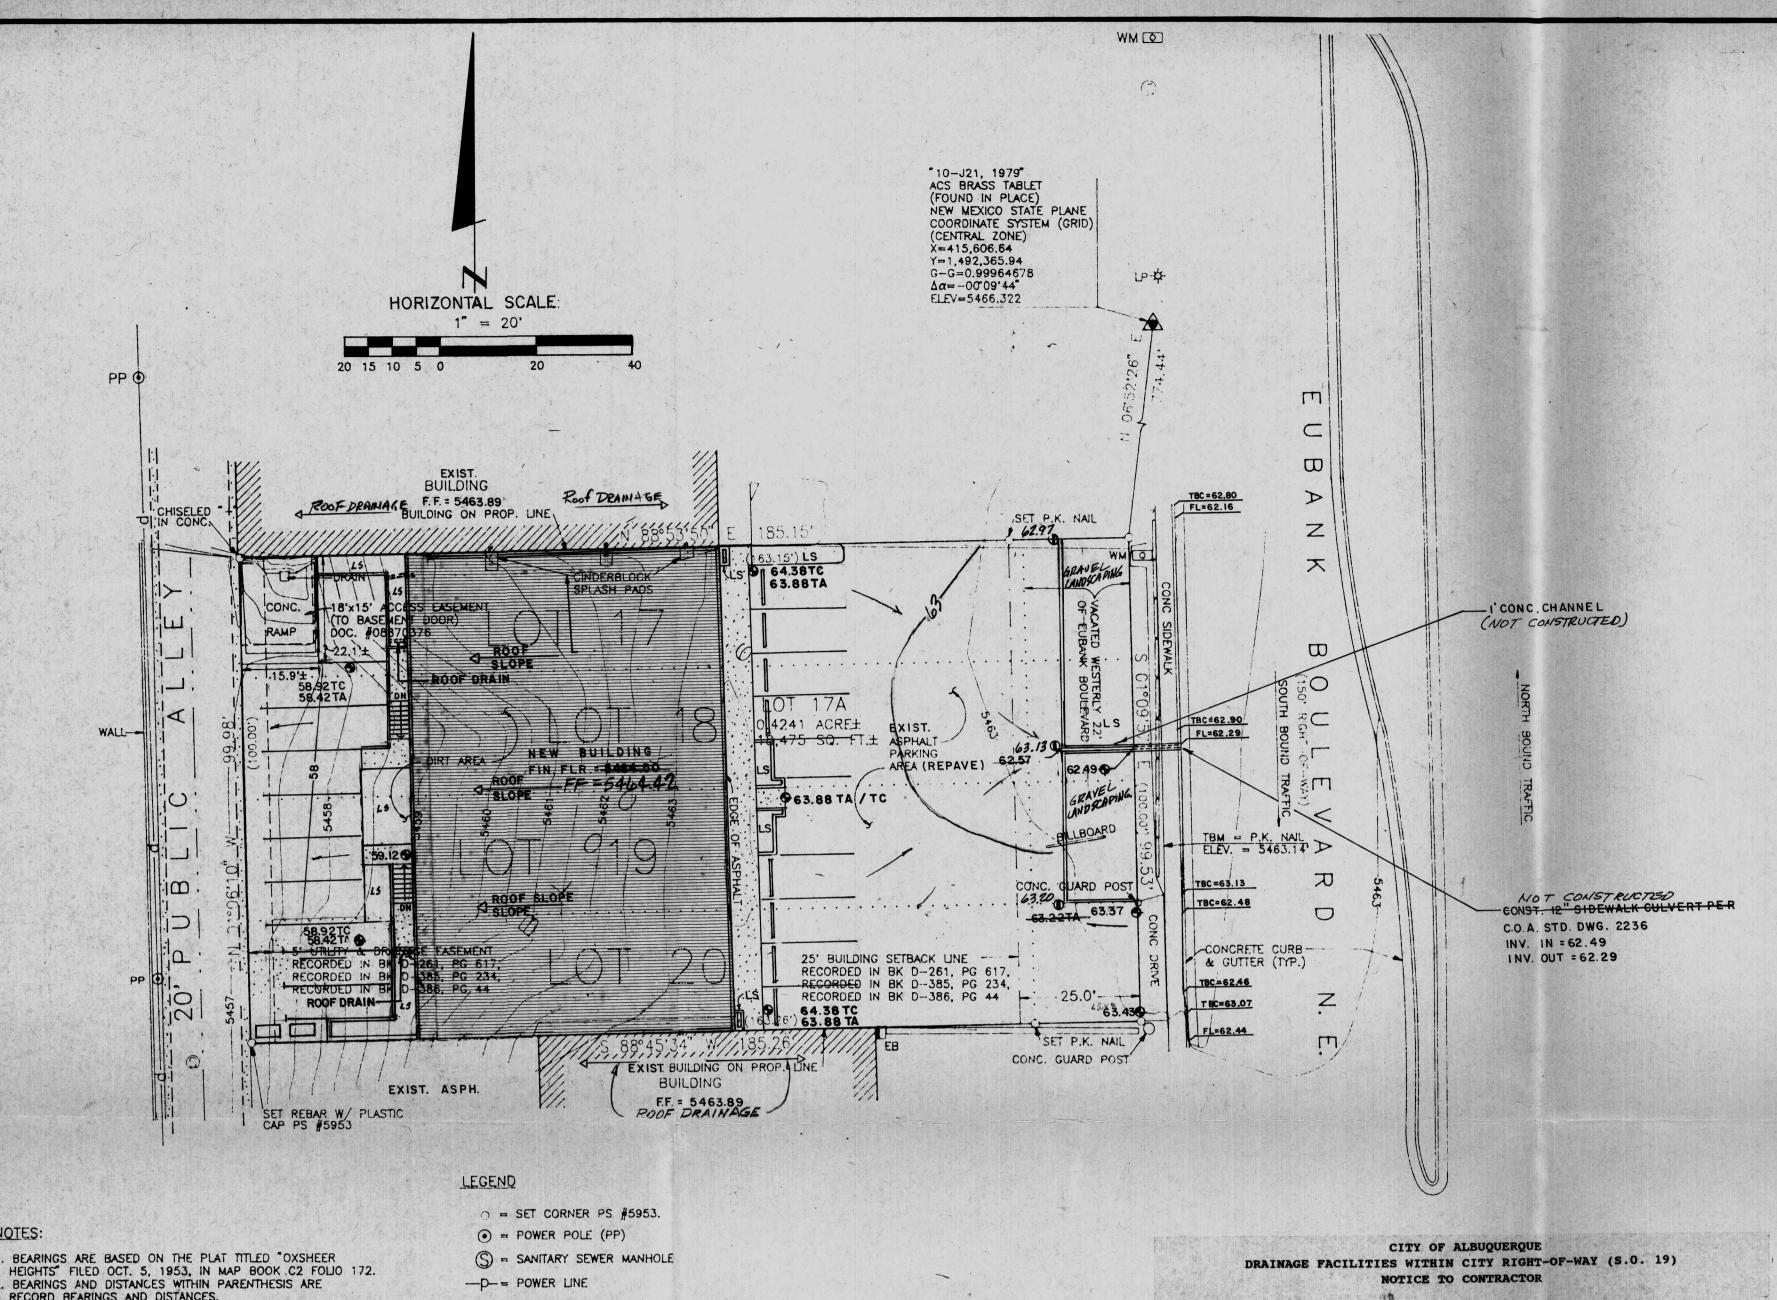
Having inspected the constructed facility and having taken spot elevations at all critical points on the site, I hereby certify that the as-constructed facility is in substantial conformance with the approved grading and drainage plan, Engineer's stamp dated 8-2-94 with the following noted exceptions:

- The sidewalk culvert was not constructed and the east border of the parking lot is not curb but portable concrete parking barriers. Essentially, runoff from the parking lot runs under the barriers and into the gravel landscaping area between the asphalt parking lot and the sidewalk.
- The roofs of the two adjacent buildings to the north and south drain to the front and rear of the buildings. The plan for accepting runoff from the roof drians and piping it through the building to the rear parking lot was not followed. The roof drainage on these buildings appears to work adequately.
