INSPECTION REPORT			
GENERAL INFORMATION			
DATE and TIME OF INSPECTION:	Friday, February 14, 2020	2:00 PM	
COMPANY NAME:	Mister Car Wash		
PROJECT NAME:	Mister Car Wash 98th and Volcano		
TRACKING NO:	NMR1002N8 HENRY BENNING		
TYPE OF INSPECTION	INITIAL		
INSPECTORS NAME	ASSAD RIZVI		
INSPECTORS TITLE:	SWPPP COMPLIANCE INSPECTOR		
INSPECTORS CONTACT:			
PHASE OF CONSTRUCTION:	ROUGH GRADING

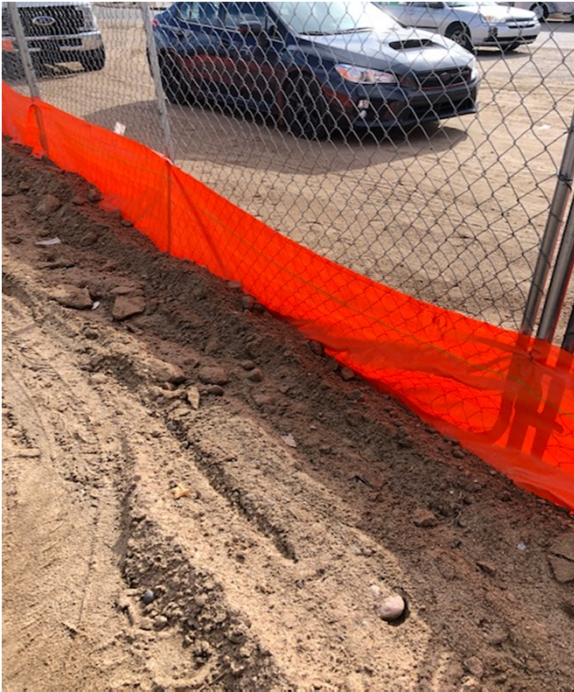
Silt Fence Established Along Perimeter
