**Re: Zocalo Lofts
Erosion and Sediment Control Plan
Engineer's Stamp Date 5-9-18 (K14E112)**

Project: **Insight Construction for Zocalo Lofts.**

City of Albuquerque Stormwater Construction Site Inspection Report

Re: Drainage Ordinance (14-5-2-1) Violations for Construction Site Waste(s)

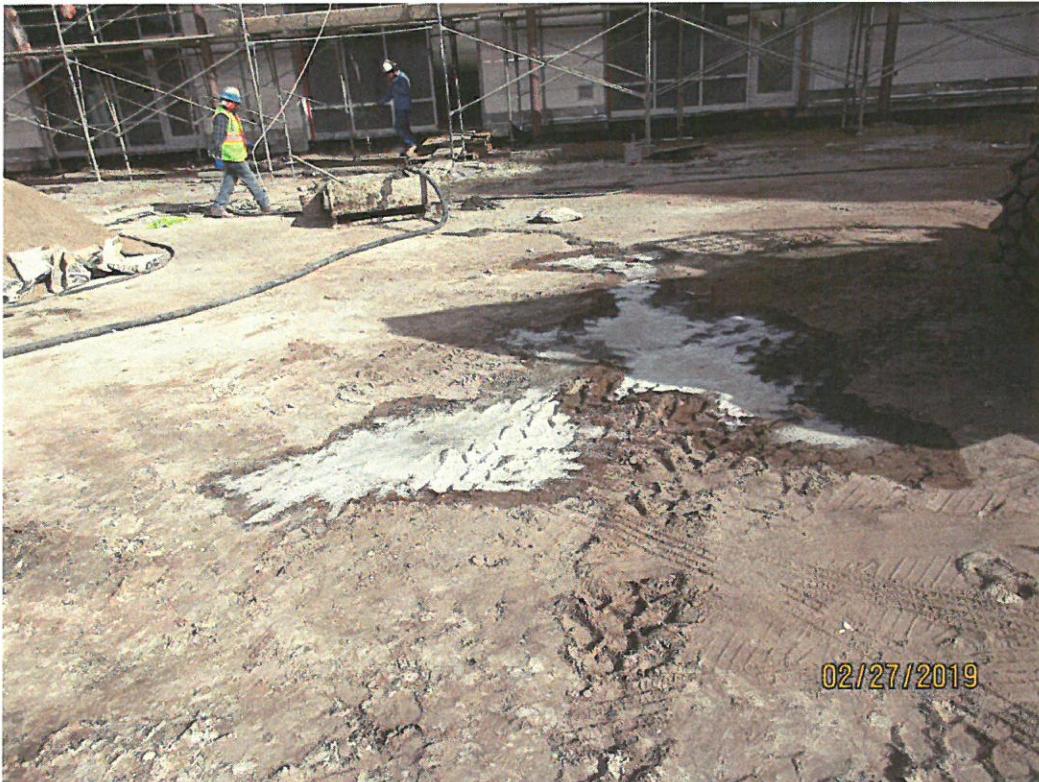
1. Numerous large stucco wash-outs on the ground.
2. Stucco wash-out tracked-out onto 5th Street.
3. Stucco wash-out in unlined pit.
4. Construction and domestic waste (trash) not in an acceptable container and in the gutter on Coal Ave.

Stucco wash-out on the ground.

1. Remove the numerous large stucco wash-outs from the ground.
2. Remove the stucco wash-out that was tracked-out onto 5th Street.
3. Remove the stucco wash-out that was placed in the unlined pit.
4. Place all construction and domestic waste (trash) into an acceptable waste container.
5. Provide an acceptable wash-out facility for stucco and ground cover, if necessary, to prevent loose stucco material from contacting the ground.
6. Have workers use an acceptable waste container.

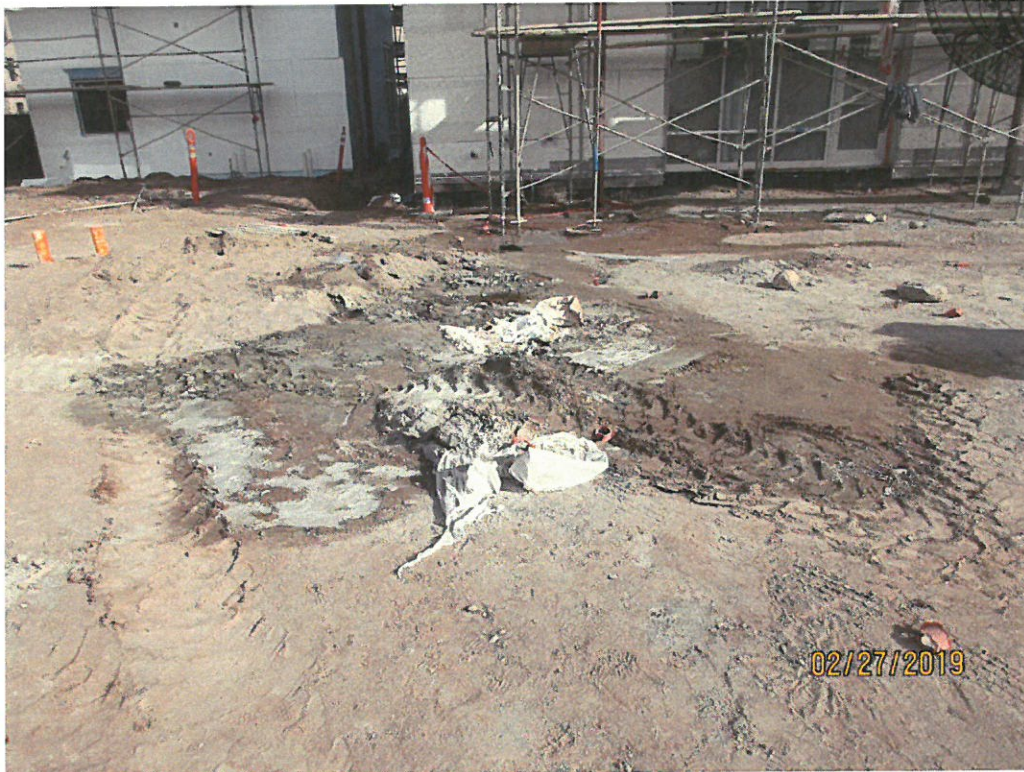
Stucco wash-out on the ground.

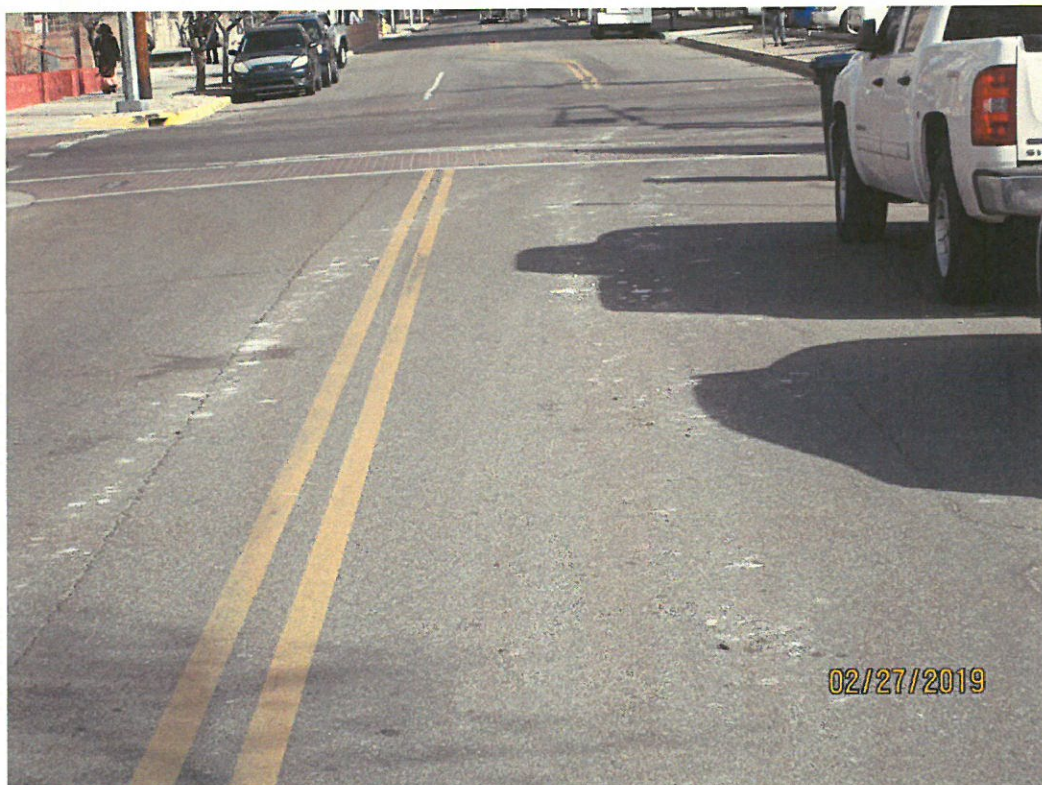
Stucco wash-out tracked offsite onto 5th street up to Coal Ave.

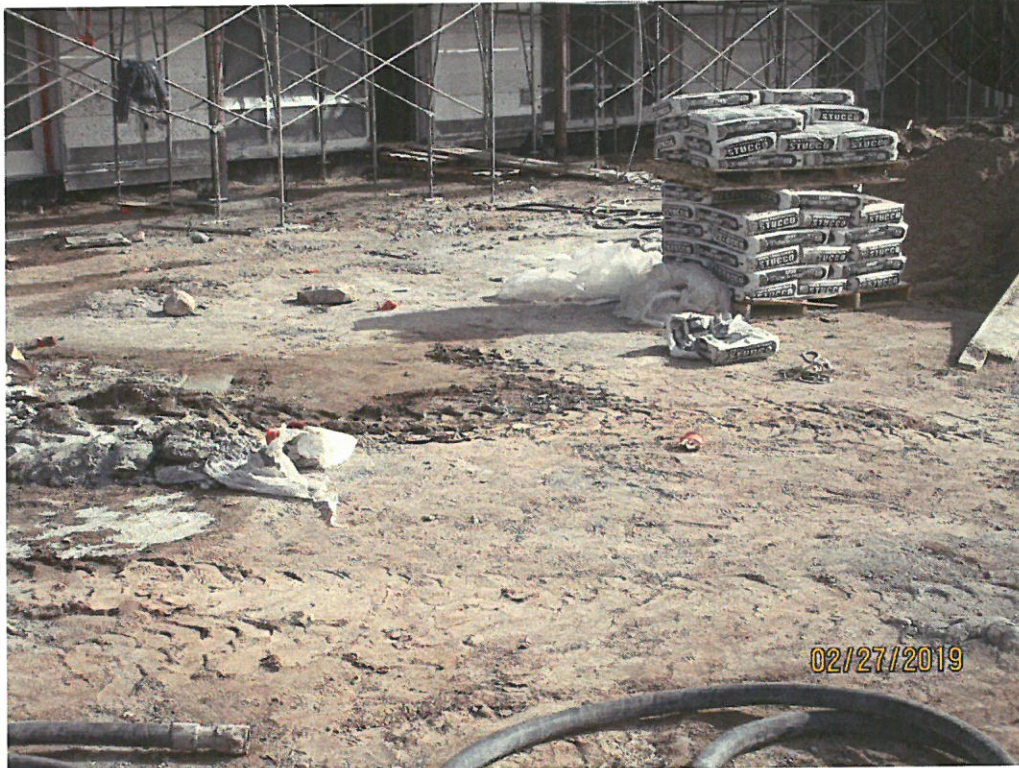
Area of site covered with stucco material.

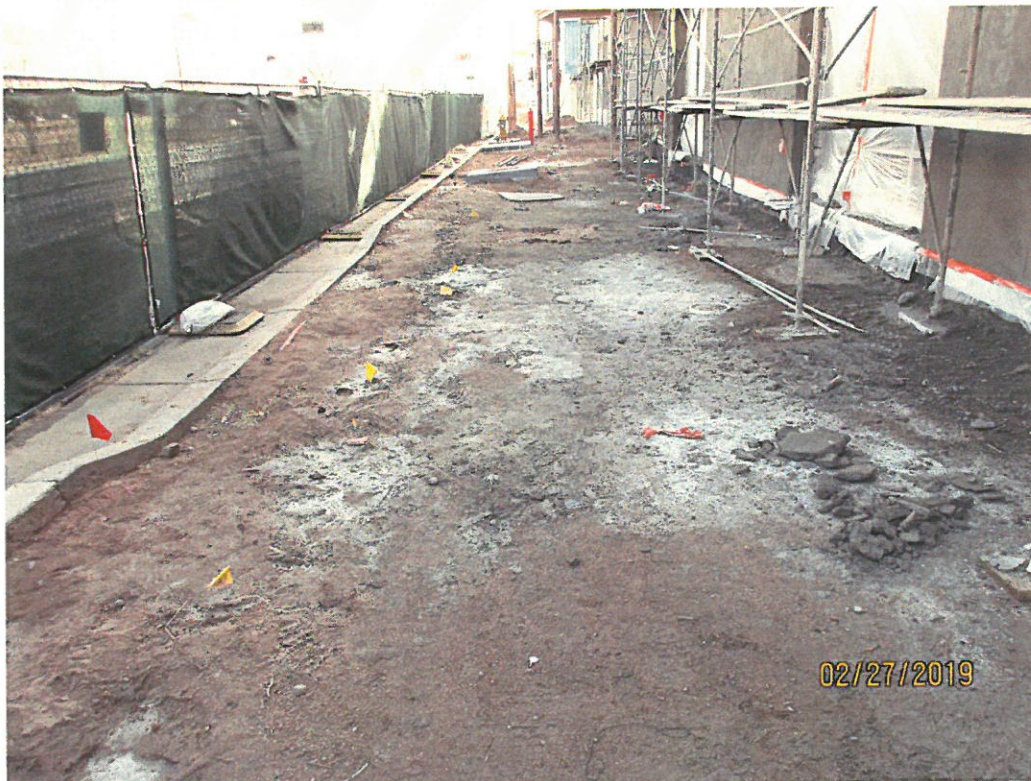
Stucco wash-out on north side of building.

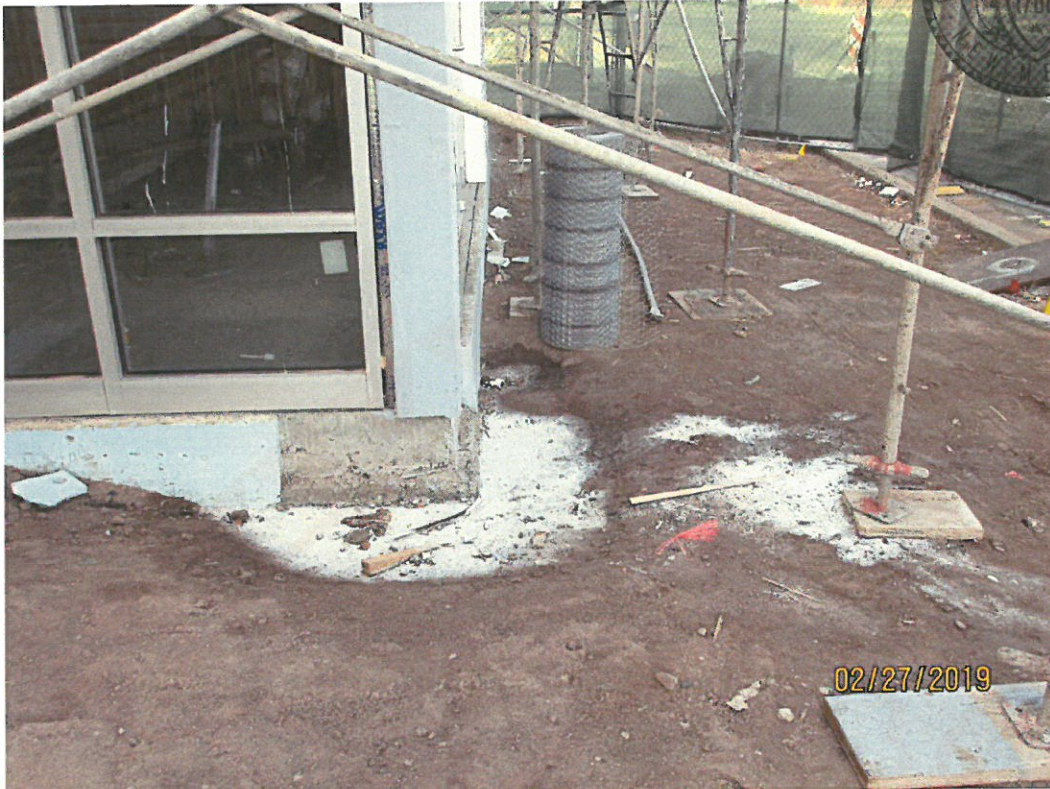
Another area of wash-out.

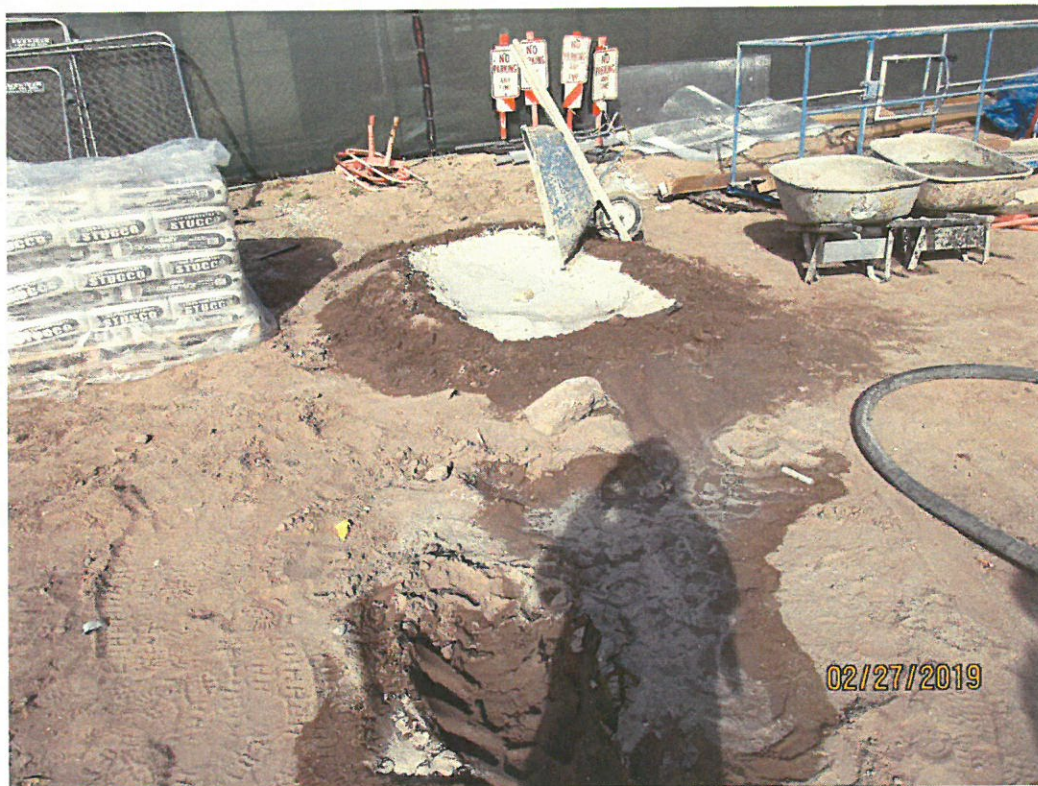
Stucco wash-out in unlined pit.

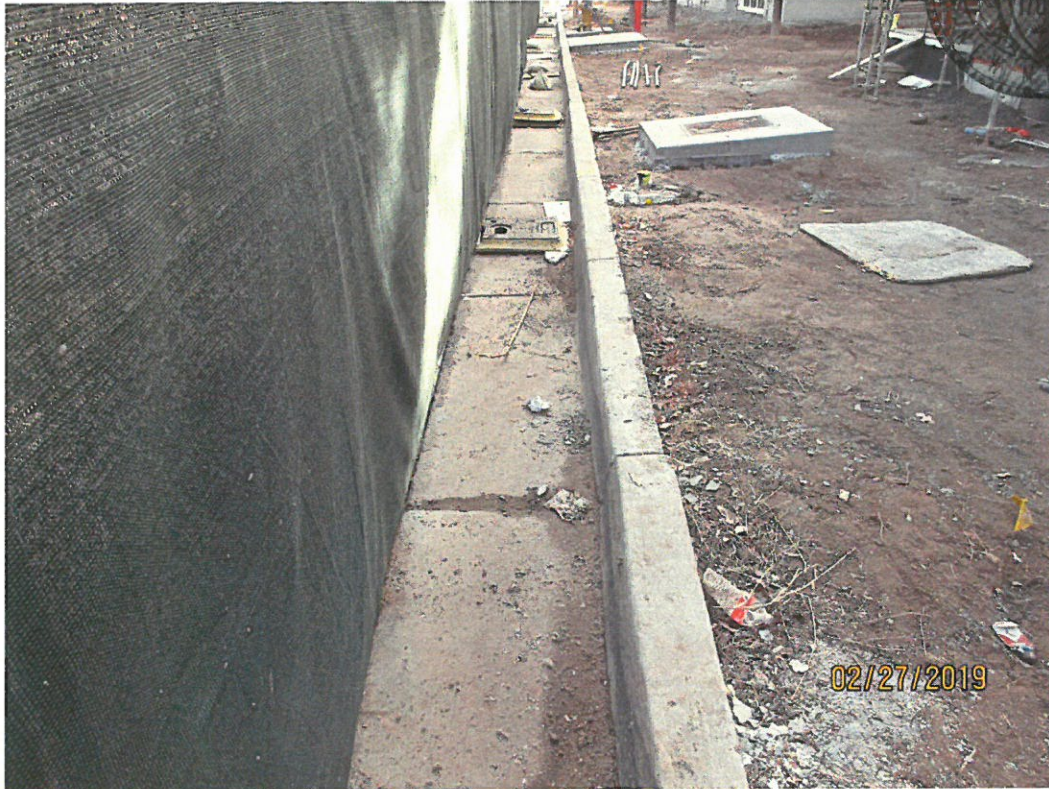
Debris and sediment in gutter of Coal Ave and onsite.

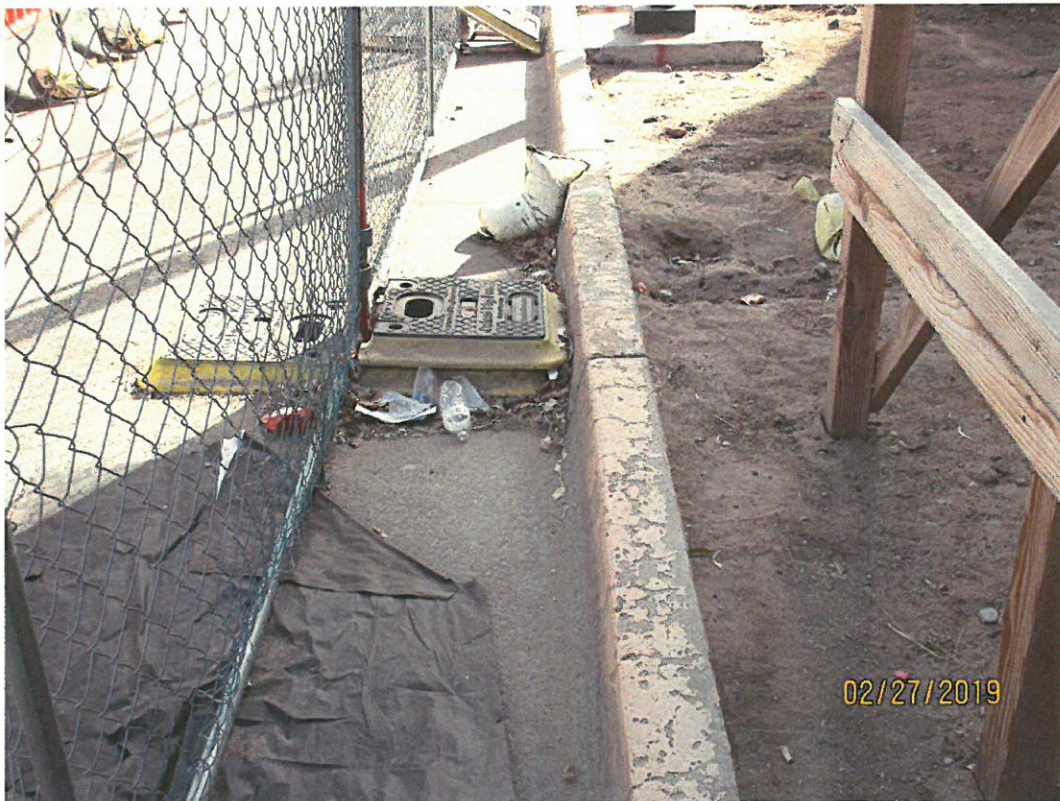
Another location of debris and sediment in gutter of Coal Ave.

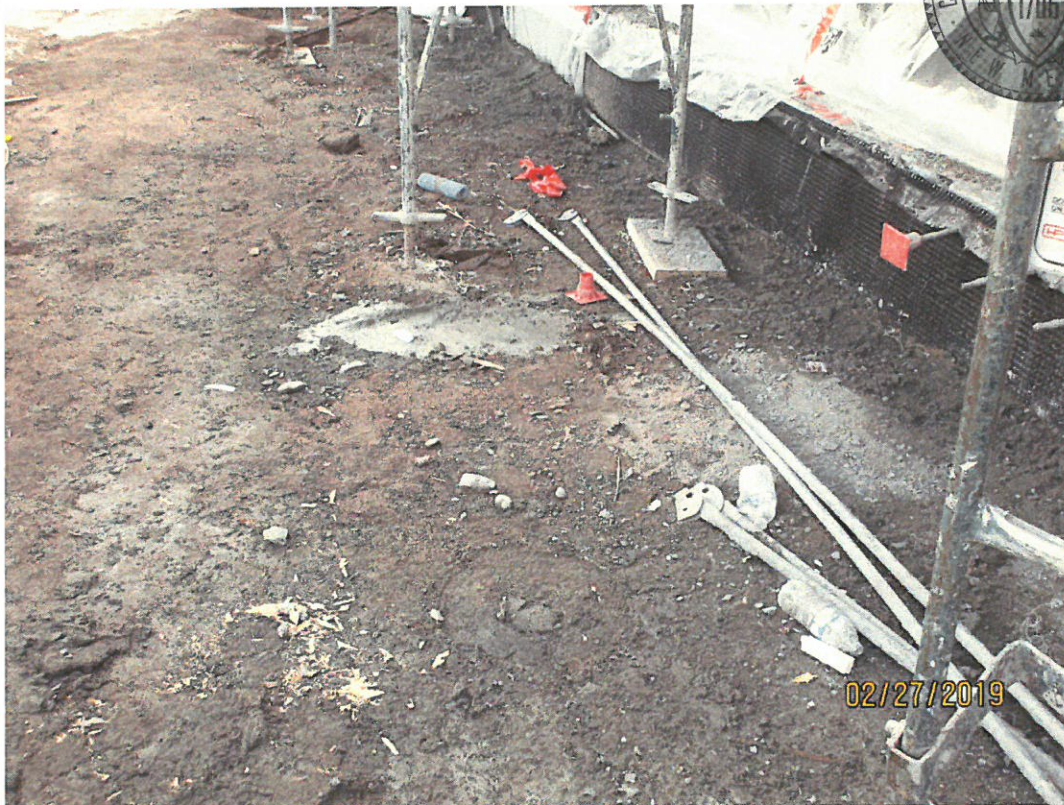
Construction waste, domestic waste and wash-out.

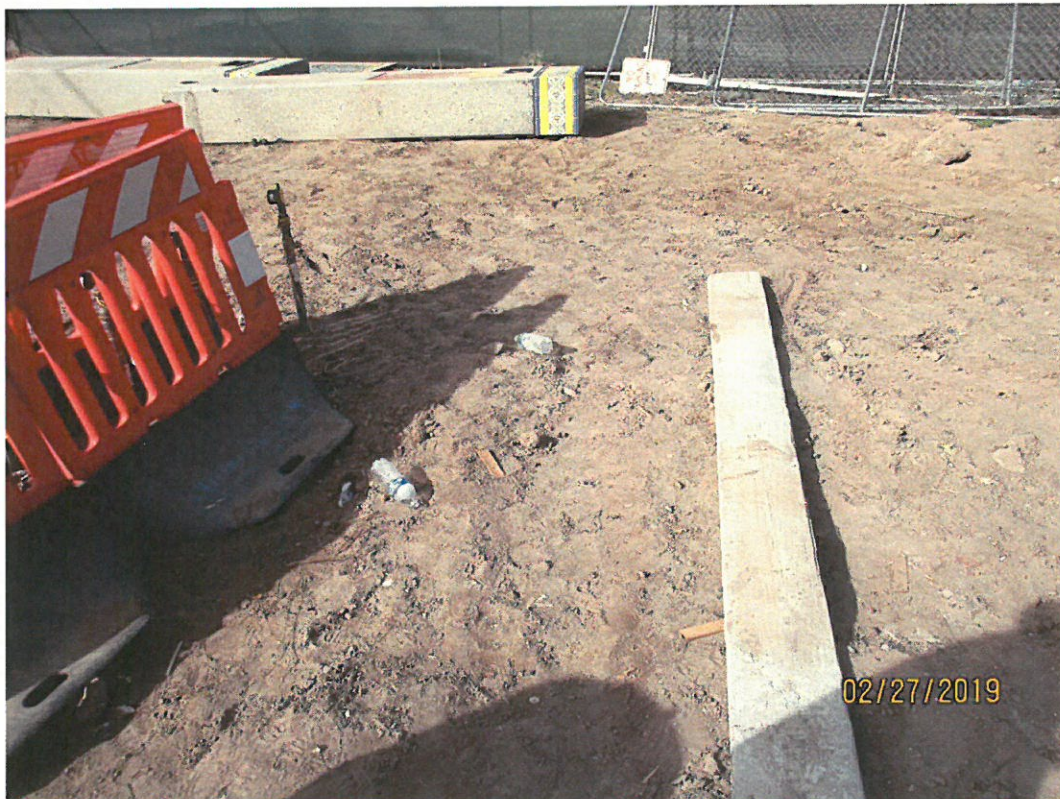
Trash not in an acceptable waste container.
