## Storm Water Compliance Inspection Form

**Inspection Type:** Routine

**Date:** 06-15-2021

**Permit Tracking #:** NMR1002UW

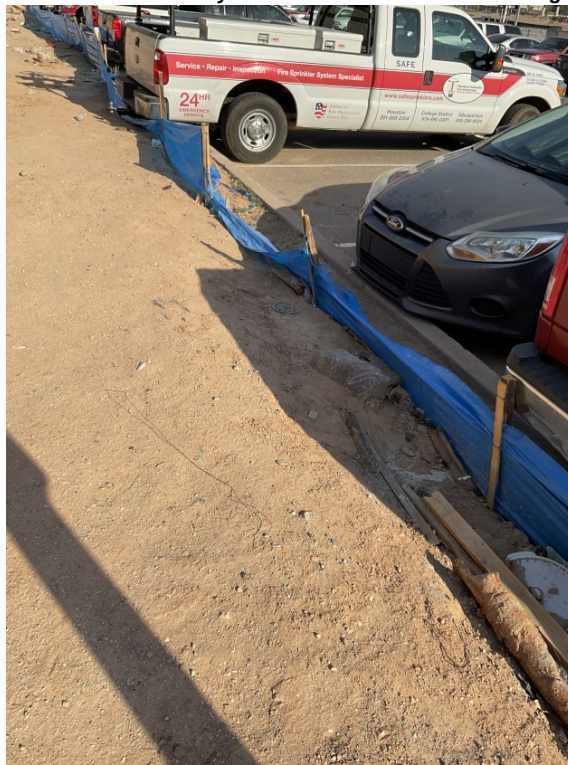
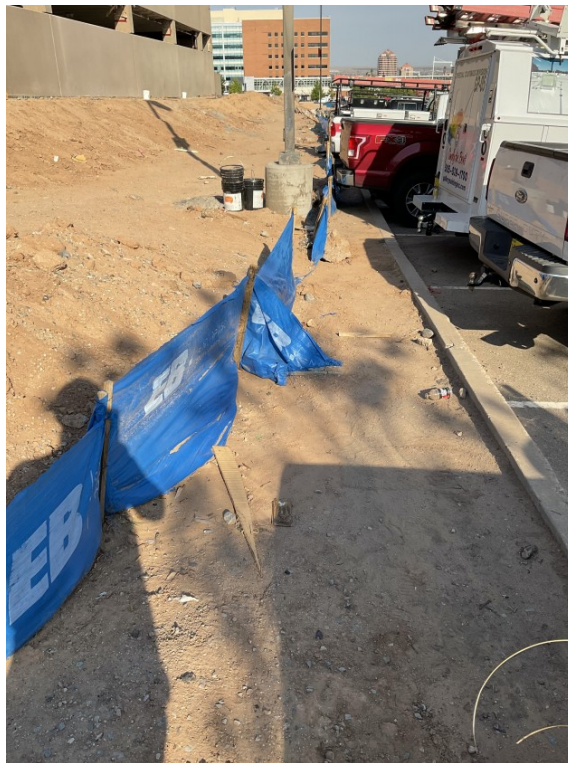
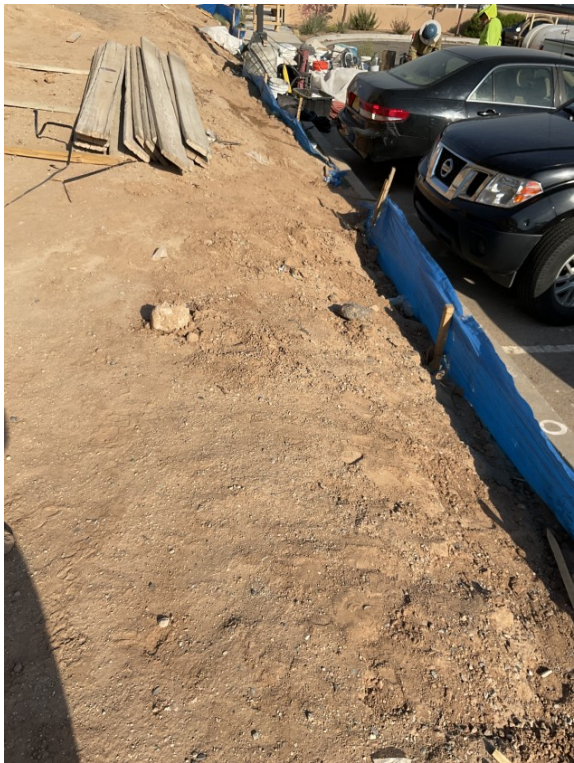
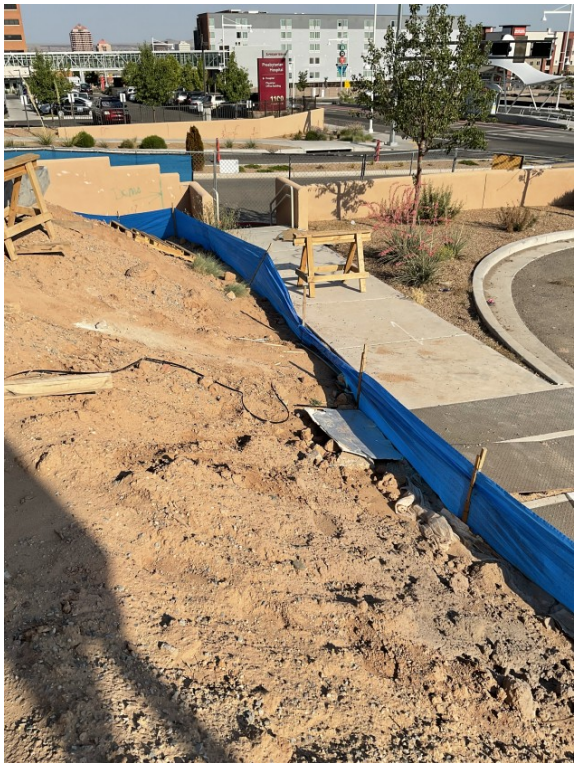
Site Walk Deficiency Photos - North side of building

| Location | Action Type | Action Required | Date Noted | Date Completed | Initials |
|---|---|---|---|---|---|
| North side of building | Corrective Action | Repair or replace silt fence | 06-15-2021 | | |
| North side of building | Corrective Action | Concrete washout on the ground in multiple locations needs to be cleaned up | 05-25-2021 | | |

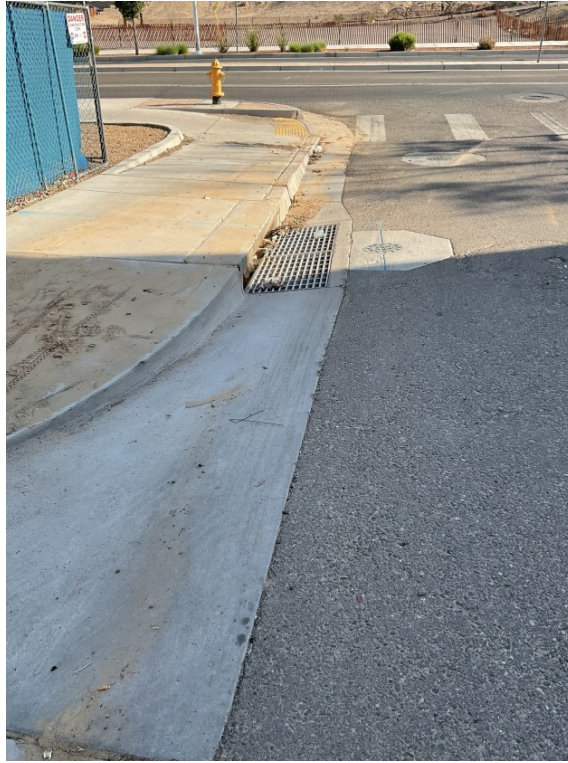
Site Walk Deficiency Photos - North east corner

| Location | Action Type | Action Required | Date Noted | Date Completed | Initials |
|---|---|---|---|---|---|
| North east corner | | Due to moving dirt inlet needs to be protected outside of entrance | 06-15-2021 | | |

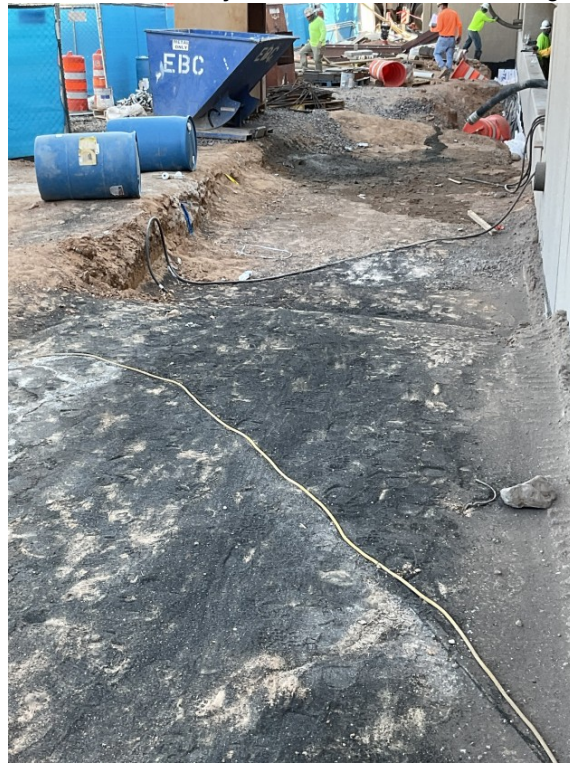
Site Walk Deficiency Photos - West side of building

| Location | Action Type | Action Required | Date Noted | Date Completed | Initials |
|---|---|---|---|---|---|
| West side of building | | Clean up concrete spoil | 06-15-2021 | | |
