PROJECT TITLE: LA MESA CHURCH ZONE ATLAS/DRNG. FILE #: K19/D99

RE: REVISED ENGINEER CERTIFICATION FOR LA MESA CHURCH (K19-D99)
RECERTIFICATION STATEMENT DATED 3/14/95
SHEETS 1 & 2 OF 2 OF 2.

GRADING & DRAINAGE PLAN
LA MESA PRESBYTERIAN CHURCH

RECERTIFICATION

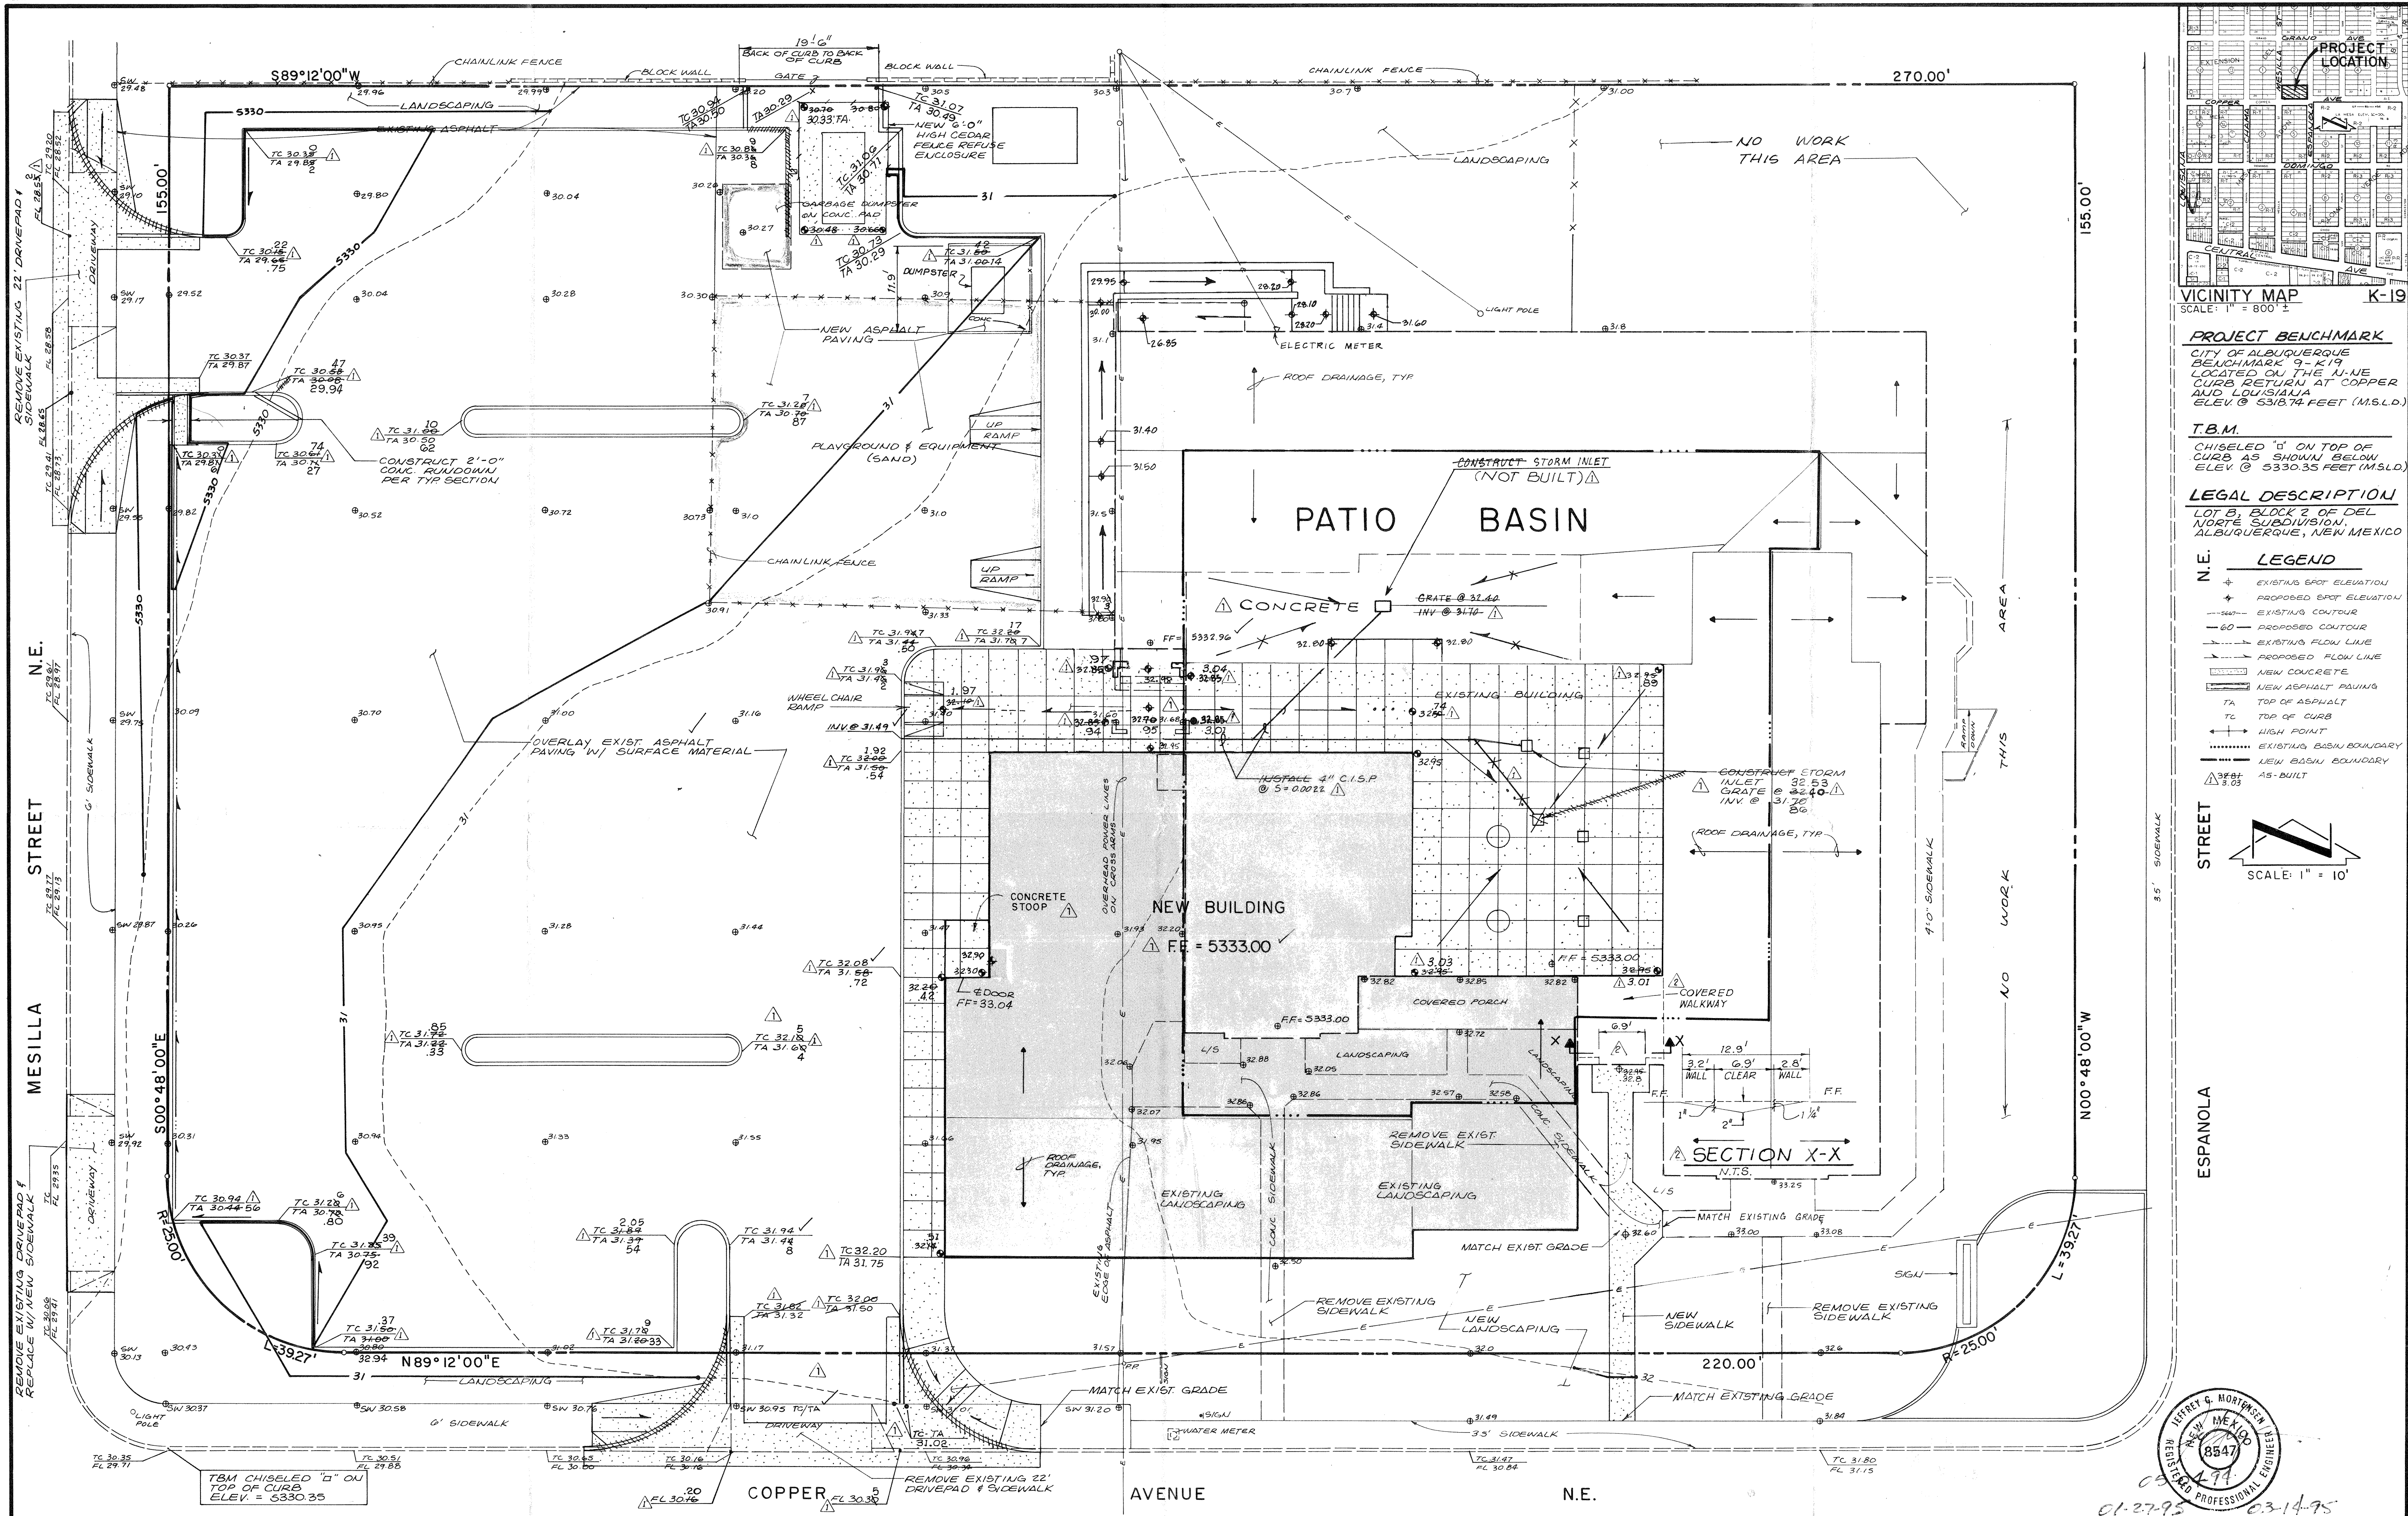
As indicated by the as-built information shown on Sheet 1 of 2, the majority of the project has been constructed in substantial conformance with the approved Grading and Drainage Plan. Modifications have been made to the Patio Basin. These modifications consist of the following: 1) deletion of the landscaped area at the north end of the patio, 2) deletion of the storm inlet that was proposed within the deleted landscape area (the storm inlet was specified in this area in the event that excess irrigation water would accumulate adjacent to the building. Now that this area is concrete, the inlet is not needed), 3) the location of the storm inlet within the concrete portion of the patio was relocated to the north to be more centrally located, 4) the patio basin overflow was not constructed per the cross section illustrated by the approved plan grades. Because of this, all water accumulating in the patio basin will have to exit via the 4" pipe. This may result in some storm water entering the doorways which open into this patio area.

As indicated by the as-built information for the south entrance to the Patio Basin, and the additional calculations shown hereon, the Patio Basin has been constructed in a manner consistent with the intent of the approved Grading and Drainage Plan. The actual construction has deviated from the approved Plan, however, the provision of an additional overflow from the Patio Basin to the south allows for adequate capacity for overflow. It is based upon this additional information and associated analysis that issuance of a permanent Certificate of Occupancy is hereby recommended. A Hold Harmless Agreement is no longer recommended or believed to be necessary.

Based upon the information presented above, acceptance of this project for Temporary Certificate of Occupancy is hereby recommended. In order to address item #4, we recommend that the overflow be reconstructed, or the Owner acknowledge this condition in the form of a "Hold Harmless Agreement" naming both the engineer and the City of Albuquerque. Upon receipt of the "Hold Harmless Agreement", or recertification, the Permanent Certificate of Occupancy should be issued.
