City of Albuquerque Stormwater Construction Site Inspection Report

Project Name and Location	Autumn View - Jacob Lee Tower and Courts		
Site Contact Name & Agency	Randy Drury Jacob Lee Homes	ESC File No. NPDES ID No.	L10E028
Date of Inspection	12-10-18	Start/End Time	11:50/11:55
COA Inspector Name	Curtis Cherne, Stormwater Quality		
Describe Present Phase of Construction	Stabilized		
Type of Inspection:	<input checked="" type="radio"/> Regular • During storm event • Post-storm event (> 0.25 inch) • 311 / Complaint Response • Follow-Up

Project Name and Location	Autumn View - Fuller Homes Tower and Coars		
Site Contact Name & Agency	Gerald Gabel Fuller Homes	Contact Phone #/ E-mail	gggabel @f.com
Date of Inspection	9-27-16	Start/End Time	11:30 / 11:50
Inspector Name, COA Dept.	Curtis Cherne, Stormwater Quality		
Inspector Phone / E-mail	505-924-3420/ccherne@cabq.gov		
Inspector Qualifications	Qualified Compliance Inspector of Stormwater- Stormwater One		
Describe Present Phase of Construction	Constructing Homes, mostly built out		
Type of Inspection:	<input checked="" type="radio"/> Regular • During storm event • Post-storm event (> 0.5 inch) • 311 / Complaint Response • Follow-Up

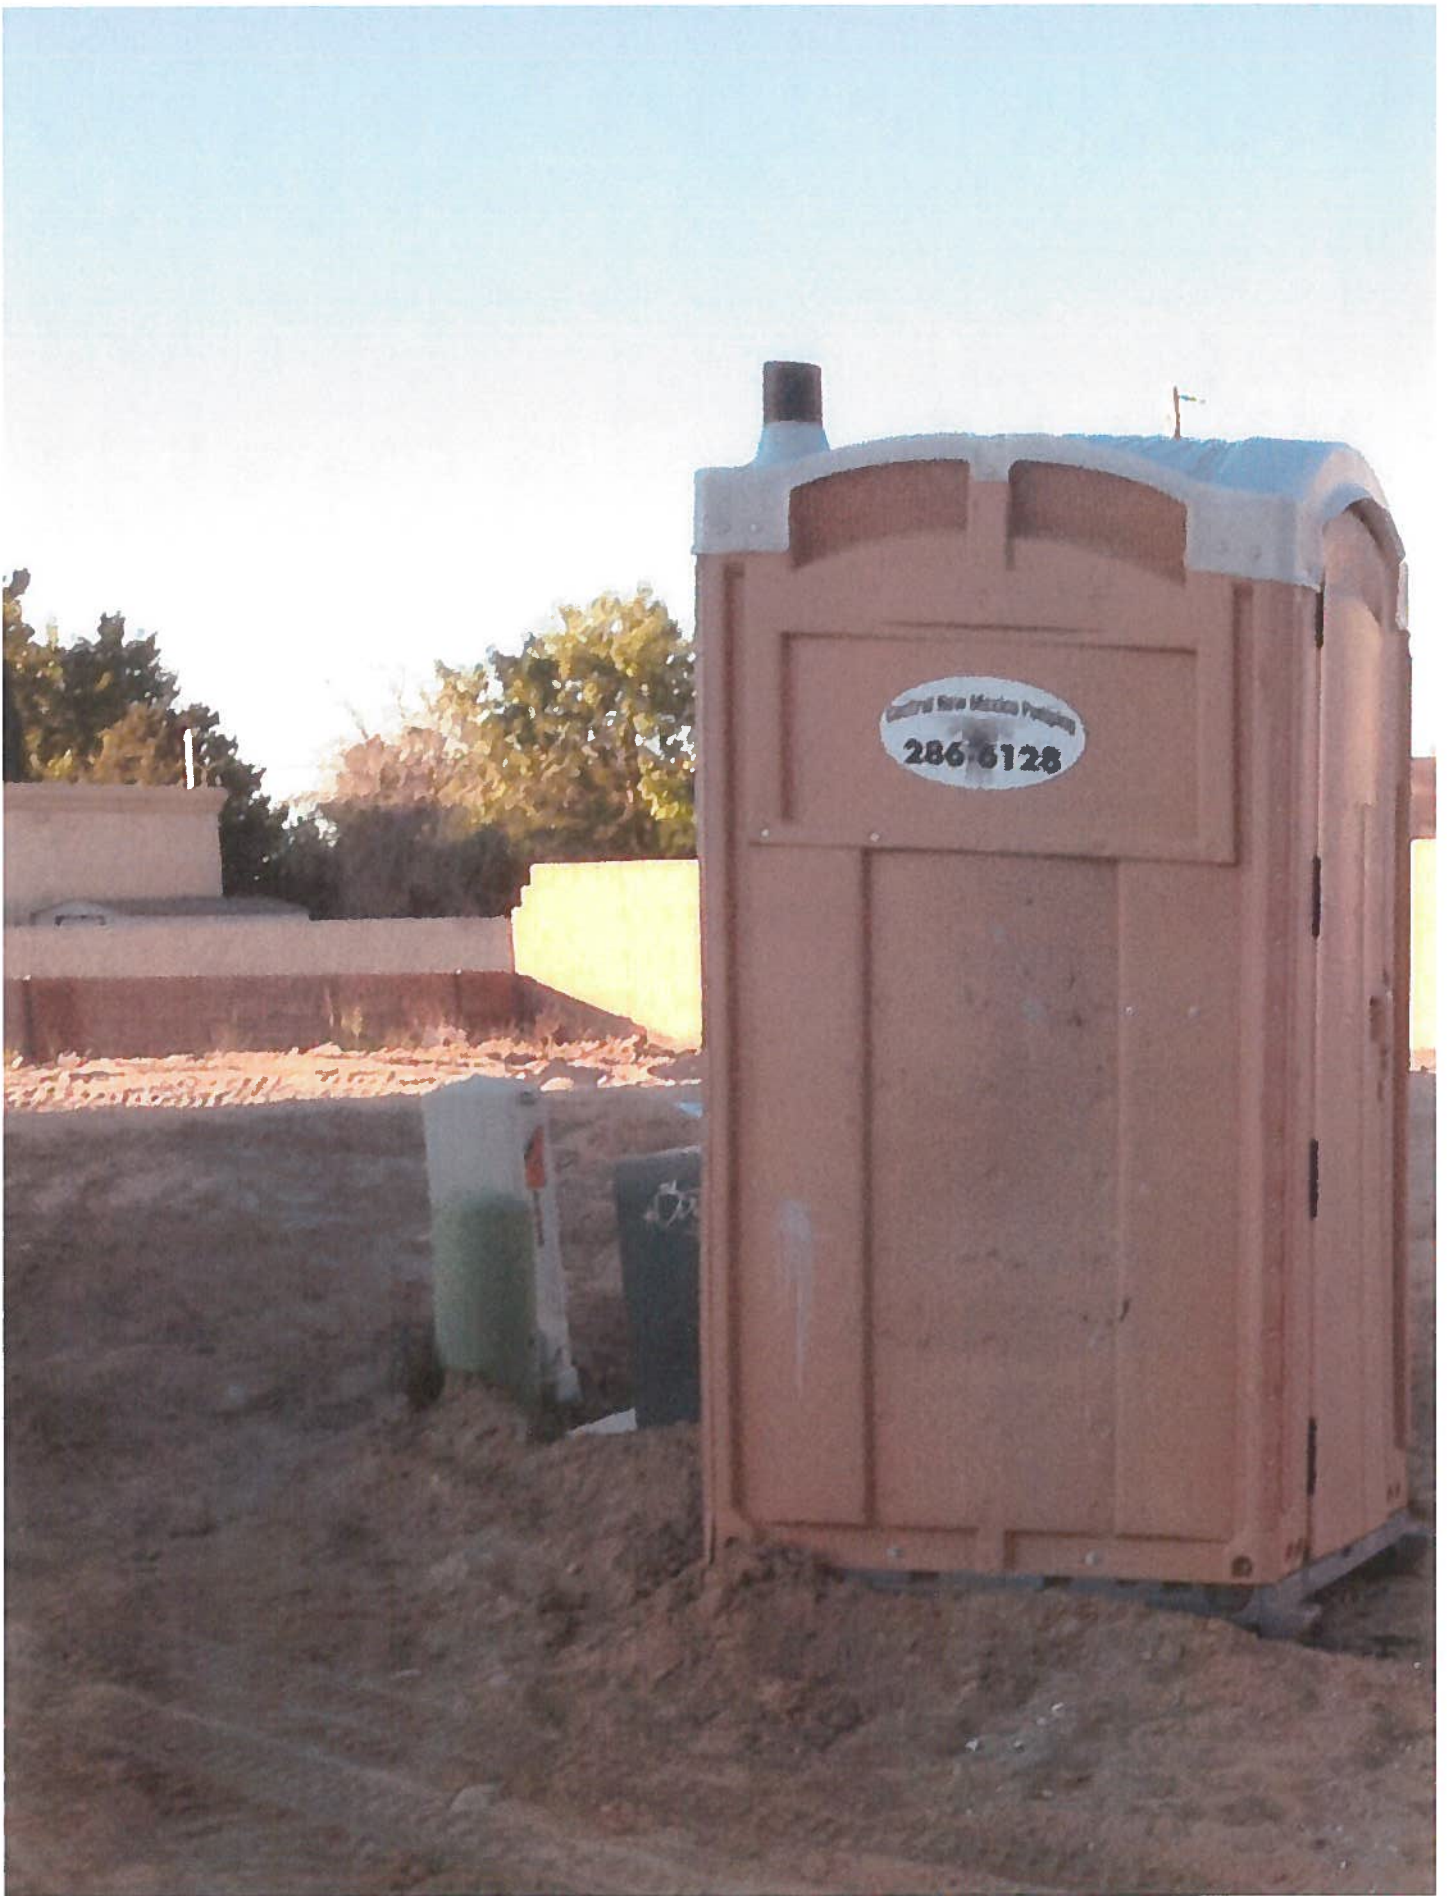
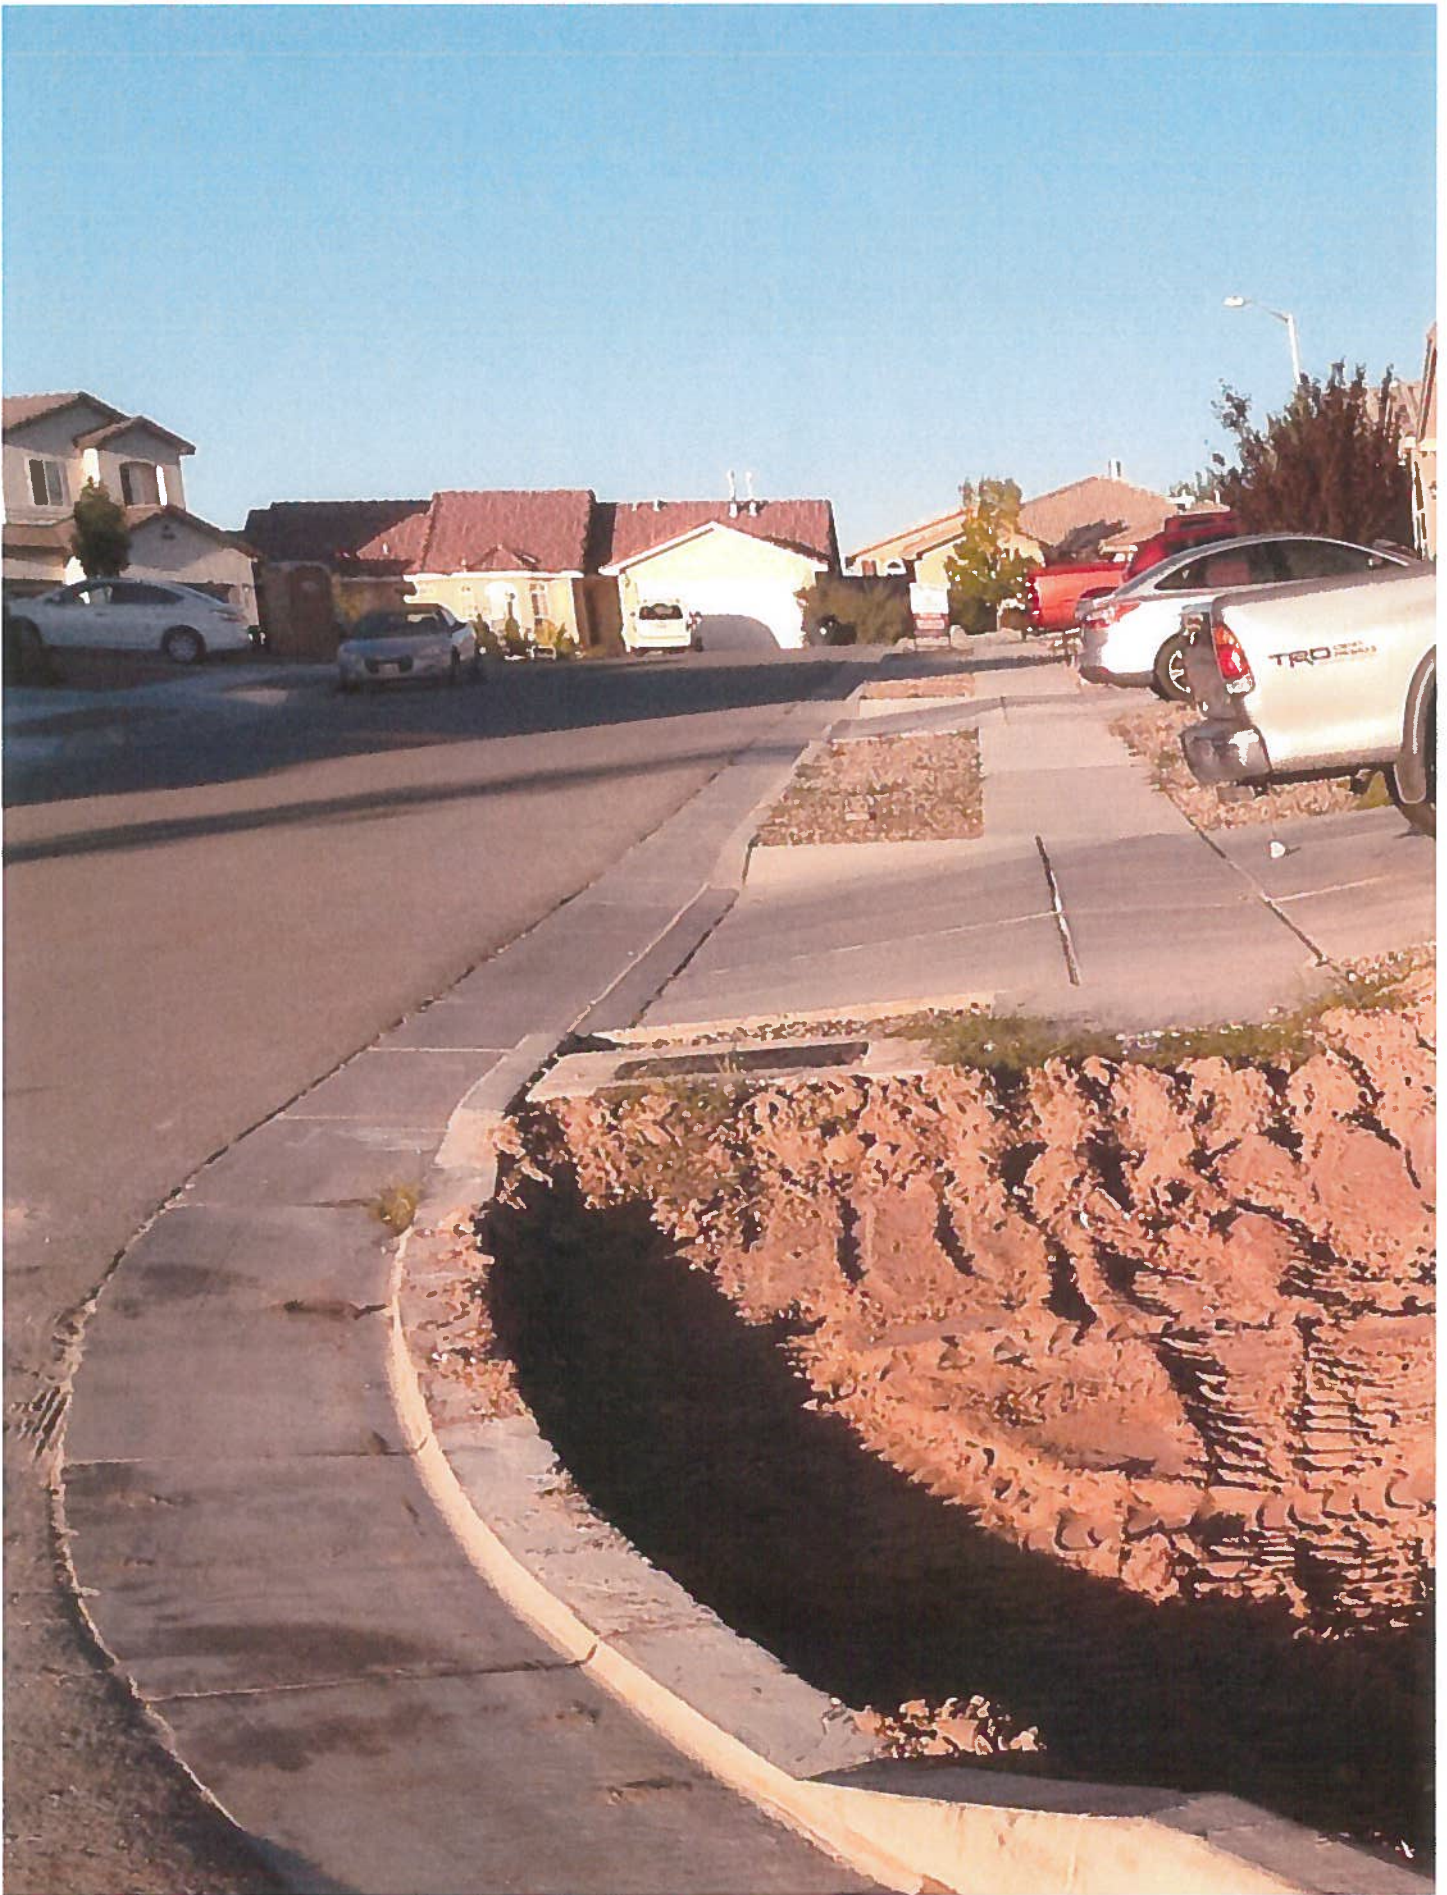
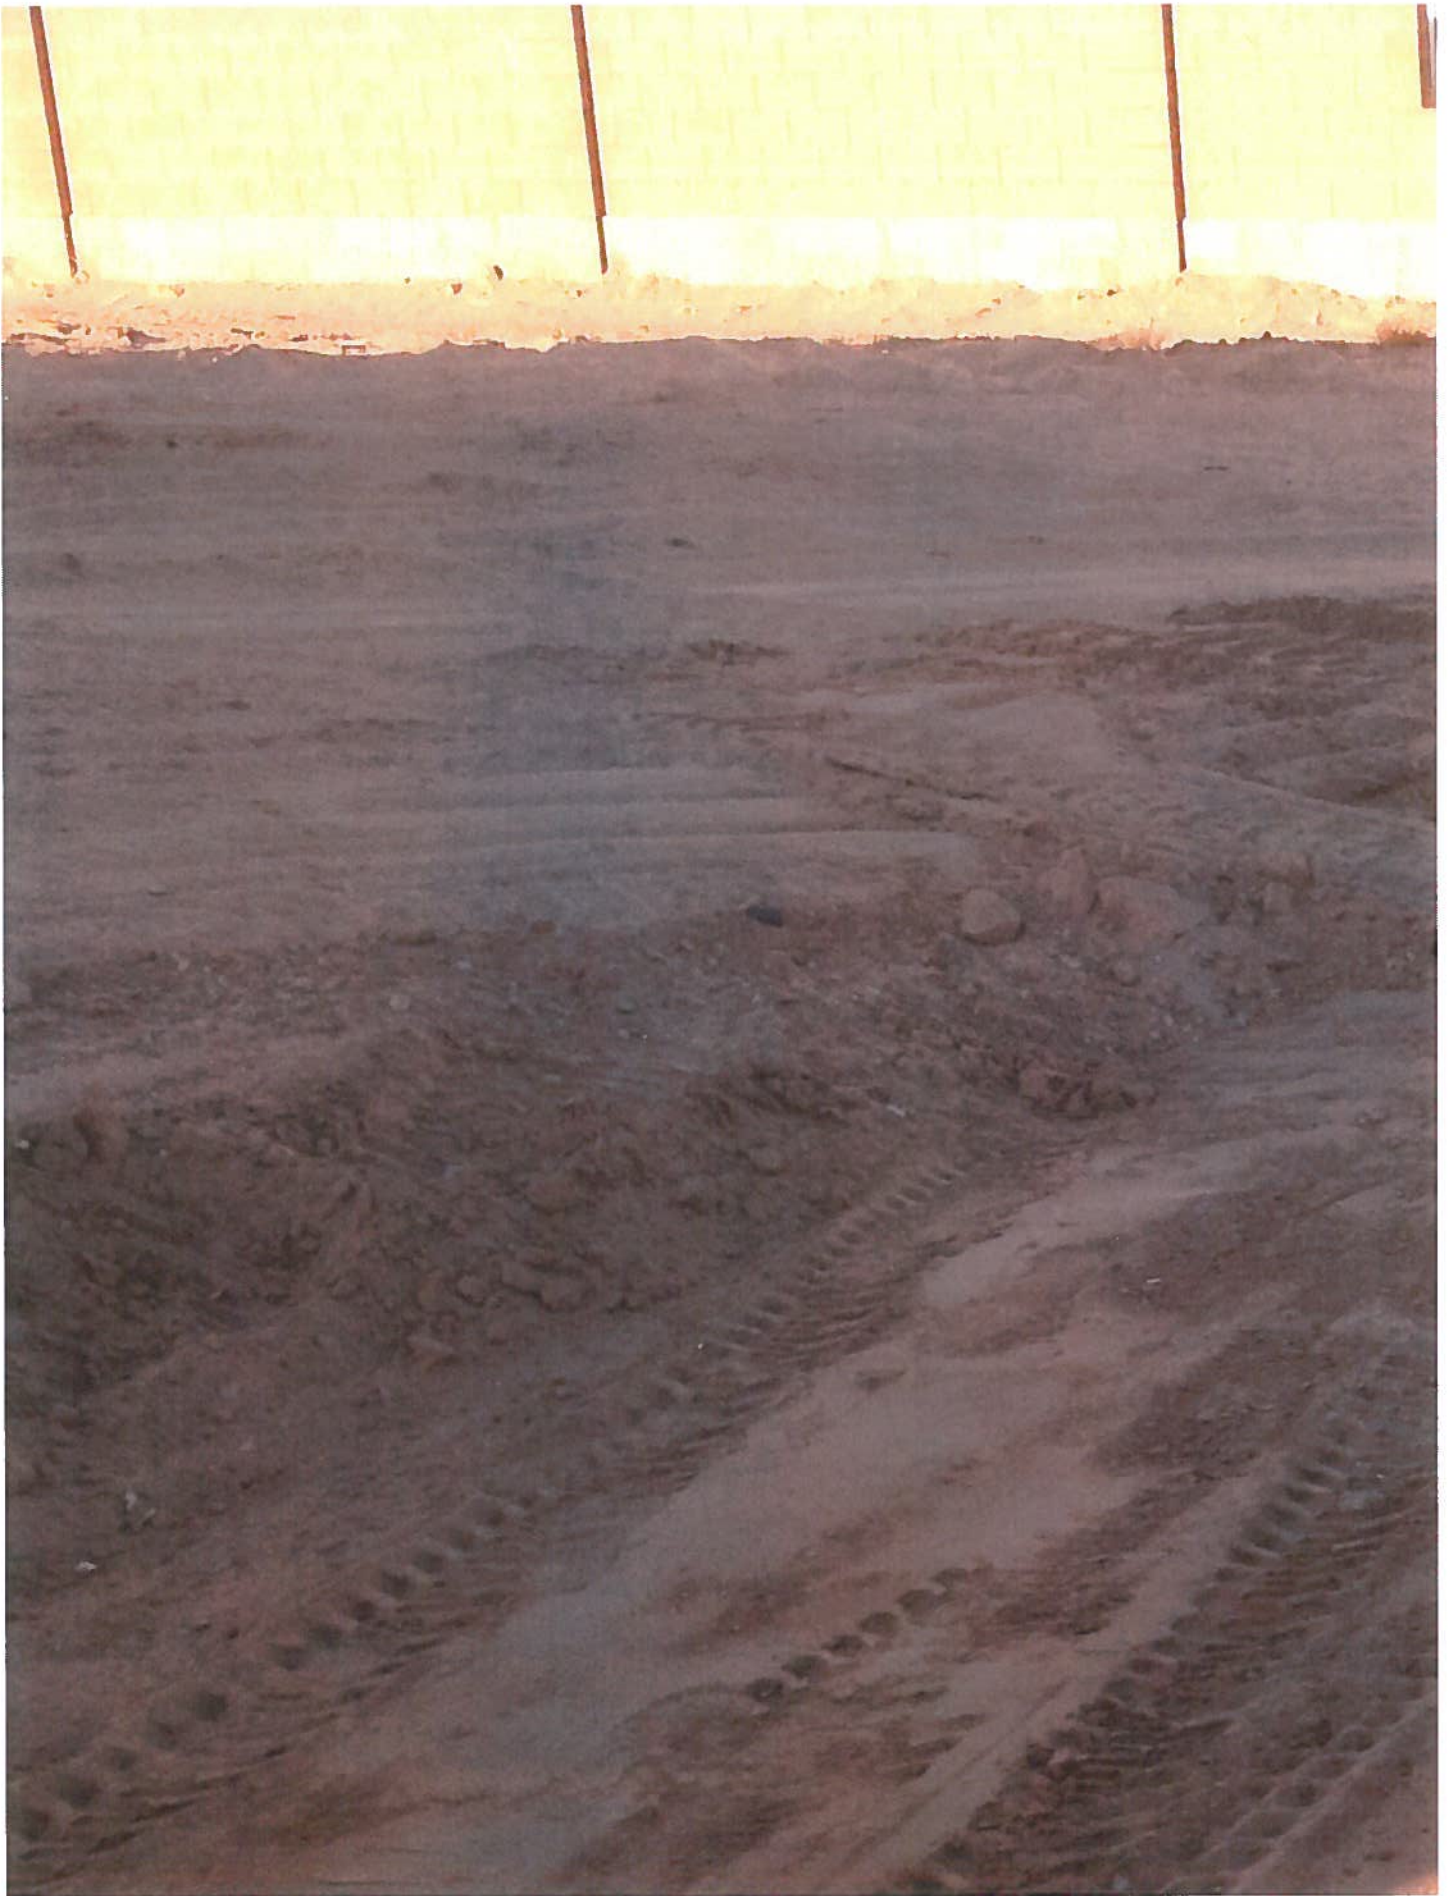
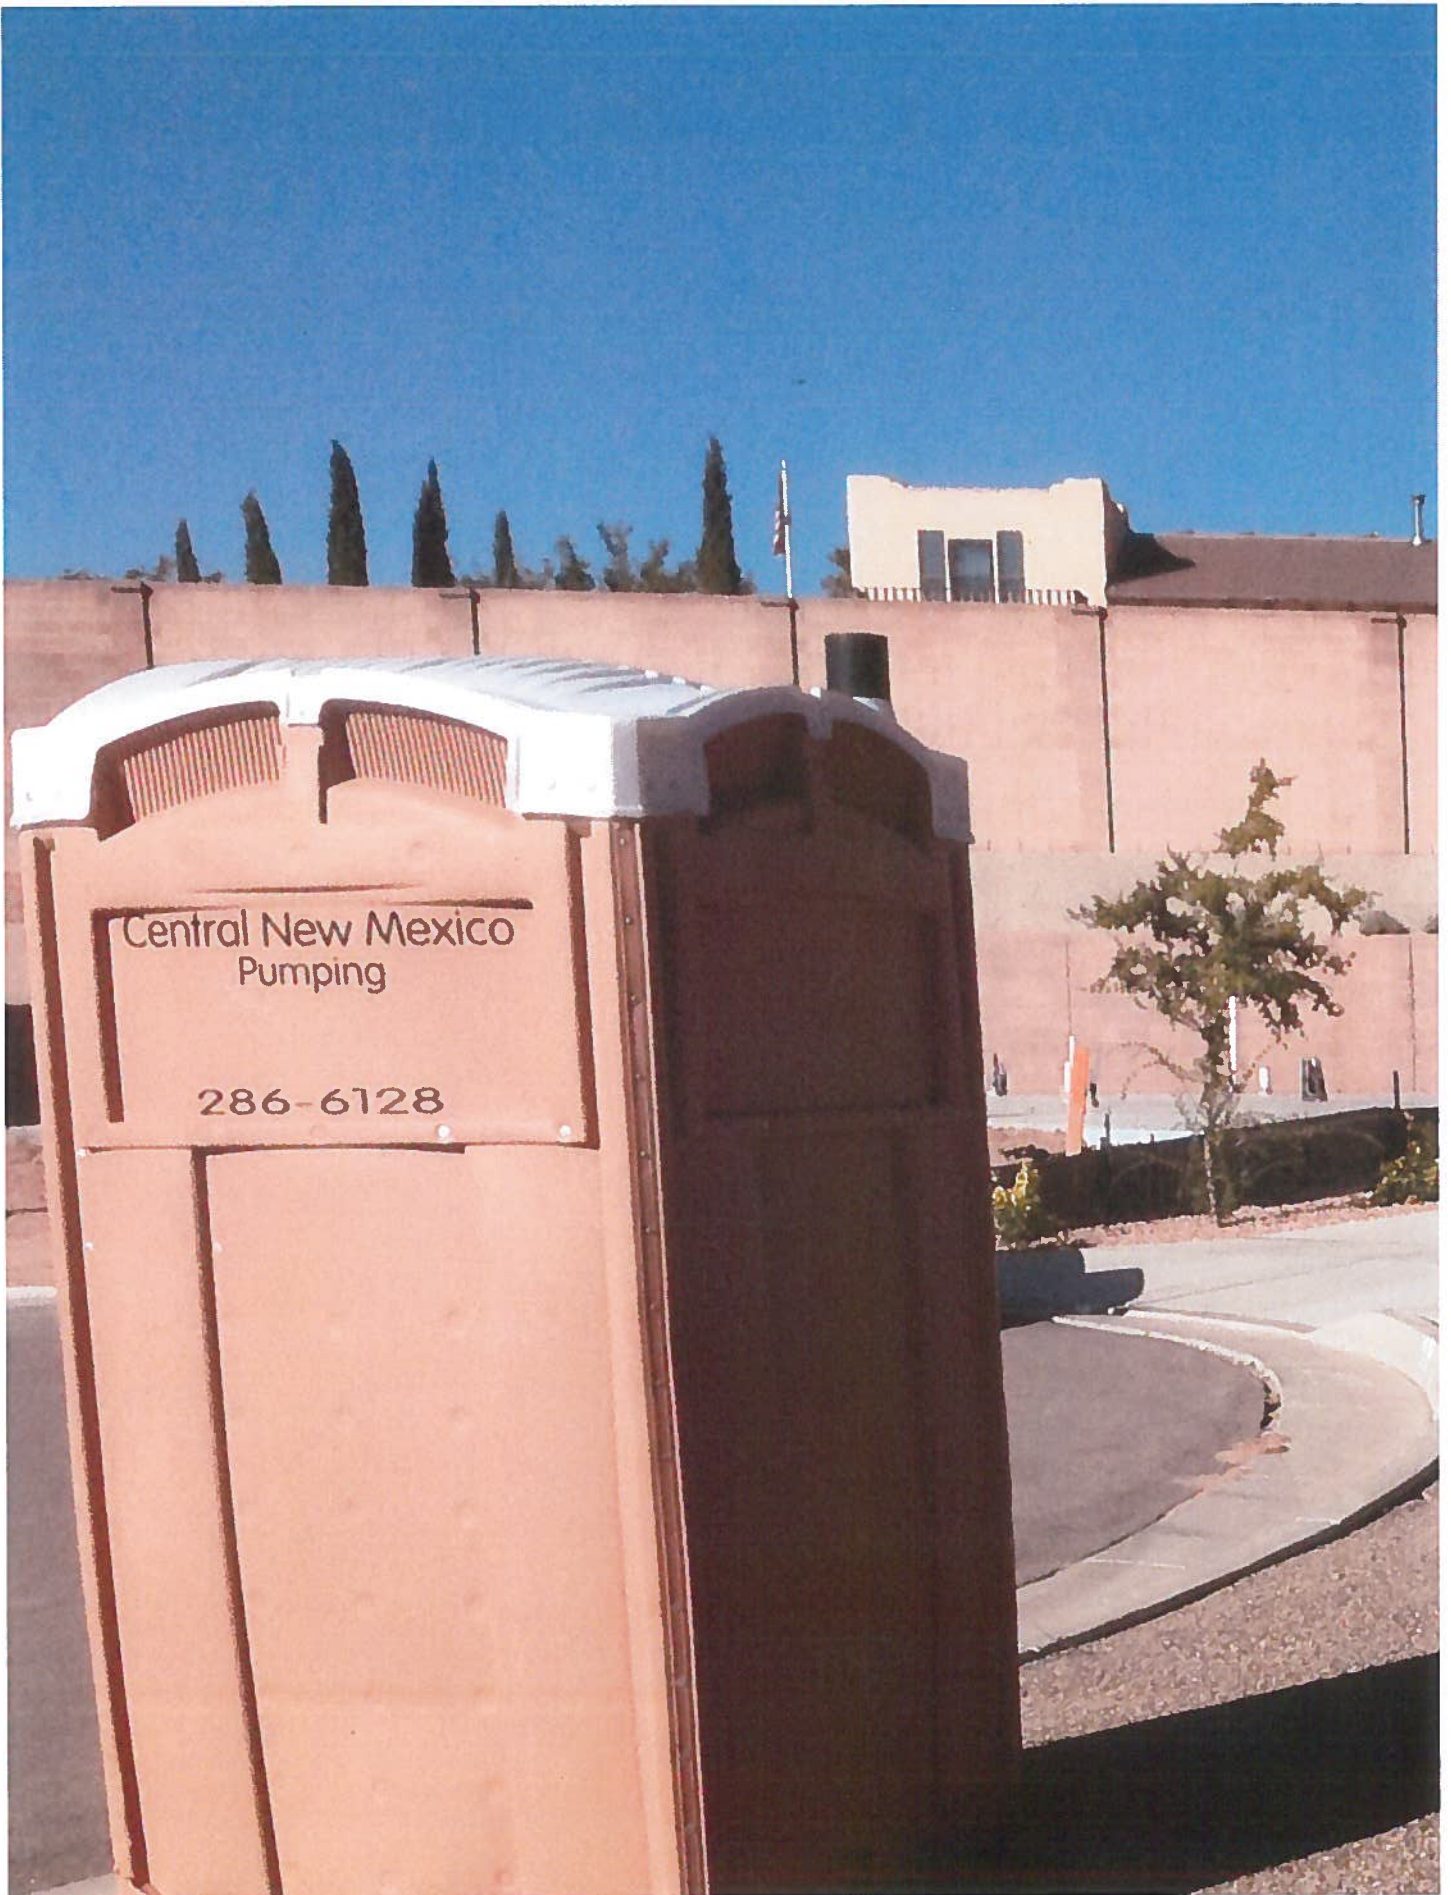
Curtis hope this will work. I sent a notice to all my subs.
I will be out of town after tomorrow until the 18th.
Thanks Gerald
