# City of Albuquerque

### Interoffice Memorandum

February 14, 2012

**SUBJECT: Certificate of Occupancy Inspection 2540 Karsten Ct**

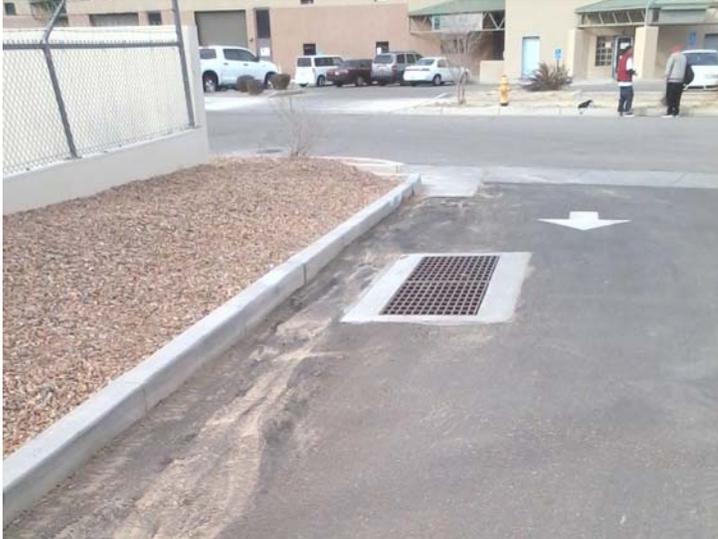
1. The furthest southwestern parking spot holds some water due to either poor control during paving or settlement. Minor issue, but likely occurred during construction.
2. The double D inlet is positioned such that most water will go around the inlet. It is not evident why the pavement was not warped to divert flows to the inlet. The inlet itself has some concerns. The grate is primed but not painted. The inlet box has nails projecting from the walls. No inlet was formed in the bottom and the inlet will hold approximately 5" of water below the outlet pipe.

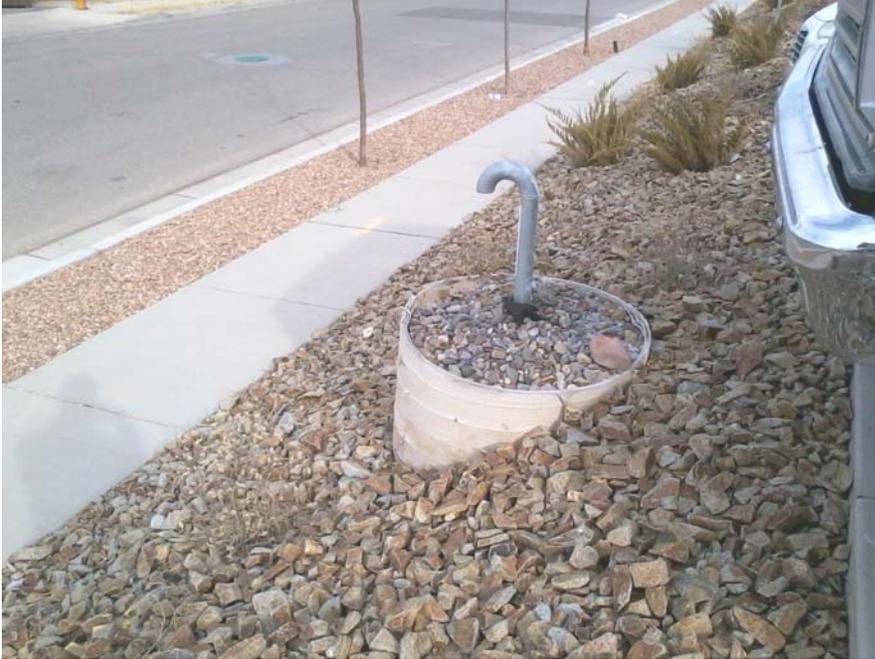
- 3.
4. Not used
5. There are 2 gas vents on the slope facing Karsten Court. The vents have retainage around them to protect the fill around them. However, the filled is held in place by degrading sonotubes. Appears to be either inadequate design or incorrect construction.

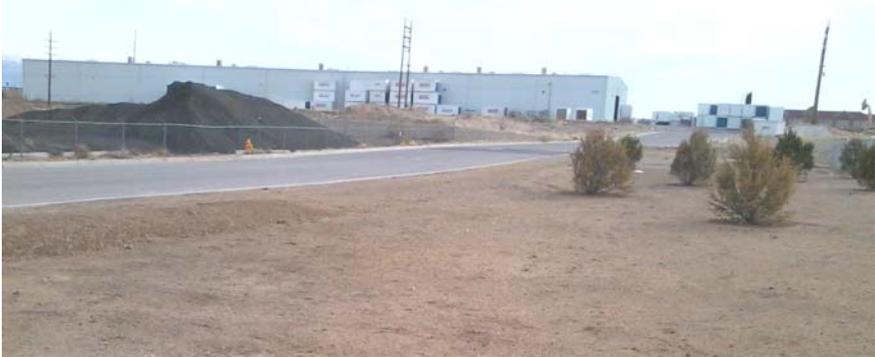
6. ADA ramp at the northwest corner does not appear to be ADA compliant the ramp narrows to less than 36".
7. The berm for the northwestern holding pond has a gap not shown on plans.

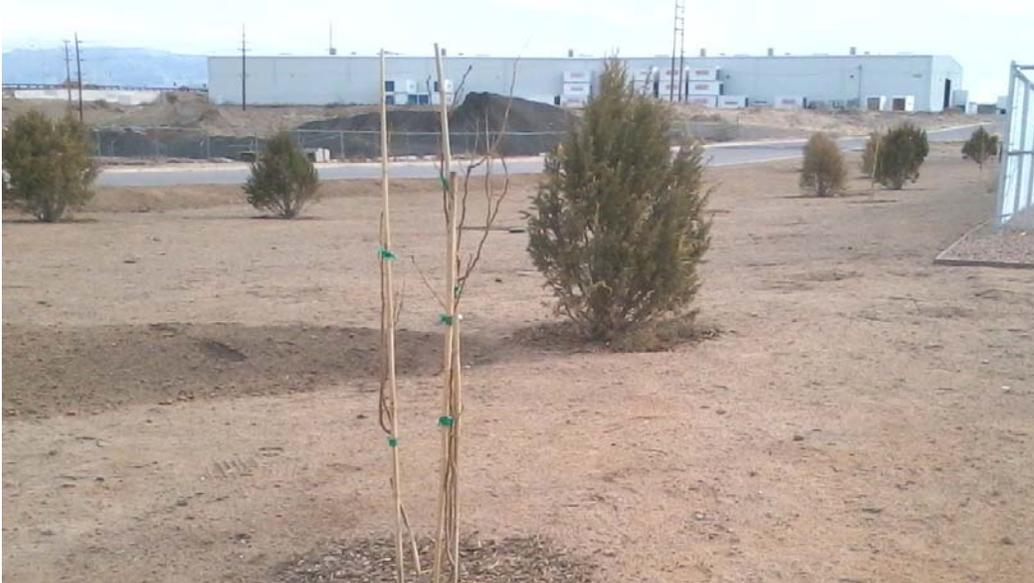
8. The northwestern pond is made up by a berm that is not compacted. There are footprints that extend up to 8 to 10 inches deep. It is likely that any water retained behind the berm with breach the berm. In addition the berm does not tie into the southern end as shown on the plans, but instead ends at a tree. It is unknown if this is intended as a spillway.

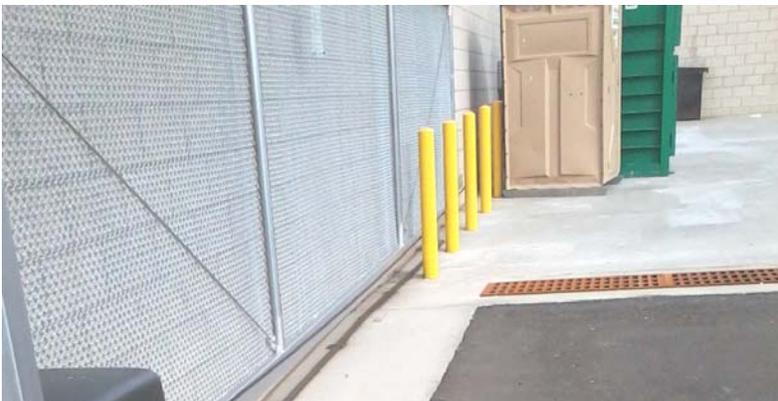
9. The fire access entrance at the northeast corner does not appear to have been built per City Standards. It is less than 6" in depth and the material is not either the gravel shown on plans or aggregate base coarse expected.
10. Private hydrant does not have bollards and water valves do not have collars.
11. Unsure how the grate downstream of the trash area at the southwestern corner of the building is supposed to work. No outlet was visible unless the pipe at the eastern end of the grate is the outlet. If so the invert is incorrect as the drain holds water and sediment.

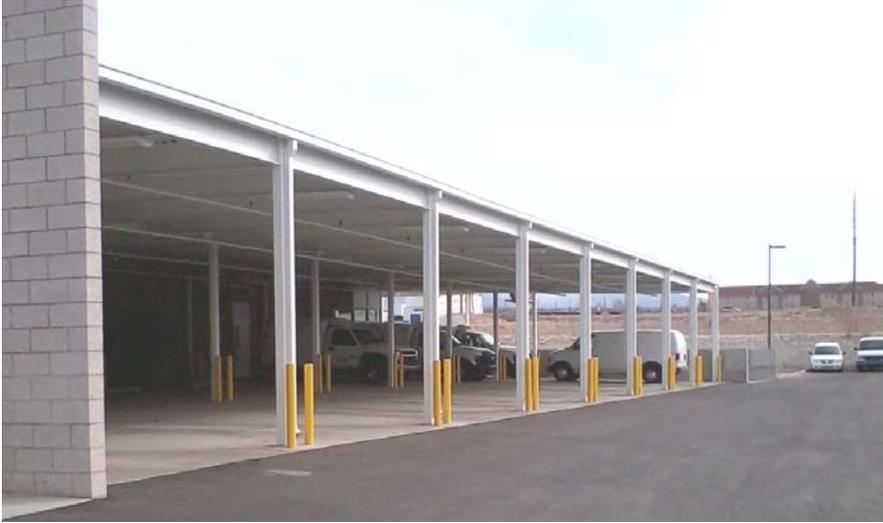
12. The large paved area to the east of the trash area is covered by a roof which is not shown on the plans. It appears to drain the same direction as the concrete area shown on the plans.
