RE: Saranam Golf Course & Montano 4701 Montano Rd NW Grading and Drainage Plan Engineer's Stamp Date: 2/15/2022 Hydrology File: E11D013B

Based upon the information provided in your submittal received 2/16/2022, the Grading & Drainage Plan **is not** approved for Building Permit. The following comments need to be addressed for approval of the above referenced project:

RE: Saranam Golf Course & Montano 4701 Montano Rd NW **Grading and Drainage Plan** Engineer's Stamp Date: 1/4/2022 Hydrology File: E11D013B

RE: Saranam Golf Course & Montano 4701 Montano Rd NW Grading and Drainage Plan

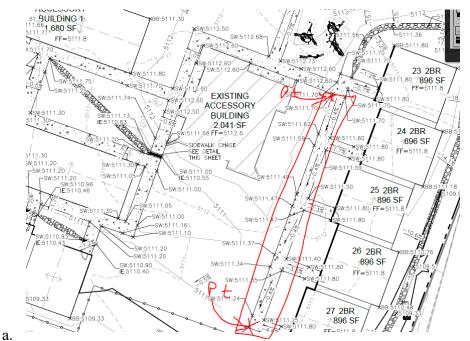
- Will this entrance work? Have you gotten comments from Traffic Section?
 a. Consider utilizing Standard Detail 2426. Geometry work needed.
 TC:5105.42 FL:5104.92 TC:5105.40
- TC:5105.22 FL:5104.90 SW:5106. FL:5104.72 FL:5105.9 CONCRETE TC:5105.37 SWALE @ FL:5105.87 SW:5106.3 :5104.59 SEE CURB -51 TRANSITION 04. L:5105.12 DETAIL CURB SW:5105.83 NSITION C:5105.64 TAIL 5105.14 W:5104.87 FL:5104.42 MATCH SW:5104.78 EXISTING FL:5104.14 MATCH EXISTING 2.
- 3. Practically, during construction so many points are not needed and it makes the plans very hard to review.

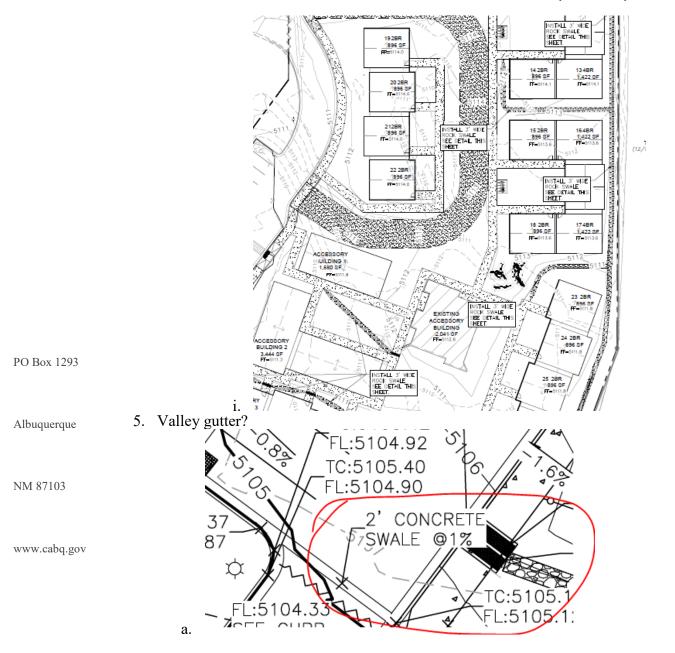
- 4. The drafting is very difficult to wrap my head around as much information is on here and makes the plans difficult to review. Please review drafting standards for company if possible. I feel line weights and work with drafting would help make the plans apparent.
 - a. What I really would like to know is how water is conveying (e.g. low/High points and grade changes, flow lines. Spots for construction where it makes sense. Contours show the big idea where points will show the small details only when needed)
 - b. For example, this section below, I cannot tell what proposed vs. existing contours are without straining my eyes.

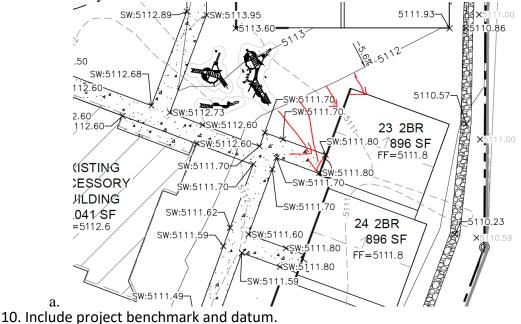
- 8. Please reference DPM Chaper 6.
- 9. Please take a second look at everything. See below, it appears flow may go directly into the doorways here.

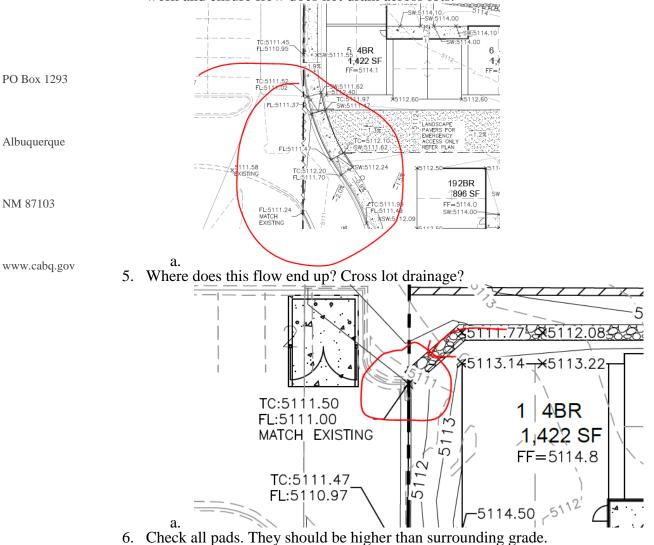
4. Is this a water block? If so, please provide elevations showing how these grades will work and ensure flow does not drain across lots.

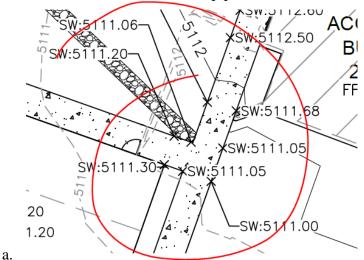
7. How will this work? Will there be a pipe under sidewalk?

b. Please show all of these details. As of now it appears this is just a ponding area.

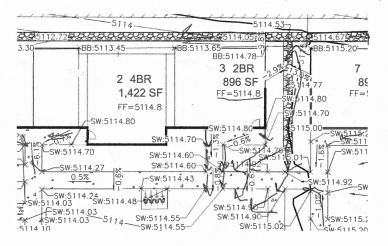
3. Check this area. Appears maybe some ponding and may flow right to the doorway area here. Response: Storm water should be draining away from all doorways and does not pond see below.

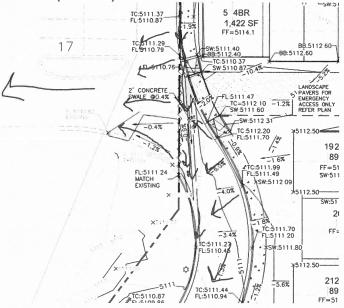
4. Is this a water block? If so, please provide elevations showing how these grades will work and ensure flow does not drain across lots.

Response: Yes there is a water block; flows from the project site are routed south towards the proposed parking area. Flows from the tract to the west flows to the west towards the existing retention pond per As-Builts (Attached).
