STRUCTURAL, SITE WORK, AND INTERIOR / EXTERIOR REPAIRS TO: CHILDREN, YOUTH, & FAMILIES DEPARTMENT OF THE STATE OF N.M. 1031 LAMBERTON PLACE NE ALBUQUERQUE, NM 87107

Sheet Title: **GRADING NOTES** 07905 ÅNW Drawn By: Project No FCA 06.27.14 Checked By: Date:

GRADING PLAN & DETAILS

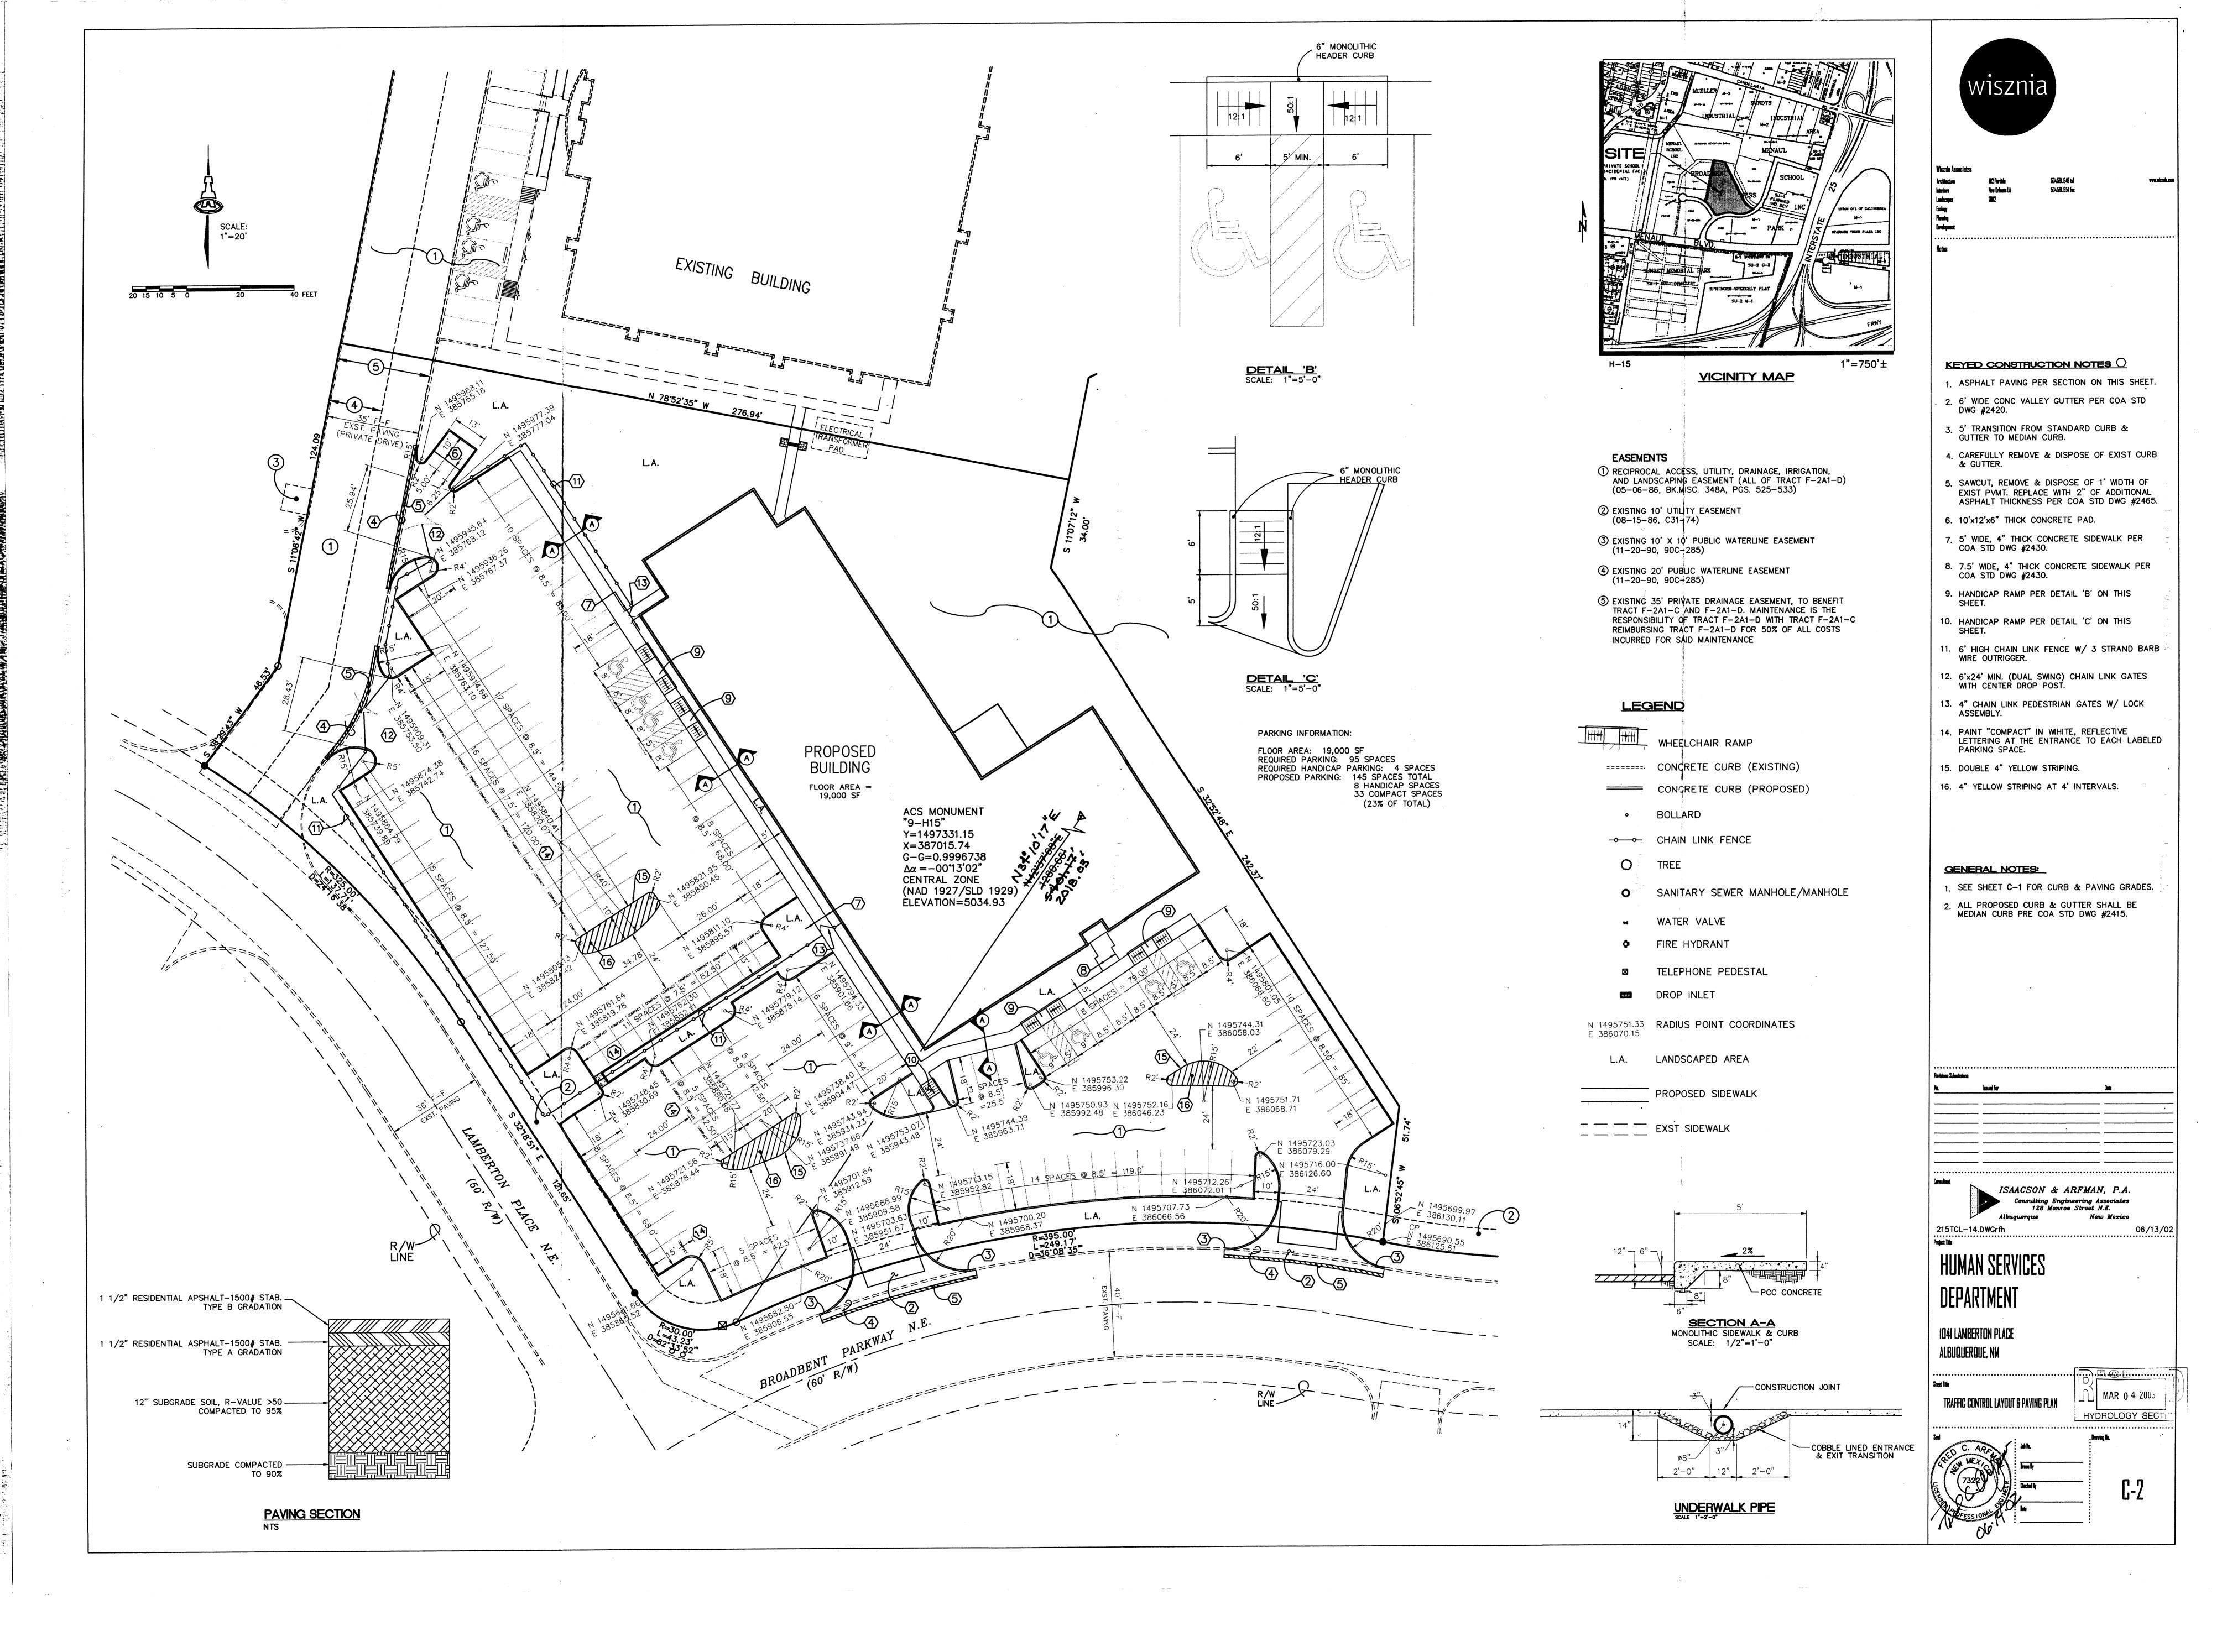
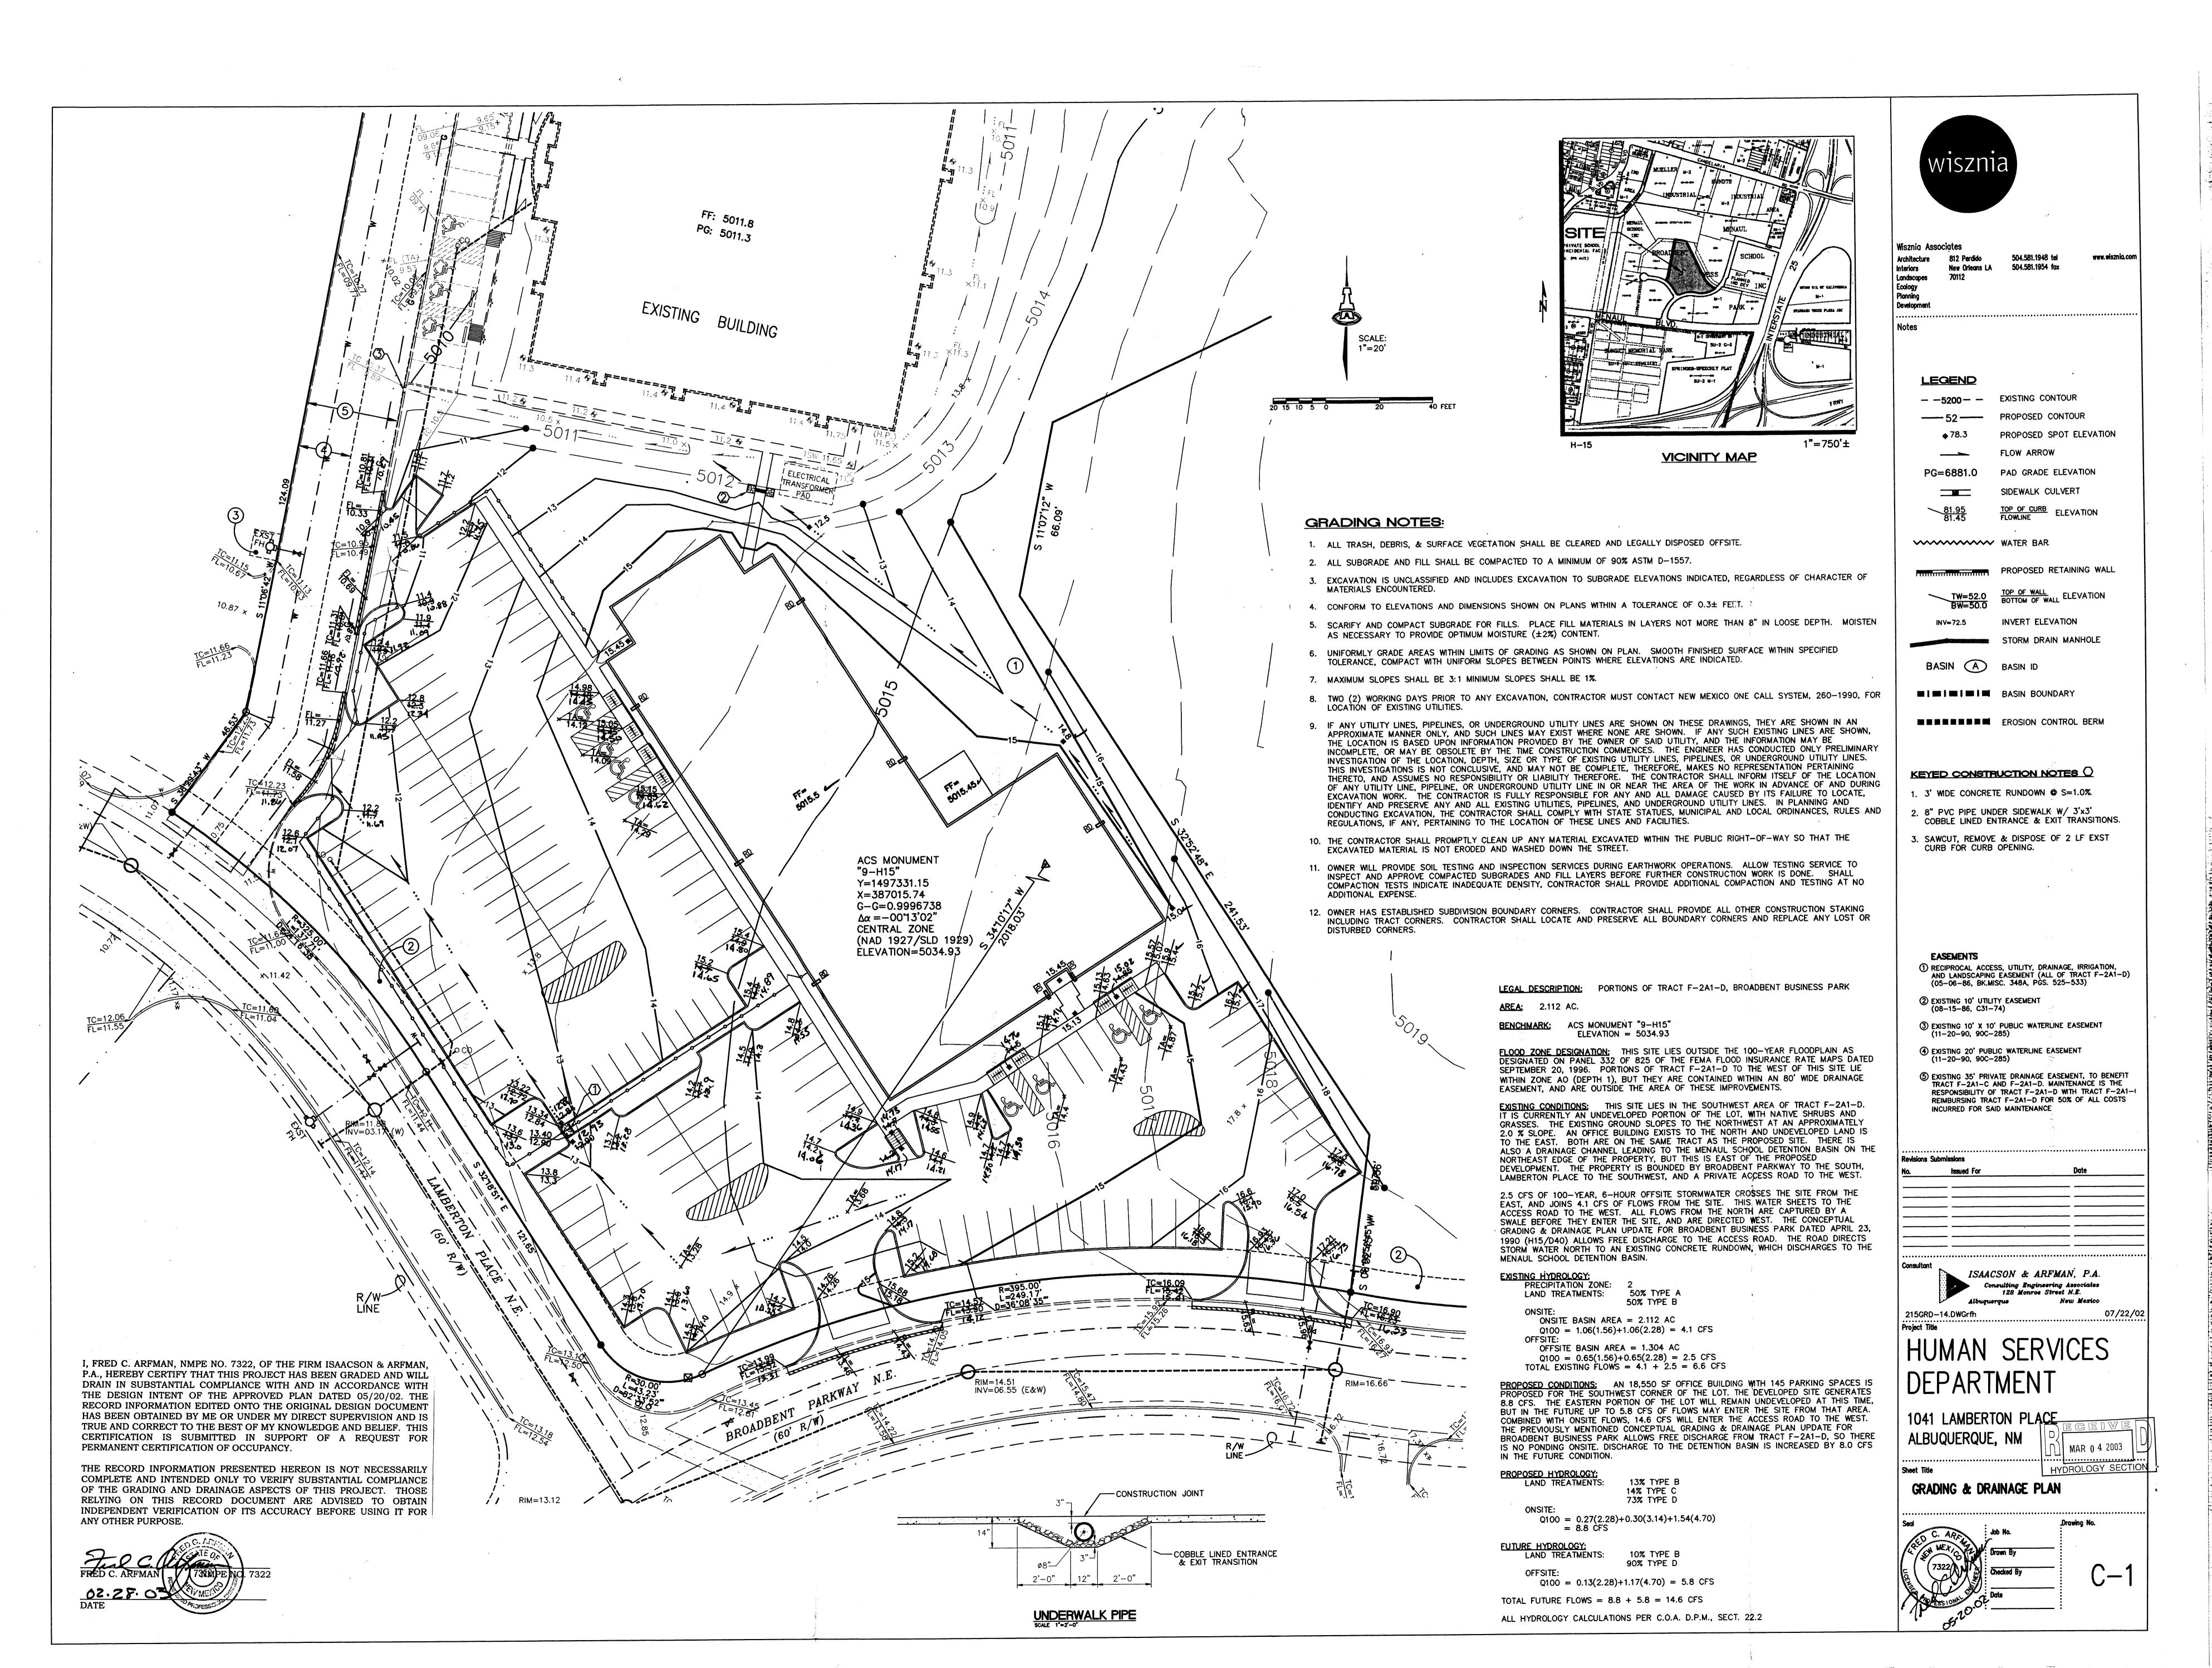
ASSESSMENT/REMEDIATION NOTES

NORTH SIDE OF BUILDING

THE ORIGINAL GRADING PLAN (2002) DID NOT INDICATE A SIDEWALK TO THE EAST OF THE BUILDING DOORWAY. THE SIDEWALK IS INSTALLED HIGHER THAN THE GRADE AT THE BUILDING, SO WATER FROM THE THREE ROOF DRAINS IS TRAPPED BETWEEN THE BUILDING AND THE SIDEWALK.

EAST SIDE OF BUILDING

THE ORIGINAL GRADING PLAN SHOWED A SWALE FROM THE SOUTHEAST BUILDING CORNER TO A CURB OPENING EAST OF THE NORTHEAST BUILDING CORNER. THE AS-BUILT GRADE AT THE CURB OPENING IS HIGHER THAN WHAT WAS SHOWN ON ORIGINAL GRADING PLAN SO THE SWALE DOES NOT FUNCTION. CURRENTLY, WATER IS BEING PONDED ADJACENT TO THE BUILDING.

SOUTH SIDE OF BUILDING

THE GRADES AT THE SOUTHEAST CORNER OF THE SITE ARE HIGHER THAN THE BUILDING. THERE ARE TWO ROOF DRAINS AT THE SOUTH SIDE OF THE BUILDING WHERE THE SOIL HAS ERODED SIGNIFICANTLY.

WEST SIDE OF BUILDING

THE GRADES ALONG THE WEST SIDE OF THE BUILDING APPEAR TO HAVE SUFFICIENT SLOPE TO THE WEST. THERE IS A SMALL HOSE BIB IN THE WALL SOUTH OF THE BUILDING ENTRANCE THAT APPEARS TO HAVE LEAKED CAUSING DAMAGE TO THE WALL. ADDITIONAL AREAS OF BUILDING CRACKING AND STAINING WERE OBSERVED.

INSTALL 12" SIDEWALK DRAINS AT ROOF DRAIN LOCATIONS (2) TOTAL) AND INSTALL AN IMPERMEABLE LINER IN LANDSCAPE AREAS. TO CAPTURE WATER DURING SNOWMELT AND MINIMIZE ICE FORMING ON SIDEWALK AND PAVEMENT, SIDEWALK DRAIN OUTLETS SHALL CONNECT TO A NEW 8" STORM DRAIN MAIN EXTENDING TO A NEW BUBBLE UP INLET IN THE NORTHWEST MEDIAN. DURING LARGER STORM EVENTS, THE WATER NOT CAPTURED BY THE SIDEWALK DRAIN DOWN PIPES WOULD CONTINUE TO BE DIRECTED TO THE NORTH PARKING LOT THROUGH THE SIDEWALK DRAIN CURB OPENING AND OVER THE SIDEWALK.

REGRADE THIS AREA TO ESTABLISH POSITIVE DRAINAGE AWAY FROM THE BUILDING AND GRADE A WATER HARVESTING BASIN WITH A PERCOLATION PIT AND SURFACE OVERFLOW TO THE EXISTING CURB OPENING.

REGRADE THE AREA ADJACENT TO THE SOUTHEAST BUILDING CORNER TO ELIMINATE THE EXISTING POND, INLET AND DRAINAGE PIPE TO DIRECT TO THE LARGER PROPOSED WATER HARVESTING BASIN AT THE EAST SIDE OF THE BUILDING. FILL AND COMPACT THE ERODED AREAS BY THE ROOF DRAINS. INSTALL PCC RUNDOWN ADJACENT TO THE SIDEWALK AND EXTEND RUNDOWN TO THE BUILDING AT THE ROOF DRAINS. FIELD ADJUST EXISTING GRADES BETWEEN CONCRETE APRON AND RUNDOWN TO ENSURE POSITIVE DRAINAGE INTO THE RUNDOWN.

ASSESS IRRIGATION SYSTEM AND GEOTECH FINDINGS. ASSESS AND CLEAN STORM DRAIN SYSTEM FROM THE INTERIOR COURTYARDS TO THE BUBBLE-UP INLET IN THE MEDIAN NORTHWEST OF THE BUILDING. ASSESS ALL EXTERIOR HOSE

CONTRACTOR SHALL PROVIDE AN ITEMIZED PROPOSAL FOR ALL WORK/REPAIRS REQUIRED PER THE ASSESSMENT.
