Albuquerque Metropolitan Arroyo

January 13, 2012

Re: Drainage Management and Construction Plans for APS Community Stadium Engineer's Seal Dated 12-21-11

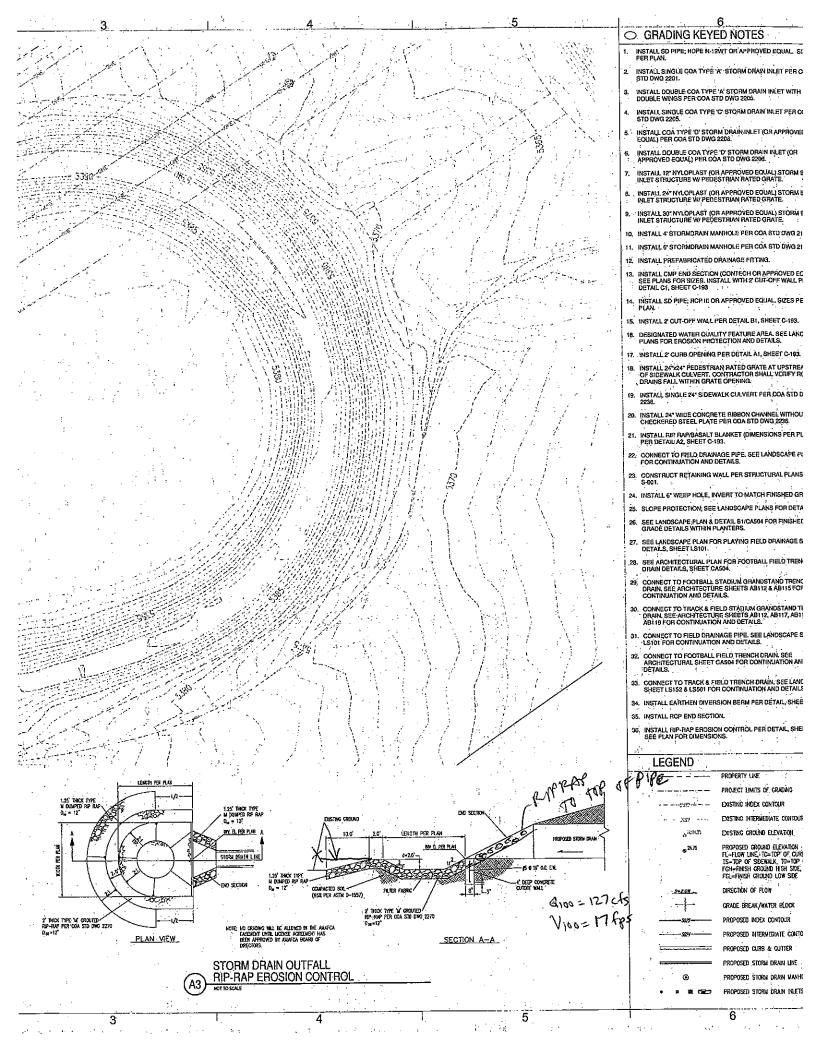
- 1. On Sheet C-107, there needs to be a base course access road to MH 12 and the water quality manhole.
- 2. On Sheet C-190, the 10-foot riprap extension should be buried. The intent is to prevent headcutting at the horizontal section (see attached). Also, the riprap around the pipe outlet should extend at least to the top of pipe. We often see erosion around pipe outlets.
