**RE: Ladera Dam 9 Diversion
LOMR Request
Engineer's Stamp Date: 04/21/2025
Hydrology File: J08D003B
Case # HYDR-2025-00137**

LADERA DAM 9 DIVERSION LETTER OF MAP REVISION

April 21, 2025
Project Number 242004

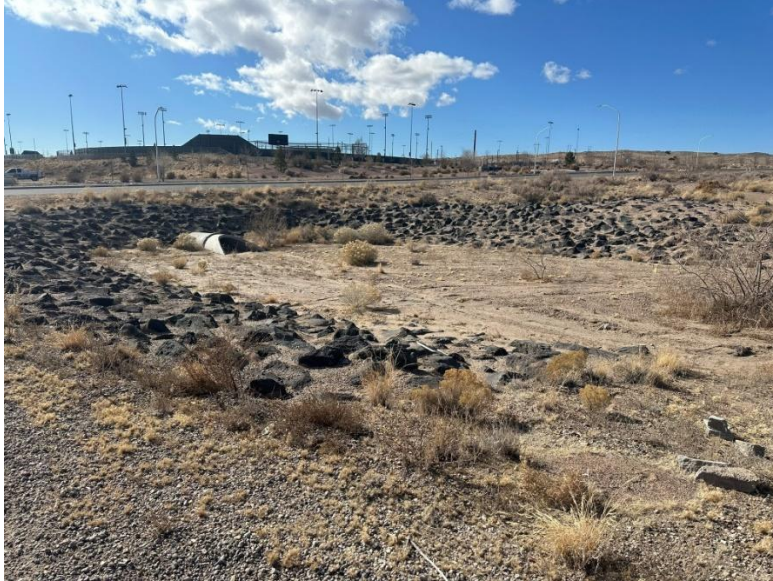
In February 2025, CDS conducted field observations of the Ladera Dam 9 Diversion Channel and its surrounding area. The fieldwork involved verifying the existing conditions of the channel, check structures, and watershed boundaries. Photos 1 and 2 illustrate significant sediment accumulation at the entrance of the 54-inch culvert and at the check structures, respectively. Detailed fieldwork photographs and their locations are provided in Appendix B.

PHOTO 1: 54- INCH CULVERT AT ARROYO VISTA BOULEVARD

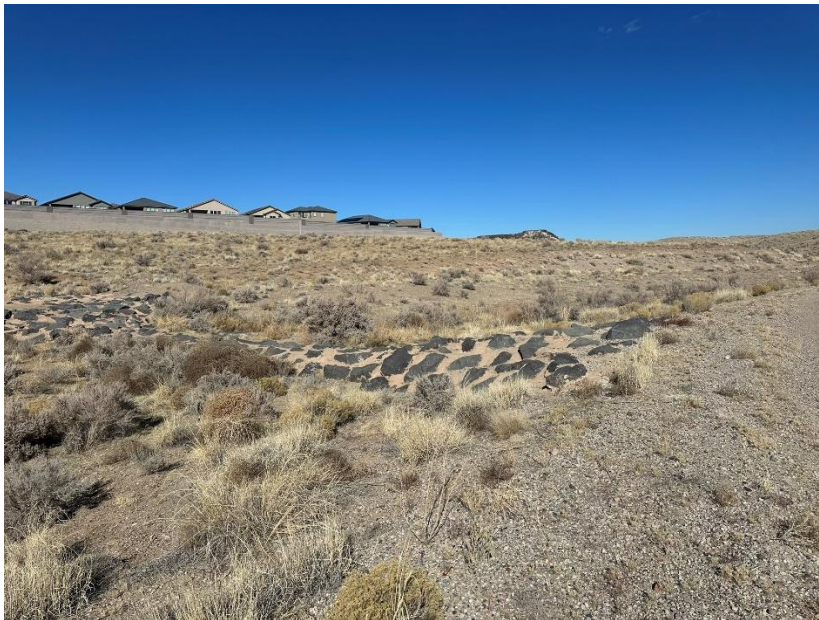
PHOTO 2: CHECK STRUCTURE UPSTREAM OF 54-INCH CULVERT

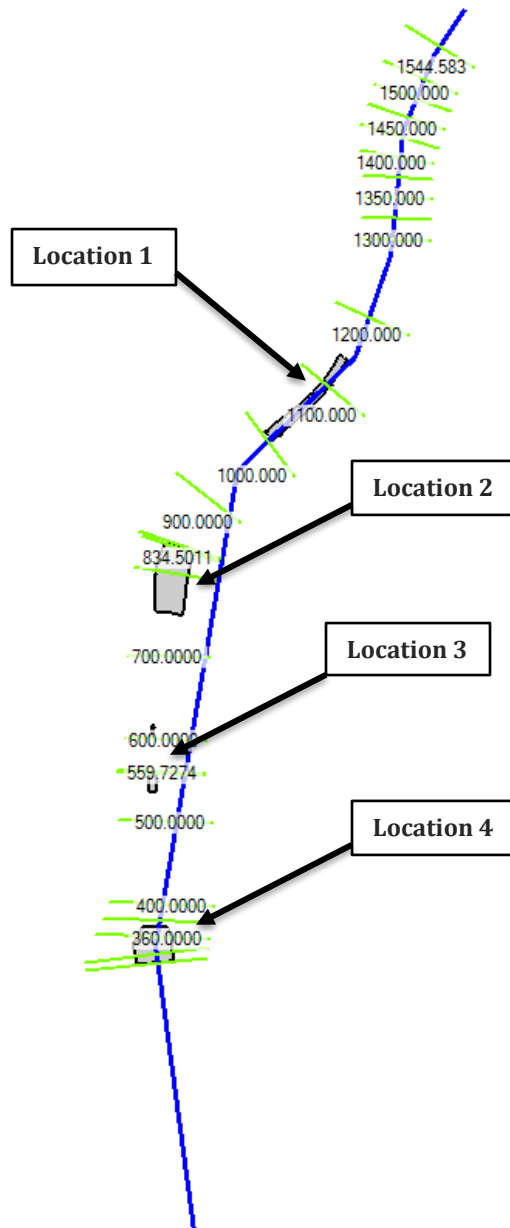
FIGURE 4: ANOMALIES IN HYDRAULIC MODEL

The revised flowrate of 71 cfs reduced the water surface elevations to make the channel average depth below 1 foot overall. At the following locations in the channel, due to a change in channel slope from a check structure, the water surface elevation show a water depth exceeding 1 foot:

- / Cross section 1100.000
- / Cross section 830.7607
- / Cross section 557.7418
- / Directly upstream of the 54-inch culvert at Arroyo Vista Blvd

CDS has concluded that these areas, shown in Figure 4, are anomalies in the model. Overall, the channel depths have significantly decreased from the effective model based on the revised analysis in this LOMR. Although there are very small areas where the calculated depth exceeds 1 foot, CDS concludes that these instances are due to minor low points in the channel geometry directly adjacent to the check structures and should be ignored. The channel depths calculated at the check structures, are shown in Figure 4. HEC-RAS model, layout, profile, water surface elevation comparisons, and data tables are included in Appendix C.
