March 10, 2021

ASBESTOS INSPECTION REPORT

The Cooperage Restaurant 7220 Lomas Blvd. NE Albuquerque, NM

Fiesta Kia Auto Group 7400 Lomas Blvd. NE Albuquerque, NM 87110

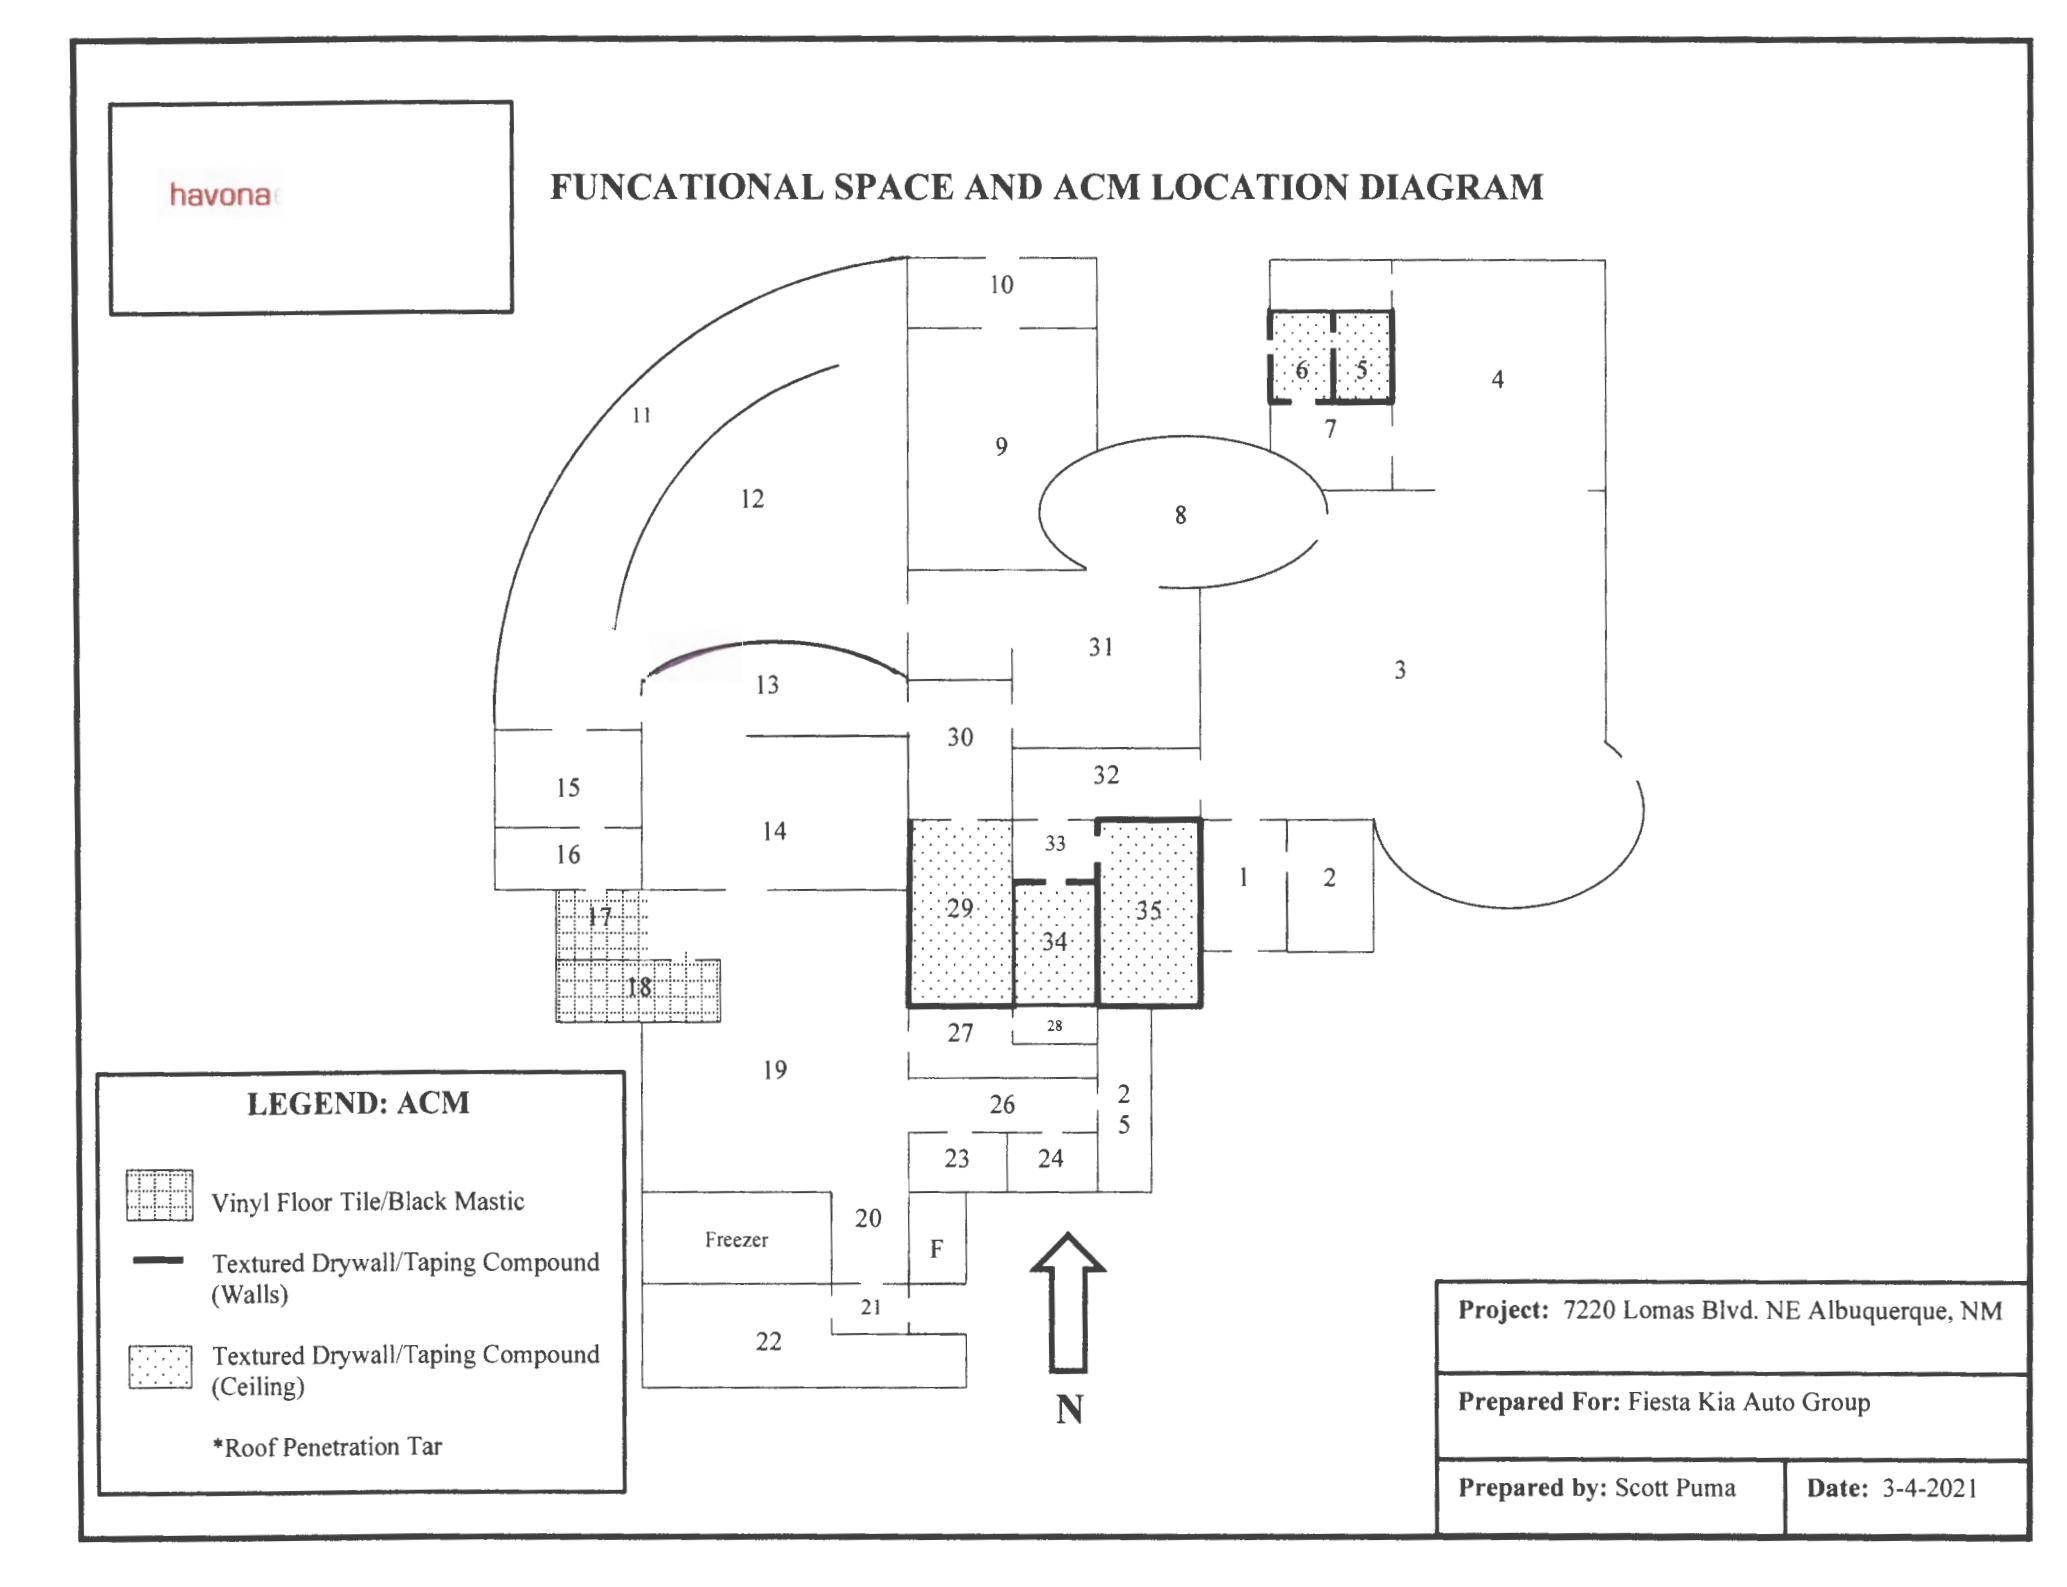
APPENDIX A

Of the materials sampled, five were identified to be asbestos containing materials (ACM). The materials identified to be ACM include the vinyl floor tile/mastic, textured drywall, taping compound, and roof penetration mastic.

Material	Location	Quantity/ Amount	Asbestos Content
12x12 Cream Streaked Vinyl Floor	17, 18	~130 Sq. Ft.	Tile: 2-3% Chrysotile
Tile/Black Mastic			Mastic: 4% Chrysotile
Textured Drywall C Knock Down	5, 6	~550 Sq. Ft.	3% Chrysotile
Pattern			
Textured Drywall E Swirl Pattern	34, 35, 30, 29	~1.300 Sq. Ft.	3% Chrysotile

Taping Compound E	34, 35, 30, 29	Included w/Texture E	3% Chrysotile
Roof Penetration Tar	Roof	~100 Penetrations	3% Chrysotile

Asbestos abatement contractors should verify quantities and amounts before bidding the project.
