### Street Reconstruction Vassar Street, South of Phoenix Ave. N.E. Due to Waterline Break

City of Albuquerque, New Mexico  
Department of Municipal Development  
Contractor: Franklins Earthmoving, Inc.

March, 2021

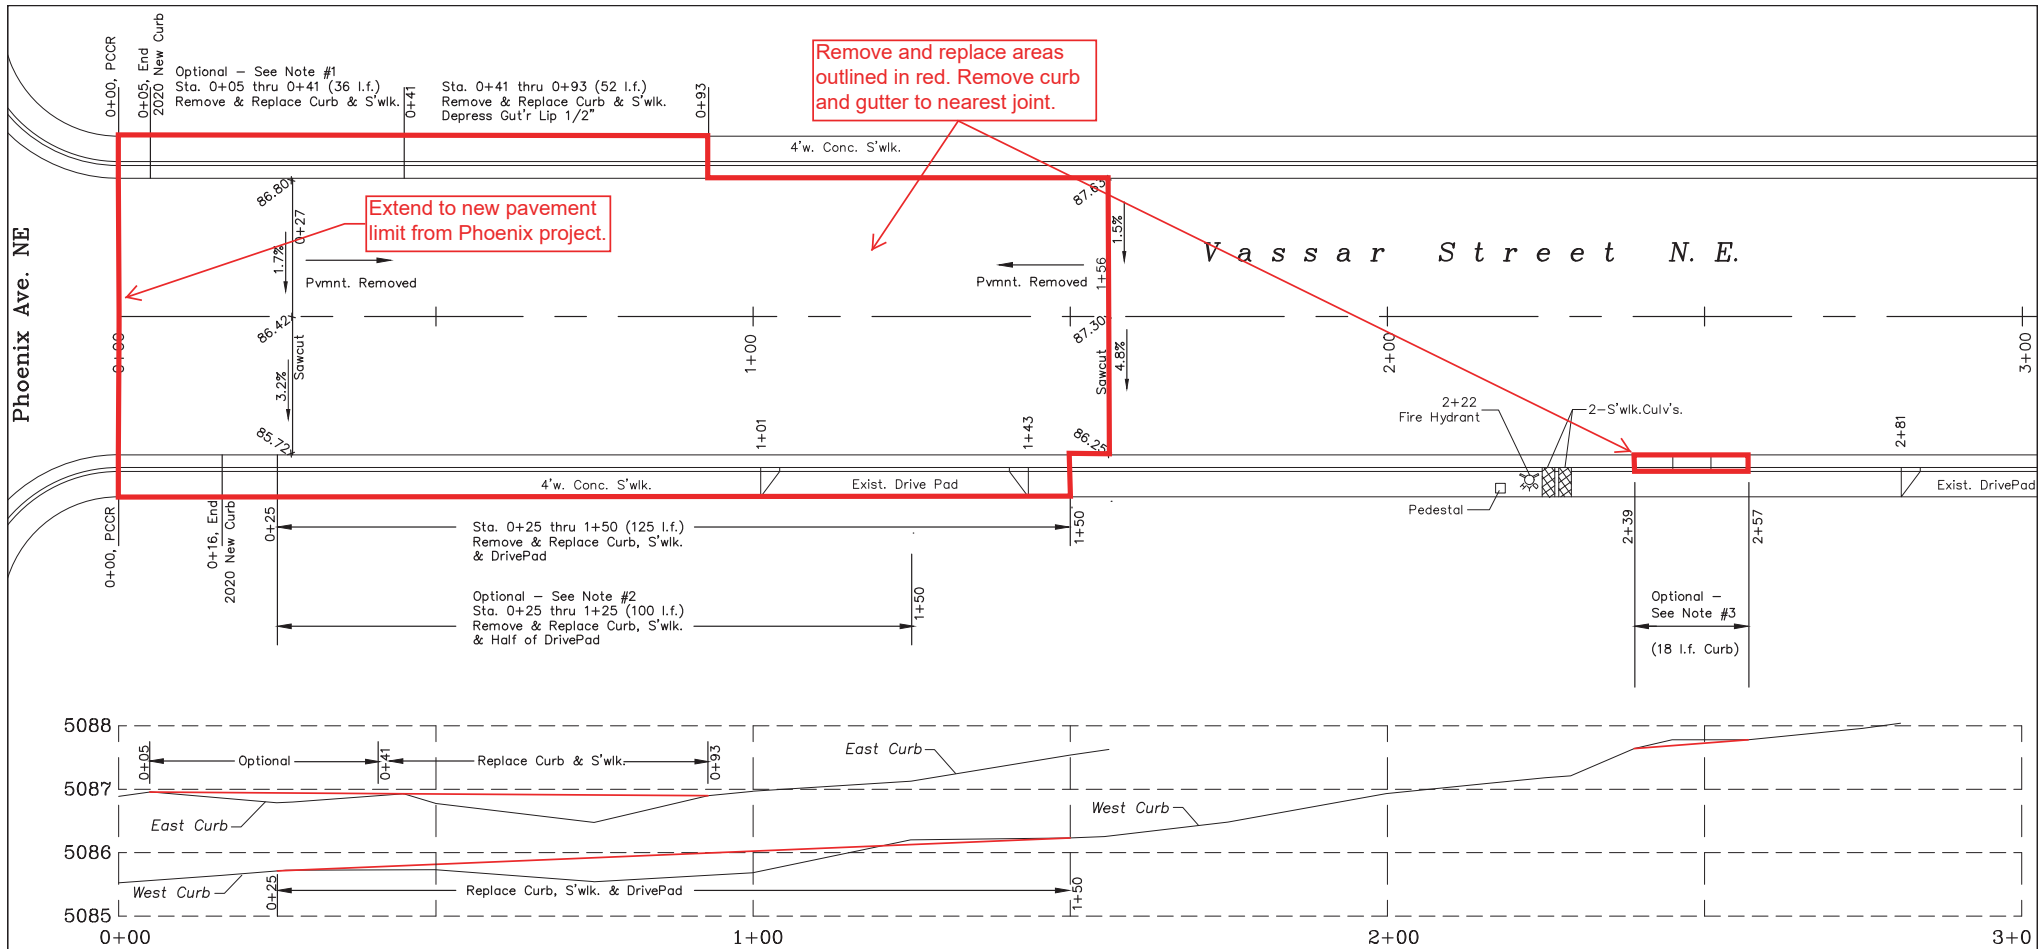
Scales: 1"=20' Horiz.  
1"= 2' Vert.

1. Though the curb profile line has a dip, there is sufficient cross slope to prevent drainage problems.
2. The east one half of the driveway measures level, and could remain.
3. 2 curb stones measure level. By removing one additional curbstone to the north, the flowline could be re-shaped to provide positive slope. 18 l.f. total curb replacement.
