SUBJECT: Sensitive Lands Analysis – UNM Commercial District

The subject property is legally described as Tracts 6-10 of Plat of UNM GIBSON COMMERCIAL DISTRICT (A Replat of Tracts A & B, EVER READY SUBDIVISION Tracts 4 & 5, GIBSON Tracts & Tract A, 40/25 ASSOCIATES SUBDIVISION)

We will be replatting Tracts 6, 7, 8, 9, and 10 of Plat of UNM Gibson Commercial District.

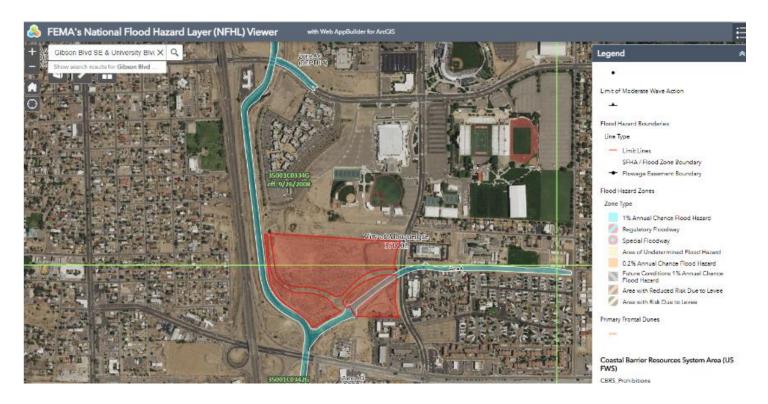
FEMAs National Flood Hazard Layer Mapping site shows the subject site (approximate location seen in red) is within the 1% Annual Chance Flood Hazard. We will have CLOMR/LOMR at some point and this Flood Zone will not be avoided as it is within a man-made concrete channel to be placed in a storm drain line.

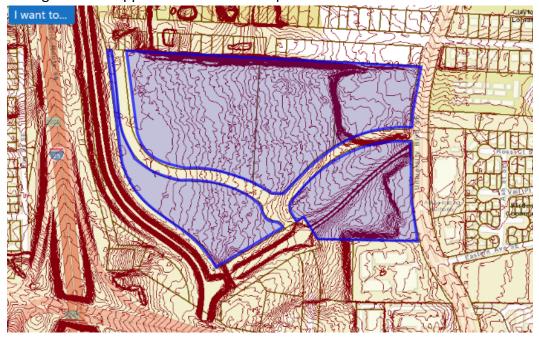
The 2-foot contour layer provided by the Advanced Map Viewer 2.0 indicates that the subject site (approximate location shown below in blue) has steep slopes which are man-made, and this entire area is intended to be regraded to support the future development.

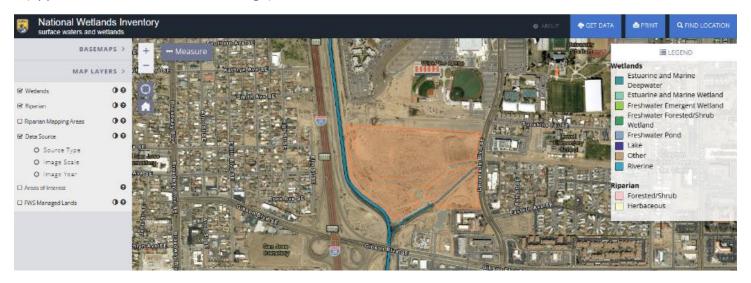
As seen below in the data provided by the National Wetlands Inventory, it shows the subject site (approximate location seen in orange) is not within a wetland area.

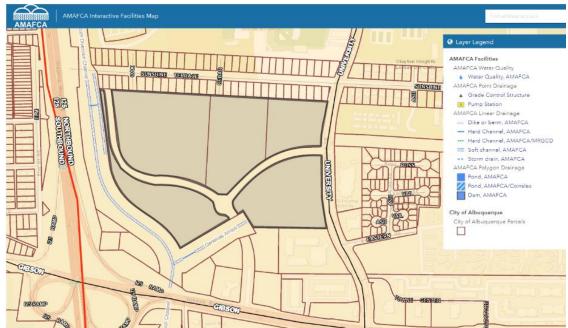
The Geneiva Arroyo abuts the site to the west and south but does not go through the five tracts that make up the property site (seen below in grey). Using the data provided by the AMAFCA Interactive Facilities Map you can see below the arroyo and site locations. The existing lined concrete channel will be hard piped and connected to the Geneiva Arroyo. Coordination with AMAFCA and COA Hydrology is ongoing as the CLOMR is being worked on.

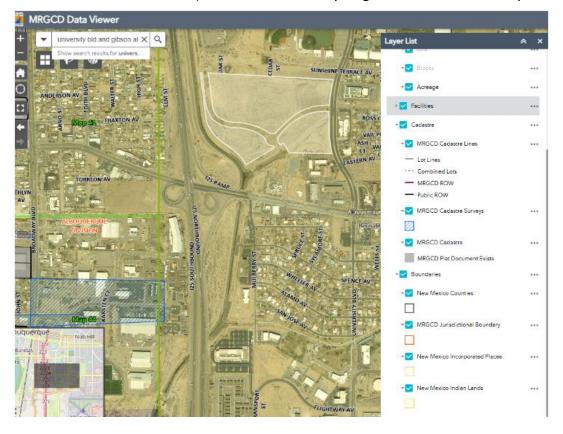
As seen in the image below, data provided by MRGCD Data Viewer confirms that the subject property (approximate location shown in white) does not contain any irrigation facilities nor acequias.

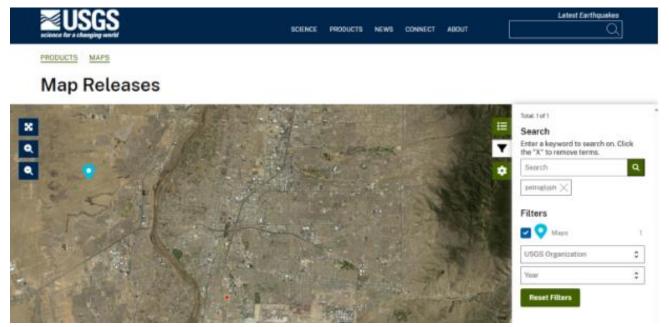
Per the U.S. Geological Survey Map Release there are no Petroglyphs on the project site (as shown by the red dot below).

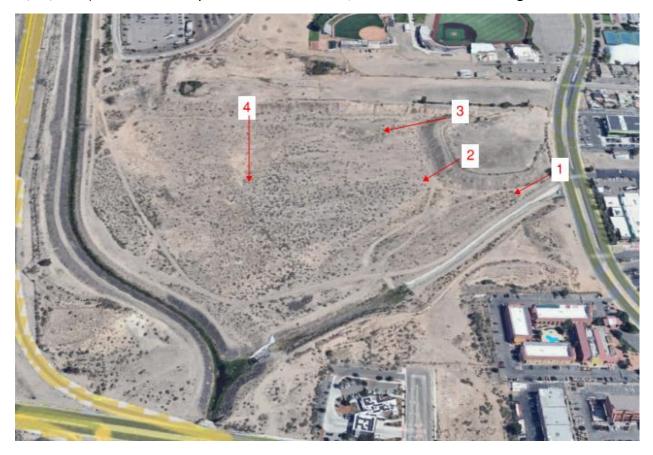
There are no visible rock outcroppings on the property site as seen in the Site Photos below (pictures taken on 6/01/2023). There are four points of view included, as seen in the below image.

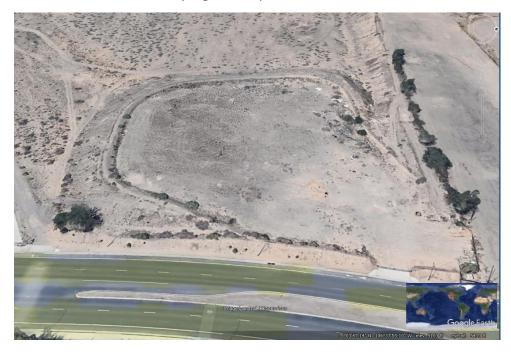
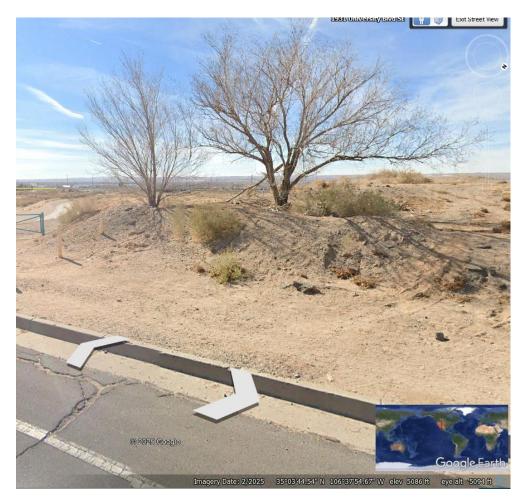
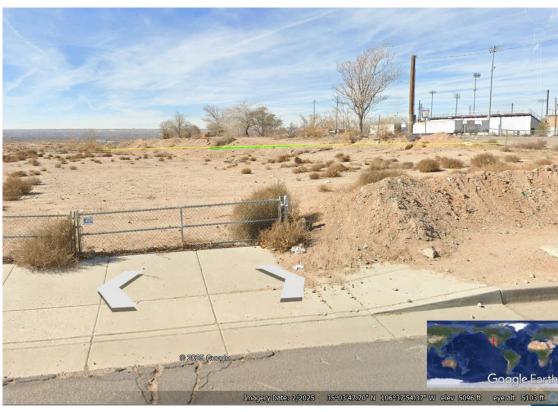
At the Northeast corner of the site are stands of mature trees; two trees (assumed to be of the mesquite tree family) are to the right of the Geneva Arroyo and a small grove of trees at the north edge of the north corner of the site, spanning approximately 450 ft. These trees will be removed as apart of this development and new trees and landscaping will be provided.
