Memorandum

Re: Sensitive Lands Analysis for La Terra

This memo responds to the Sensitive Lands criteria in IDO Section 14-16-5-2. The subject properties are legally described as *Tract 4 Bulk Land Plat of the Trails Unit 3A* and *Tract 5 Bulk Land Plat of the Trails Unit 3A*. We have analyzed the project site for the presence of sensitive lands and any constraints related to such lands.

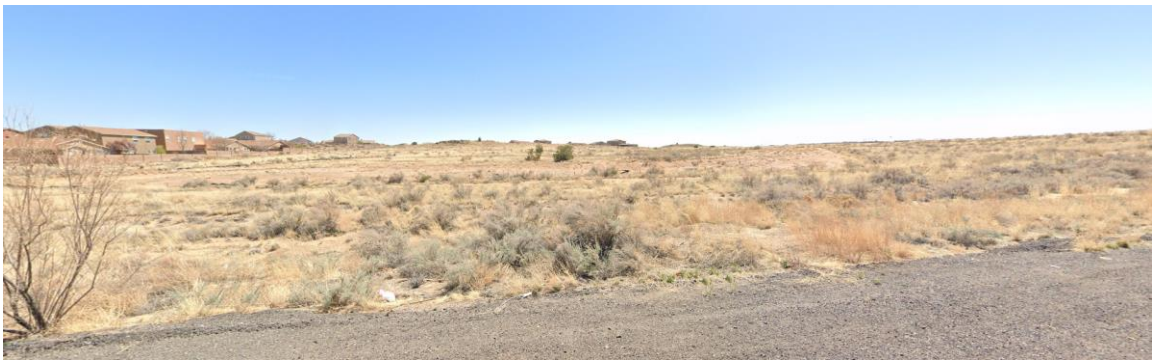
- Irrigation facilities (acequias): Due to the subject site's location and distance from the Rio Grande there are no irrigation facilities or acequias on or near the site. Data provided by MRGCD confirms the subject property is outside of the MRGCD jurisdiction.
- Large stands of mature trees: The subject sites are vacant parcels with nominal vegetation. There are no large stands of mature trees on either parcel. The image below depicts the subject sites facing south from Paseo Del Norte.

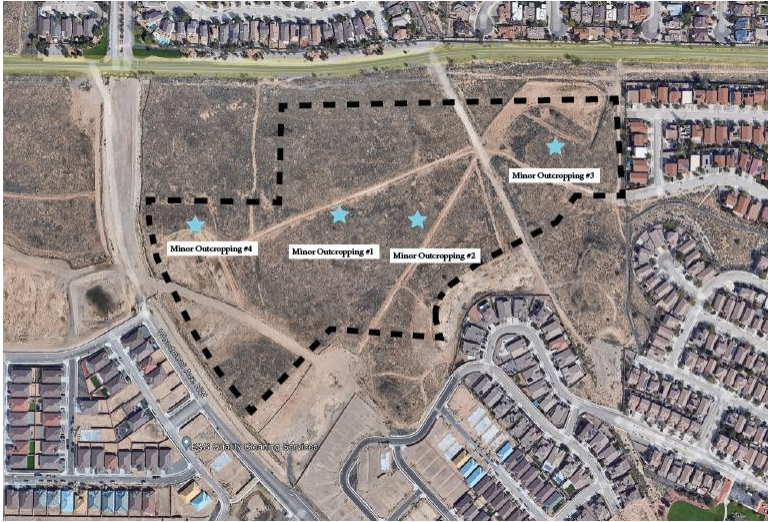
Approximate locations of Minor Rock Outcroppings

In addition to the Major Rock Outcropping, there are 4 other minor rock outcroppings that exist on the property as well as several surface level basalt areas, which do not rise above the surface elevation of the surrounding area. As requested as part of the DFT review, the Project Team did an additional site visit to assess and locate the minor rock outcroppings on the property. The approximate locations for the minor outcroppings are shown on the map below:

In conclusion, none of the minor rock outcroppings meet the criteria as established in the IDO for preservation. While the Planning staff noted that they could be interesting design features, there are several issues that prevent their preservation, which include:

Due to these constraints, it is not practicable to preserve the minor rock outcroppings. We will, however, be using the basalt – in the form of rip rap and boulders for the landscape and signage gabion baskets to ensure a direct relationship between the built environment and the Major Rock Outcropping on the site.
