Memorandum

Re: Sensitive Lands Analysis for Keystone

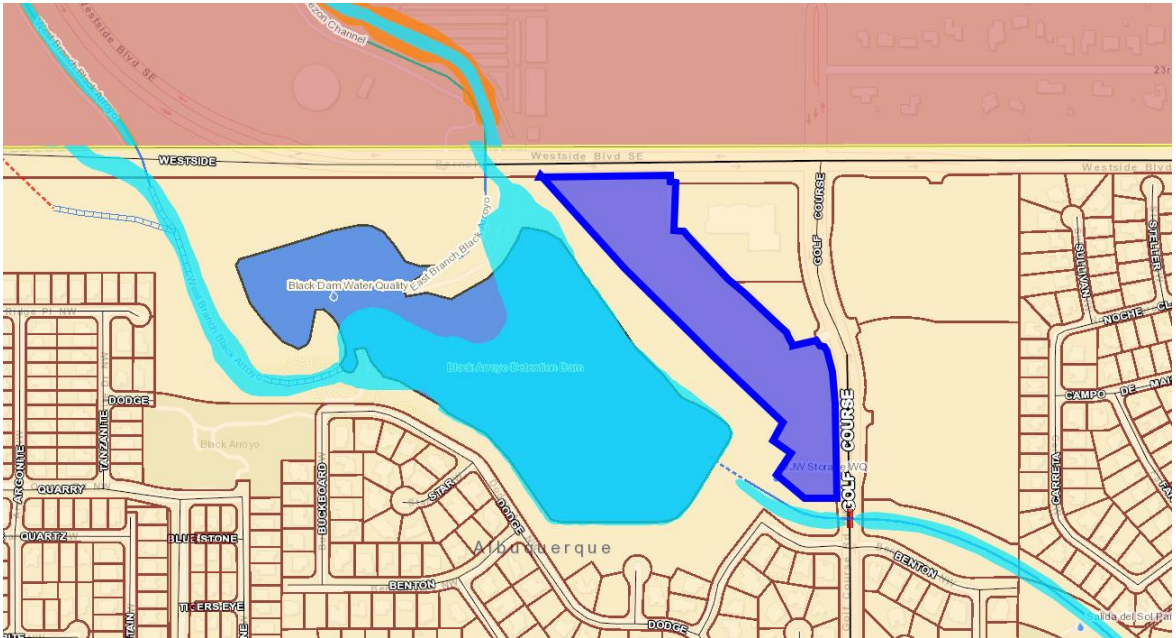
AMAFCA Map

1. Arroyos: The property is currently vacant, and no natural arroyos exist on the land. The subject site is depicted in dark blue on the map below. Using data provided by AMAFCAS Interactive Mapping service, the Black Arroyo Detention Dam is to the southwest of the subject site depicted in light blue and labeled on the map below. The Cabezón Channel and the West Branch Arroyo drain into the detention dam from the northwest. The Black Arroyo Channel runs along the southeast of the site also depicted in light blue on the map below.

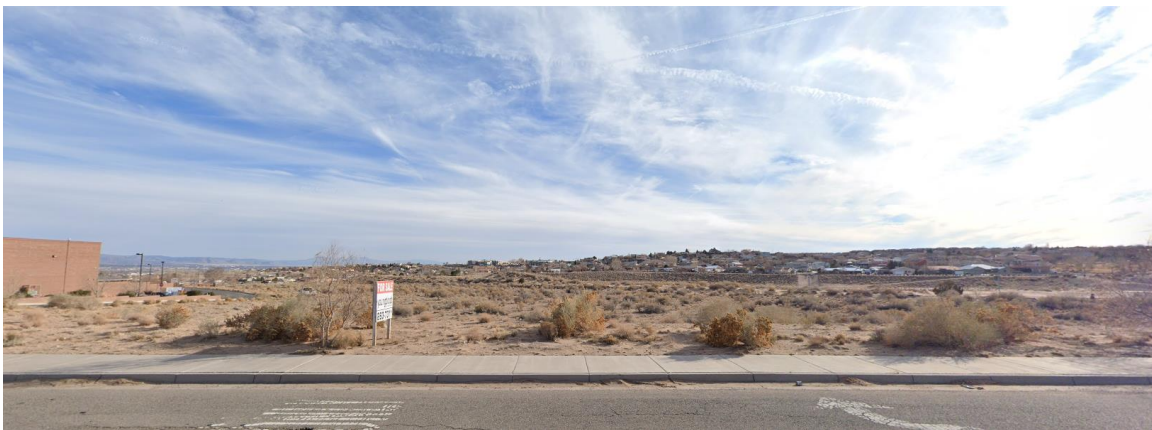
- Irrigation facilities (acequias): Data provided by the Middle Rio Grande Conservancy District (MRGCD) mapping shows the subject site is outside of the MRGCD jurisdiction and does not appear on any of their maps. Based on this research and due to the subject site's location and distance from the Rio Grande, there are no acequias or irrigation facilities on or near the site.
- Large stands of mature trees: The subject site is currently vacant with small shrubs and vegetation. There are no mature trees on the subject site. The images below shows the subject site and lack of any significant vegetation.

Site facing south from Westside Blvd.

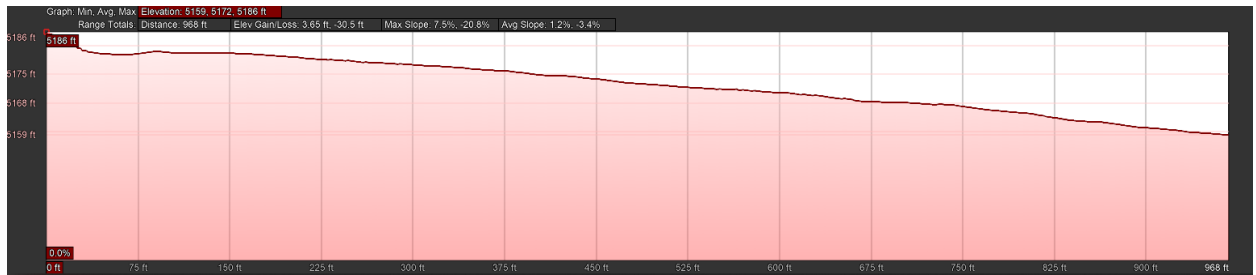
North South Slope & Elevation Profile (Max slope 7.5%)

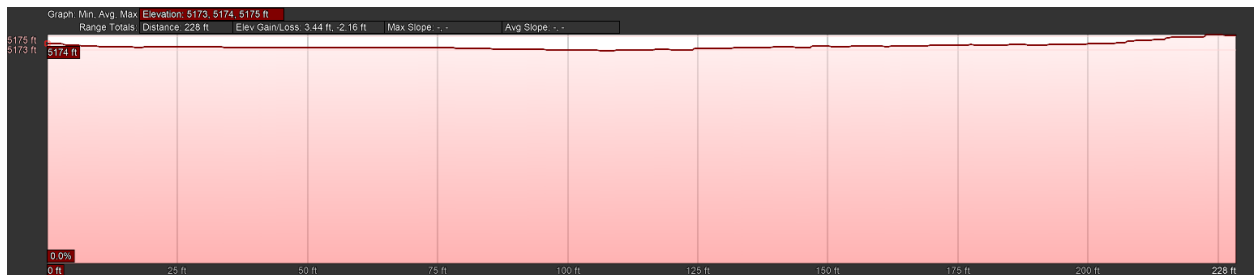
East West Slope & Elevation Profile

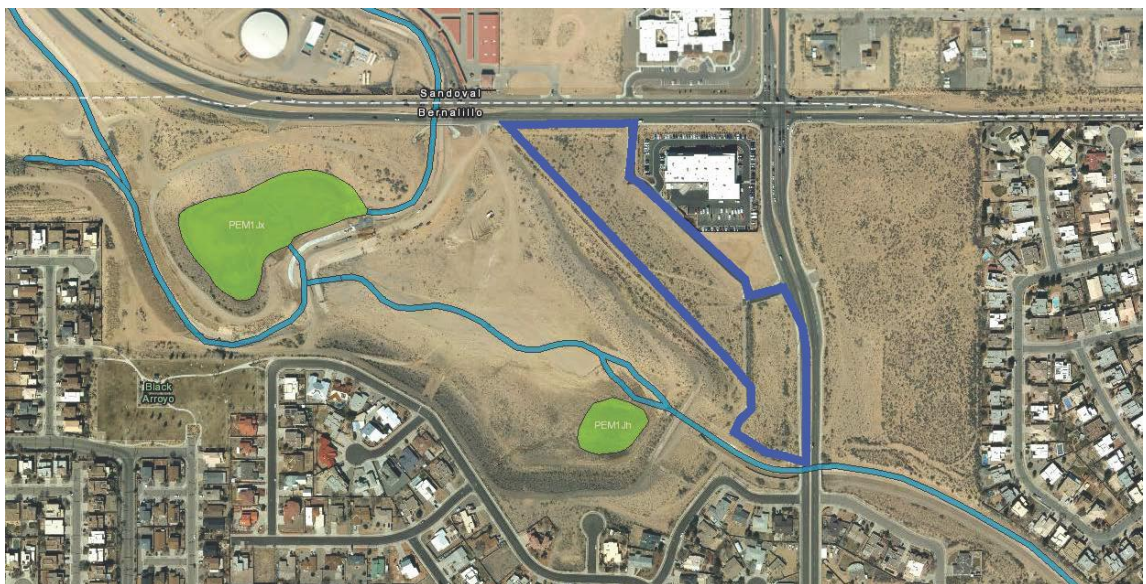
9. Wetlands: Data provided by the National Wetlands Inventory surface water and wetlands mapping shows the subject site which is outlined in blue in the image below is not considered a wetland area. The Black Arroyo Detention Dam area has two emergent wetlands which are depicted in the image below. These will not be adversely affected by the proposed development of the subject site.
