# Memorandum

**Date:** September 15, 2022

**Re:** Sensitive Lands Analysis for Meridian

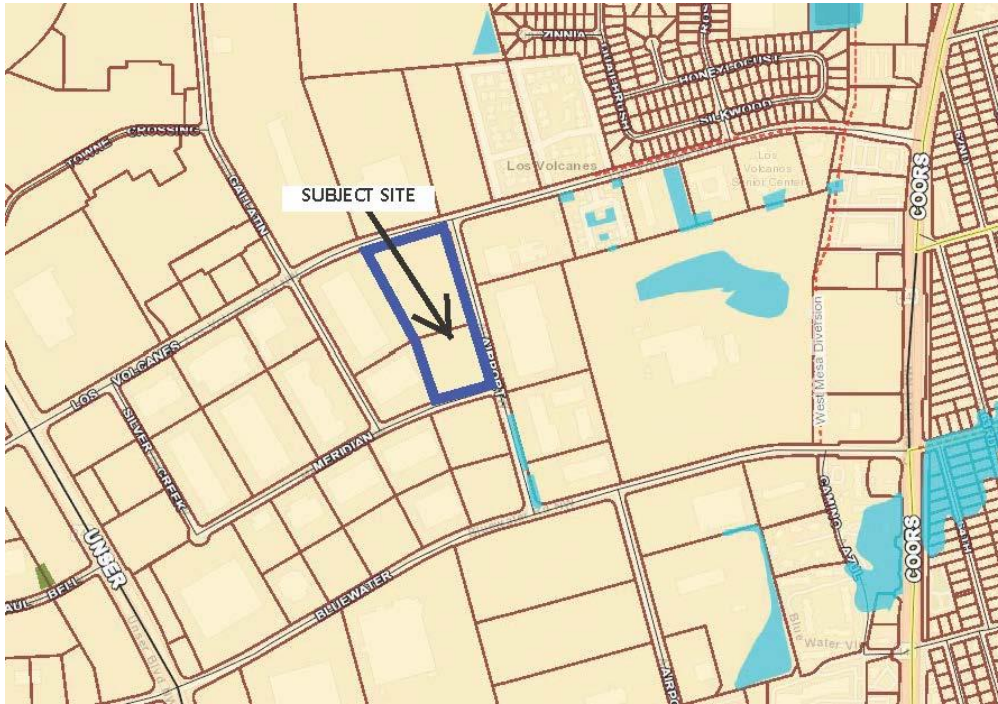
1. Arroyos: No natural arroyos exist on the subject site. Using data provided by AMAFCAS Interactive Mapping service, there are no manmade arroyos that run through the subject site. The closest arroyo is the West Mesa Diversion Channel to the east of the site depicted in a red dotted line on the map below and is operated by the City of Albuquerque. There is a planned

linear hard channel drain depicted in light yellow on the map below that runs along Coors Boulevard.

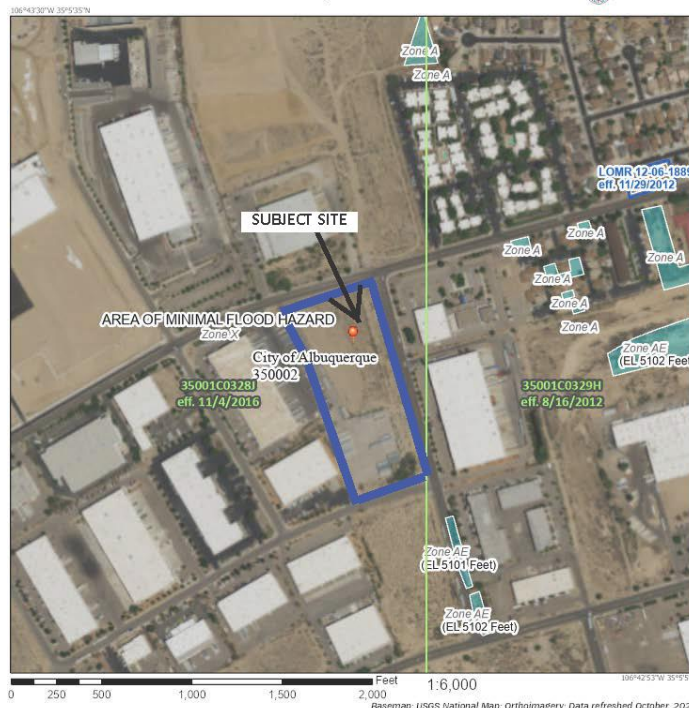
### National Flood Hazard Layer FIRMette

2. Floodplains and Special Flood Hazard Areas: Using data provided by FEMA's National Flood Hazard Layer (NFHL) mapping the subject site is considered a flood zone X. Flood zone X when it is unshaded as it is in the map below is determined to be outside of the 500-year flood and protected from the 100-year flood making it an area of the lowest risk of flooding.

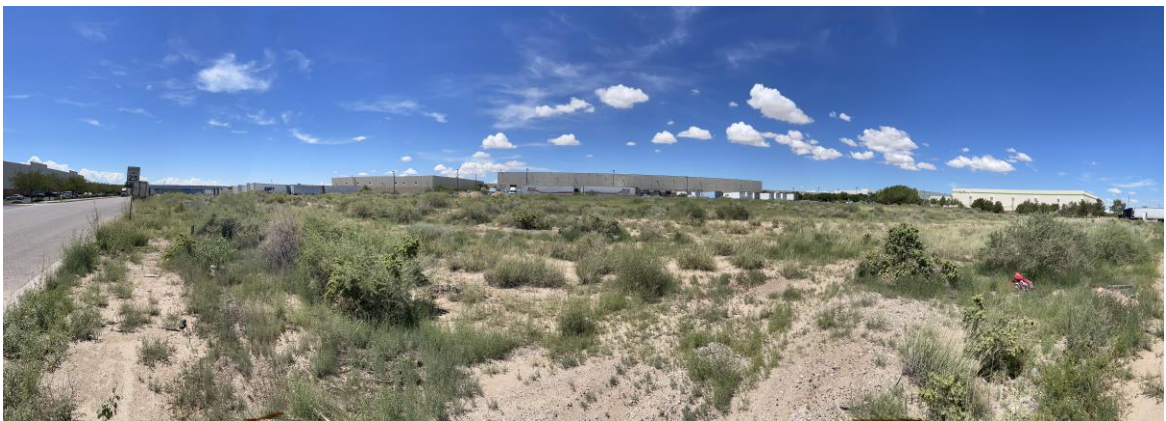
*Subject Site Vegetation*

- Large stands of mature trees: The subject site is a partially vacant dirt lot with the lower southern portion being used for tractor-trailer parking. There are no mature trees on the subject site. The image below depicts the small to medium-sized shrubs and vegetation on the subject site.
