TO: City of Albuquerque Planning Department
FROM: Yolanda Padilla Moyer, PE
DATE: October 20, 2025

SUBJECT: Sensitive Lands Analysis - Artiste Subdivision

Purpose of Site Plan and/or Plat:

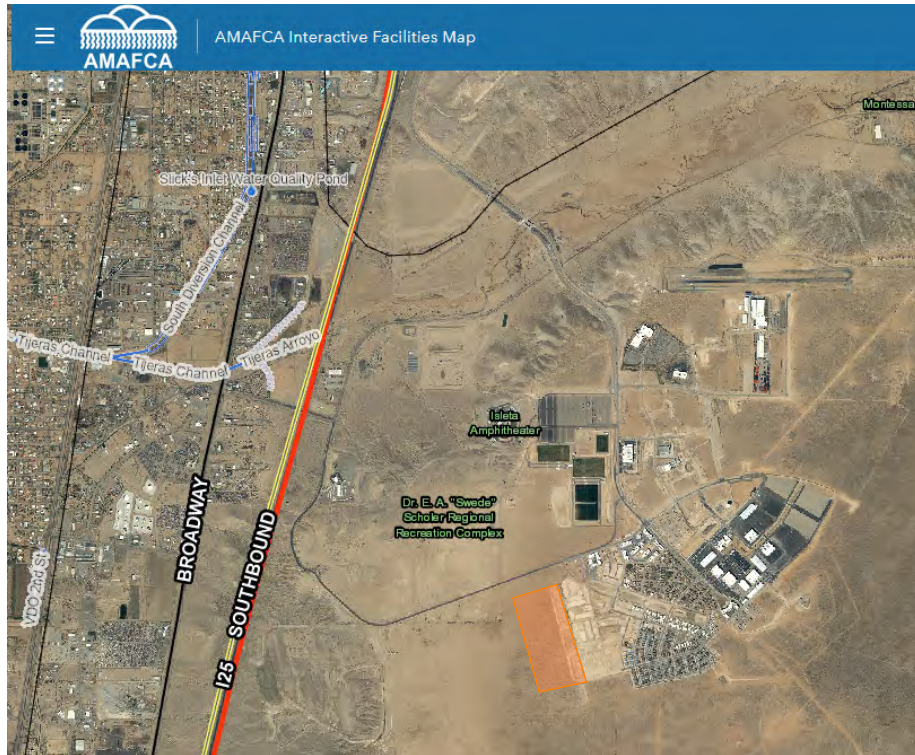
Using data provided by the AMAFCA Interactive Facilities Map, you can see to the right, that the approximate location of the subject site (notated by the orange box) does not have any arroyos or drainage facilities on or around the site.

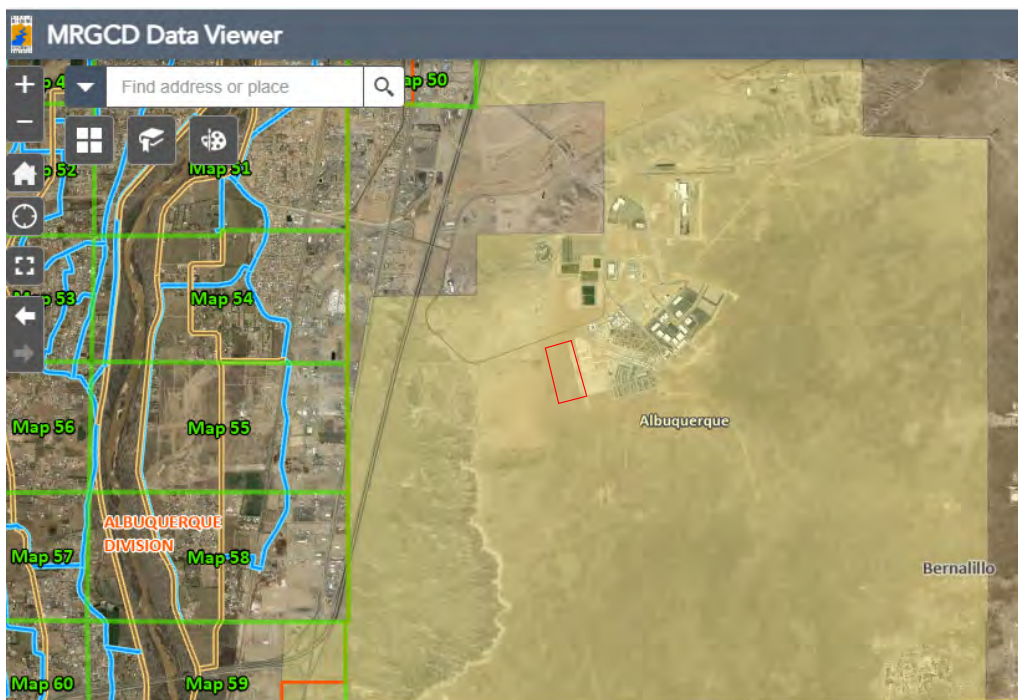
There are no irrigation facilities or Acequias on or near the subject site (approximately notated via the red box). The data provided by the MRGCD Data Viewer confirms that the subject property is outside the MRGCD's jurisdiction.

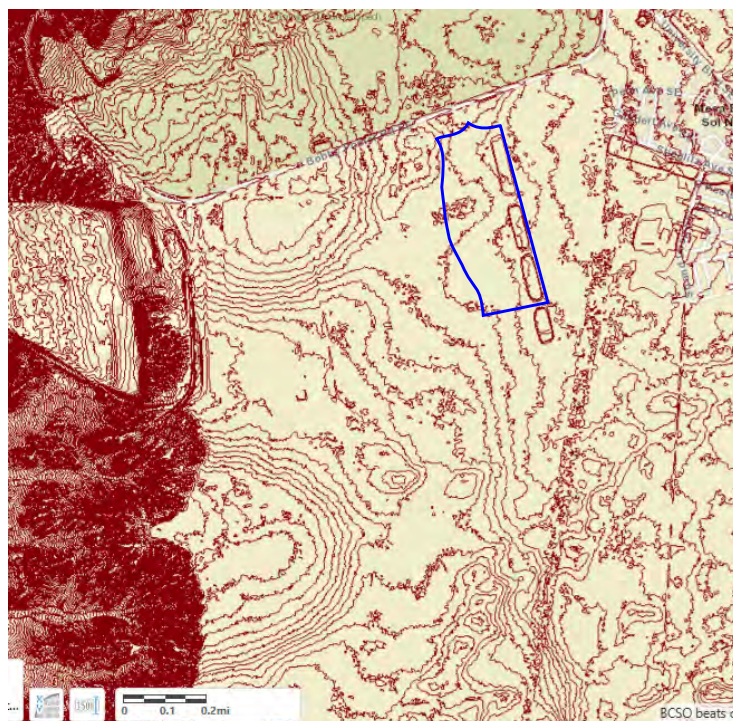
Rock Outcroppings are defined by the IDO (effective April 2025) as 'Bedrock or other stratum a minimum of 4 feet high on its steepest side as measured from the adjacent 10 percent slope line and in excess of 300 square feet in surface area' and analyzing the 2-foot contours, as seen below (provided by the Advanced map Viewer 2.0), it is apparent that there are no rock outcroppings to the magnitude of 4-feet high.

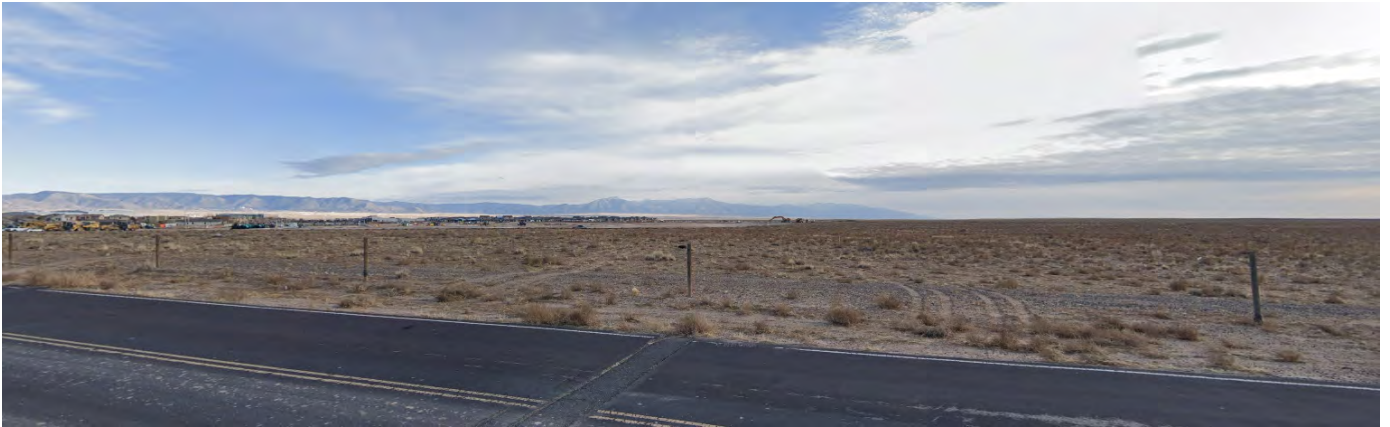
The image below, captured in January 2025, is from Google Maps street view and shows that the site does not have any large stands of mature trees.

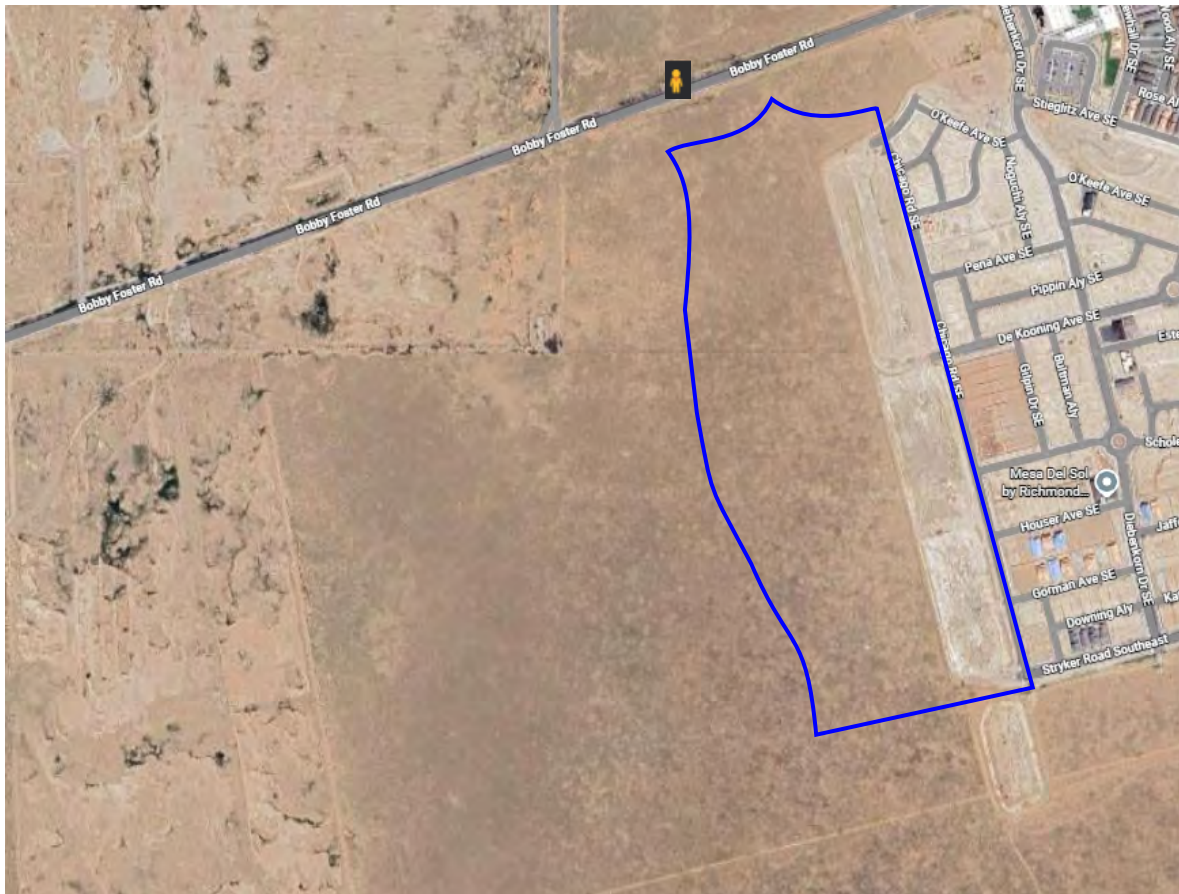
The street view was captured approximately where the little yellow man is notated on the picture below with the site approximately notated in blue.
