SENSITIVE LANDS ANALYSIS

IDO Section 14-16-5-2

Preliminary Plat – Paseo del Norte and Kimmick Drive NW

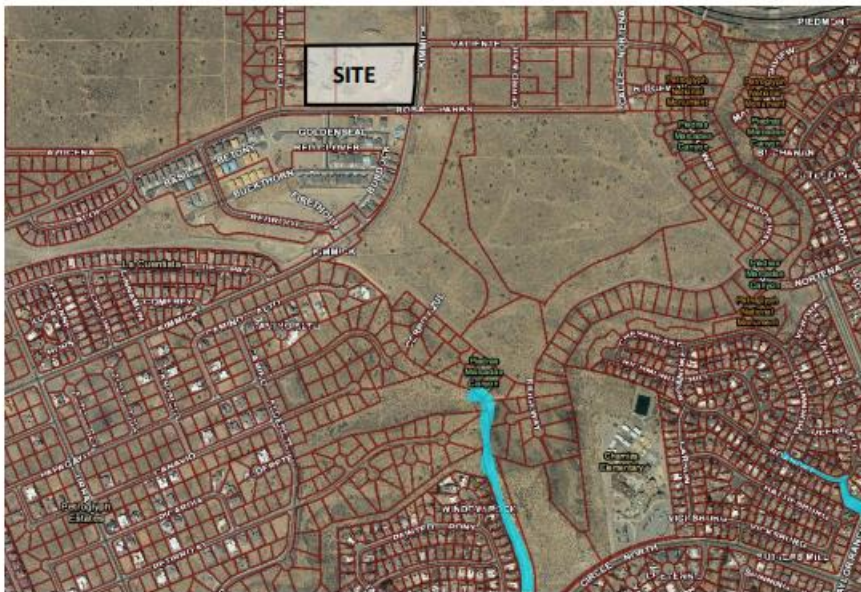
Based on the **AMAFCA Interactive Facilities Map**, the nearest arroyo/floodplain feature is the **North Branch Piedras Marcadas Channel**. The **North Fork of the Boca Negra Arroyo** lies farther south of the site. **No identified arroyo or floodplain feature is located within the subject property boundaries.**

Figure 1: AMAFCA Facilities Map of Site and Vicinity.
