PROJECT: PASEO EAST SIDE LOTS / VOLCANO CLIFFS UNIT 26 (T/MPOS)

RE: PR-2025-020092 | MAJOR_PLT-2025-00016 – MAJOR PRELIMINARY PLAT | SENSITIVE LANDS ANALYSIS SUPPLEMENTAL

3) Natural “sensitive lands / steep slope” assertions are not supported as an intact natural landform: historic imagery documents repeated disturbance

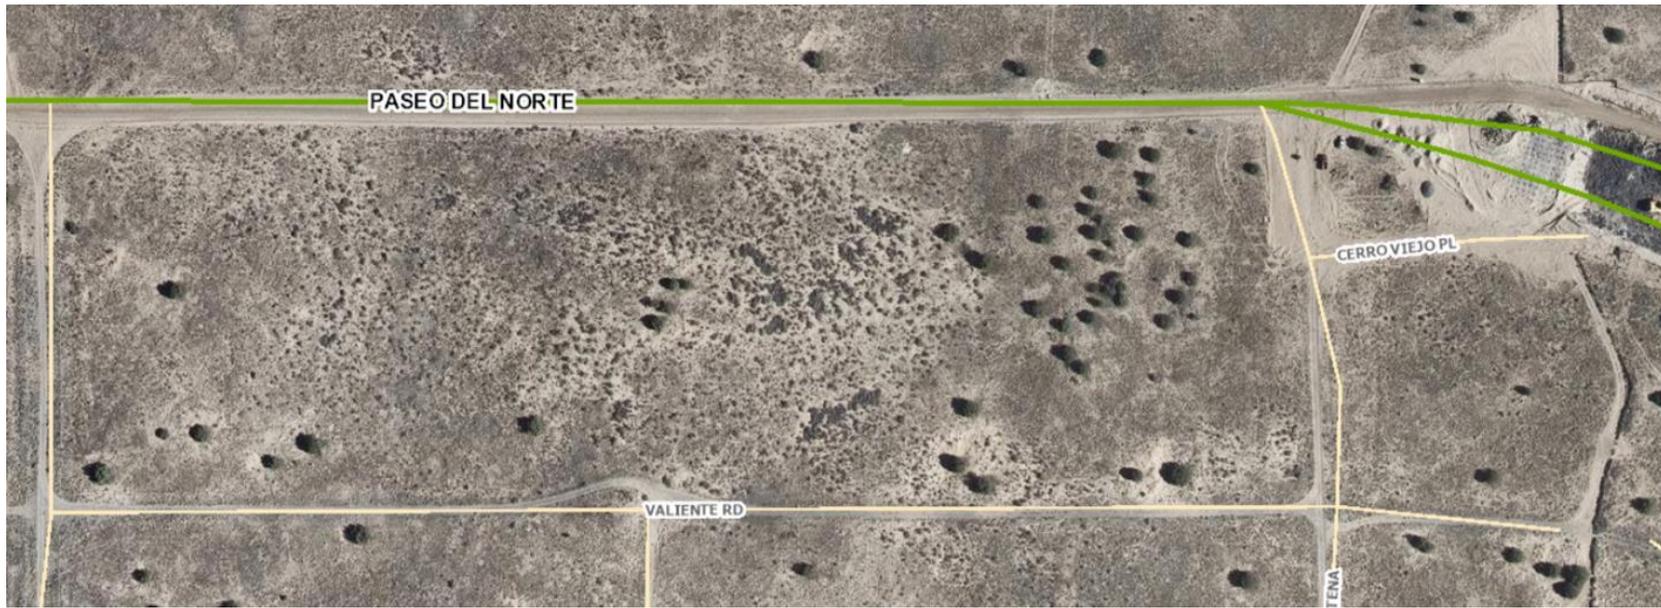
Exhibit A- 2006 – Site Undisturbed / Baseline Condition

- **Exhibit A – 2006:** Site largely undisturbed / baseline condition.
- **Exhibit B – 2008:** Paseo extension timeframe; disturbance visible, including impacts in the northeast portion and adjoining corridor areas.
- **Exhibit C – 2012–2014:** Substantial grading activity along perimeter street corridors.
- **Exhibit D – 2014–2016:** Broad grubbing/vegetation removal across the site; clear evidence of disturbance and clearing.
- **Exhibit E – 2016–2018:** Continued grading activity, including visible earthwork patterns in the northeast and southeast portions.
- **Exhibit F – 2018–2020:** Period of limited disturbance; vegetation re-establishes across portions of the site.
- **Exhibit G – 2021–2023:** Renewed grading/grubbing activity.

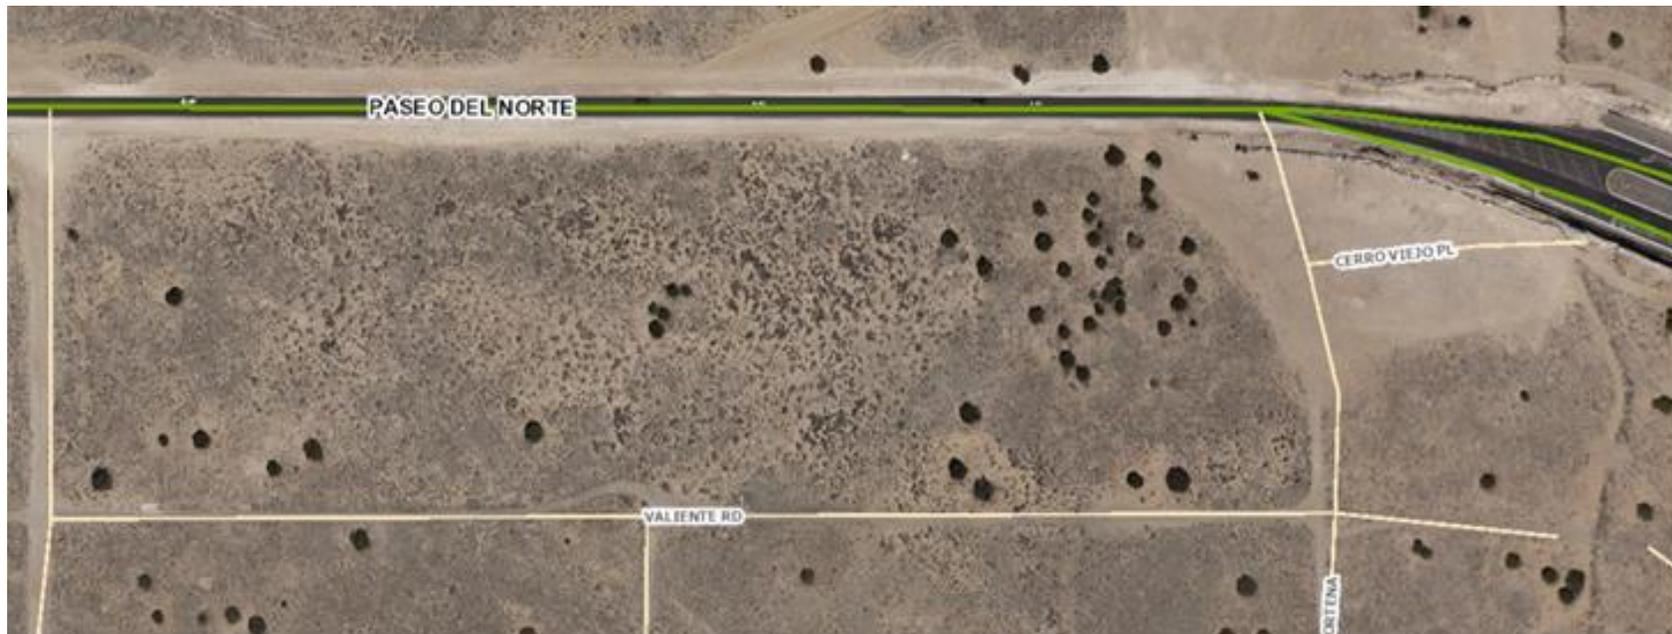
Exhibit B- 2006-2008 –: Saw Disturbance in the Corners of the Site

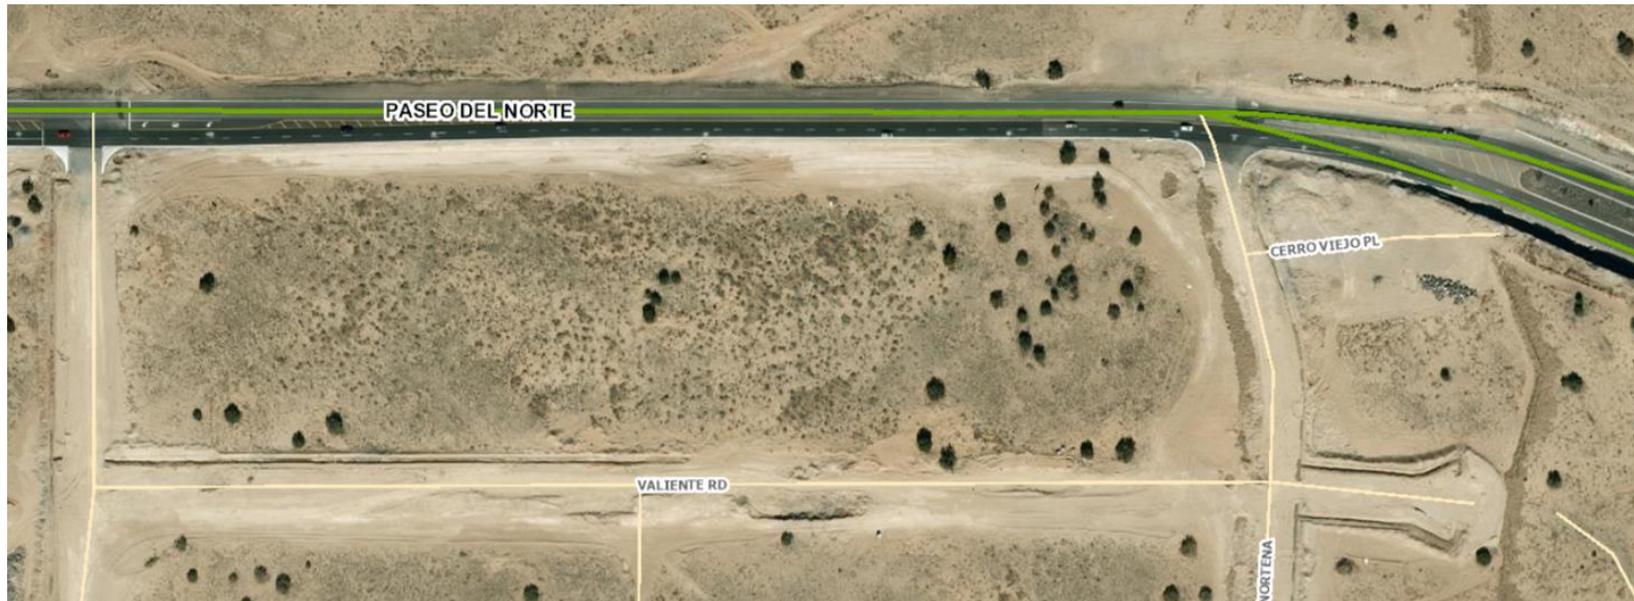
Exhibit C - Exhibit C – 2012–2014: Substantial grading activity along perimeter street corridors.

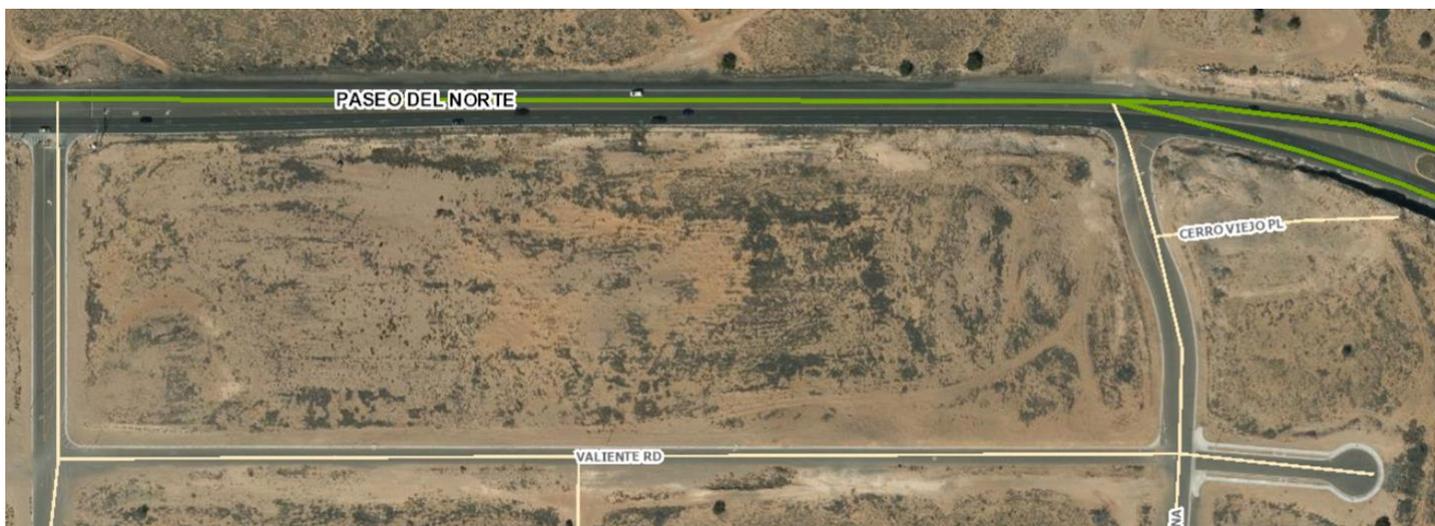
Exhibit D – 2014–2016: Broad grubbing/vegetation removal across the site; clear evidence of disturbance.

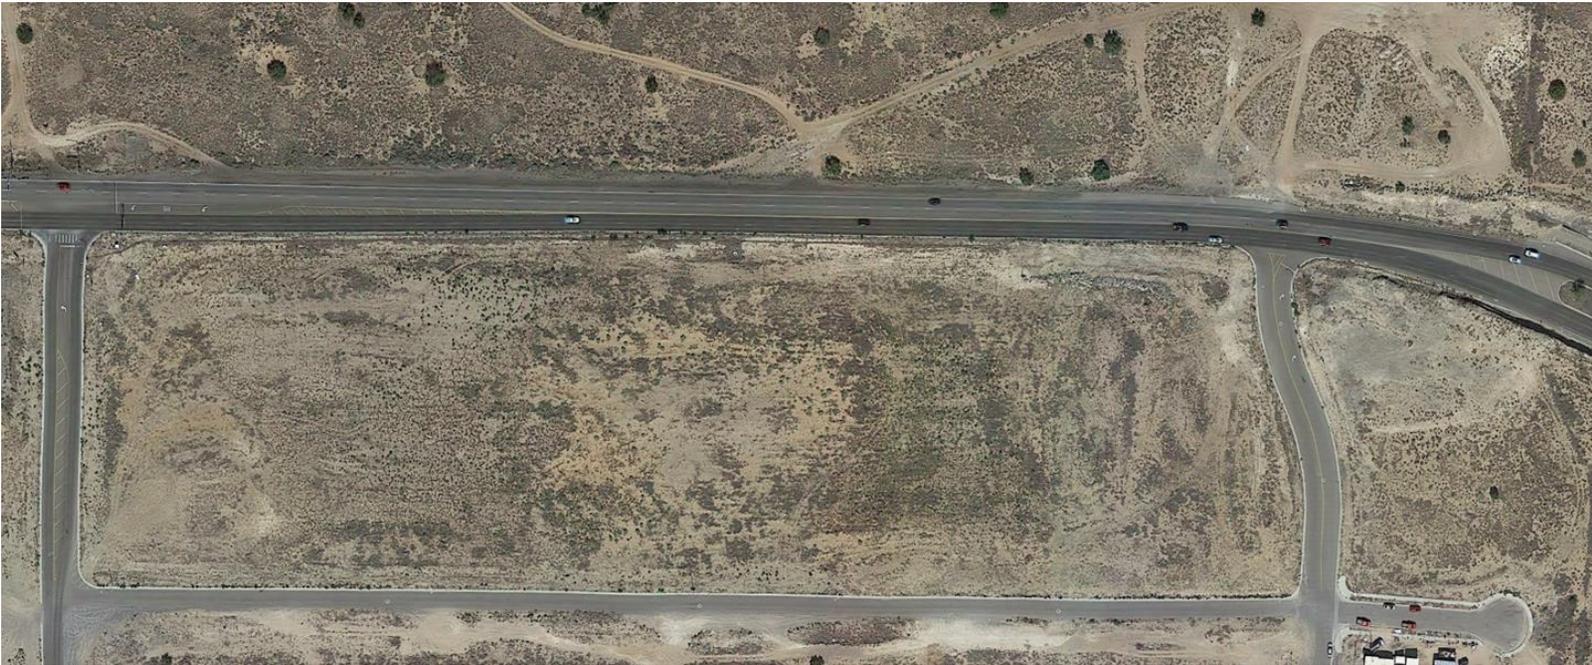
Exhibit E – 2016–2018: Continued grading activity, including visible earthwork patterns in the northeast and southeast portions

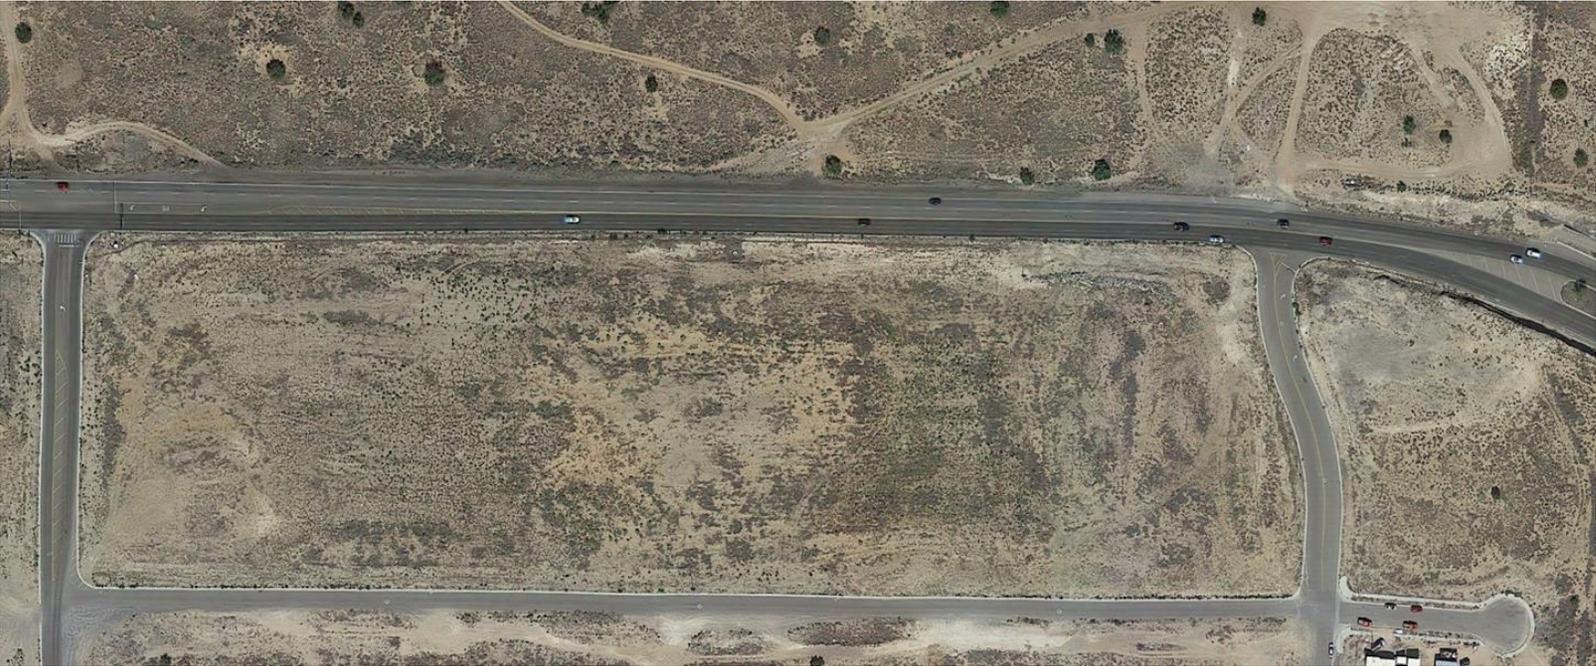
Exhibit F – 2018–2020: Period of limited disturbance; vegetation re-establishes across portions of the site.

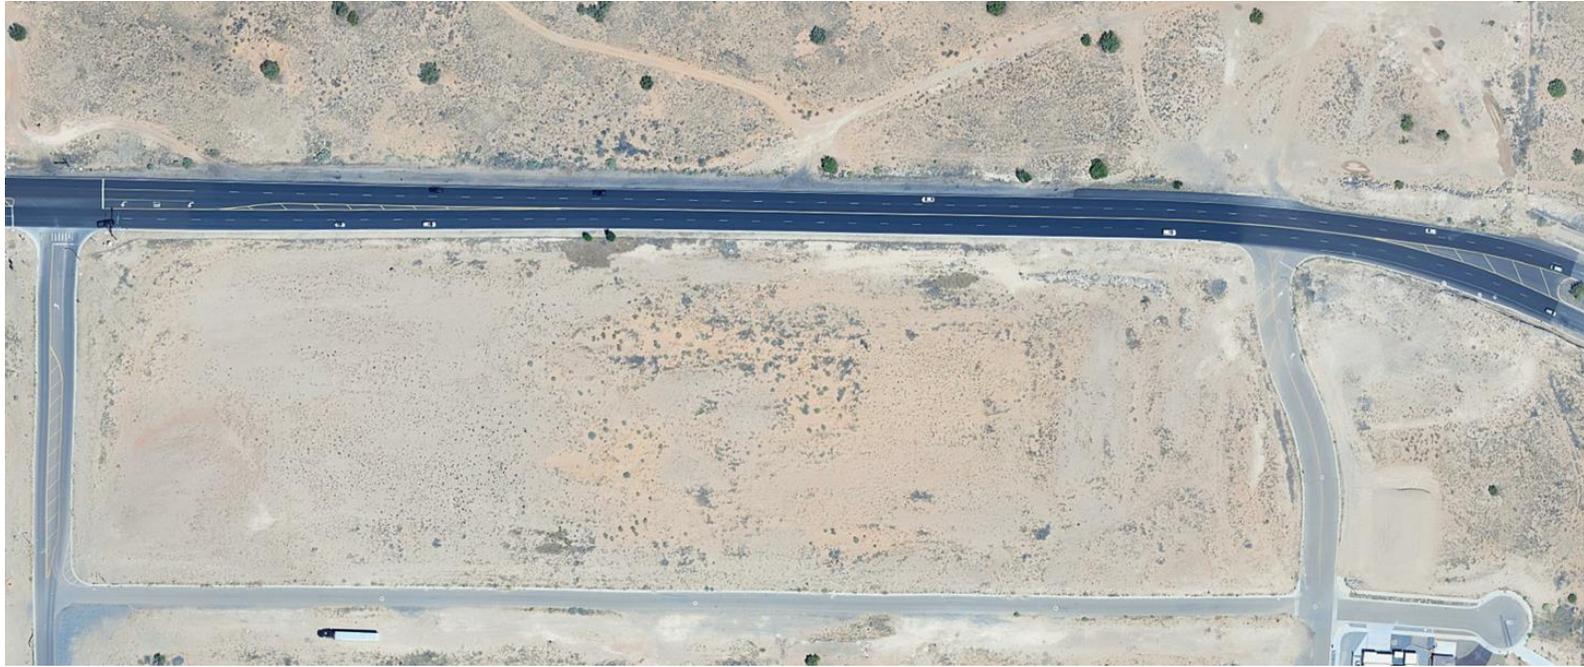
Exhibit G – 2021–2023: Renewed grading/grubbing activity.
