Site: Eagle Ranch MVD

The following violations were observed at yesterday's inspection.

## **Re:** Drainage Ordinance (14-5-2-1) Violations for Erosion and Sediment Control and Trash

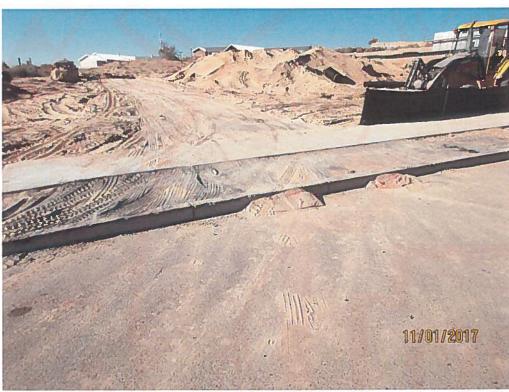
No track-out pad. Sediment in access road.

1. Install a stabilized construction entrance (track-out pad) per the approved Erosion and Sediment Control plan.

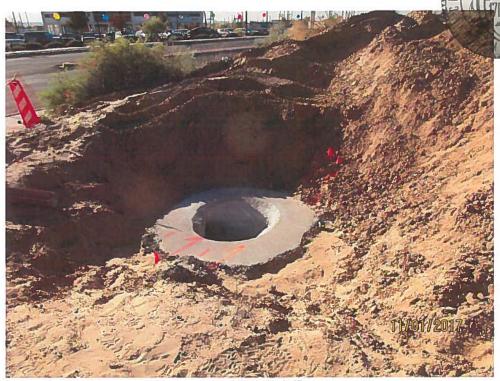
Opening into storm drain system with no BMP.

2. Provide a sediment BMP or cover the opening into the storm drain system.

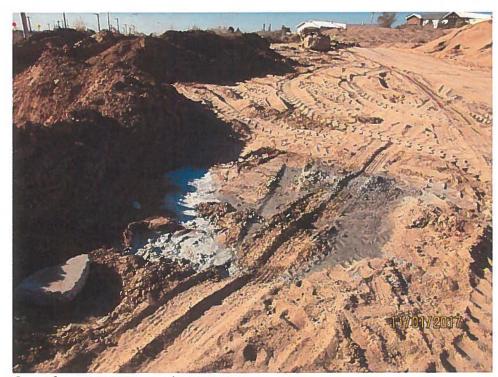
One of two concrete wash-outs.

- 3. Remove all instances of concrete wash-out and bring-in or install an acceptable wash-out facility was not observed onsite.
- 4. Provide a sediment BMP or stabilize the disturbed area in the northwest corner of the site.
- 5. Provide a sediment BMP at the asphalt interface.

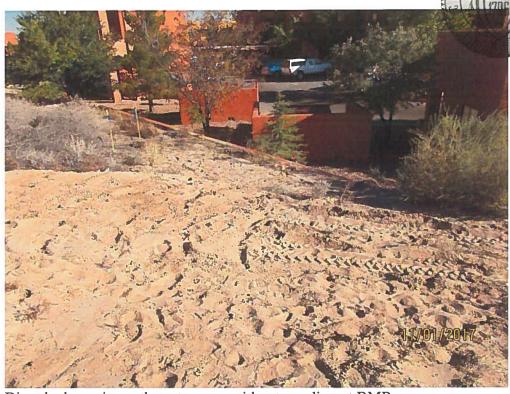
Disturbed area in northwest corner without a sediment BMP.

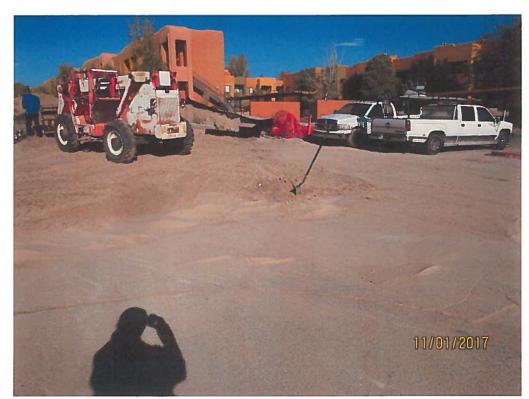
No sediment BMP at asphalt interface.

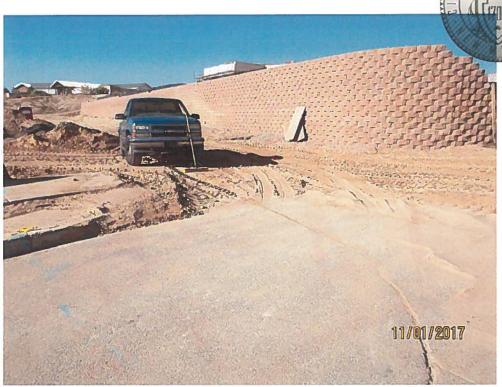
No sediment BMP at asphalt interface.

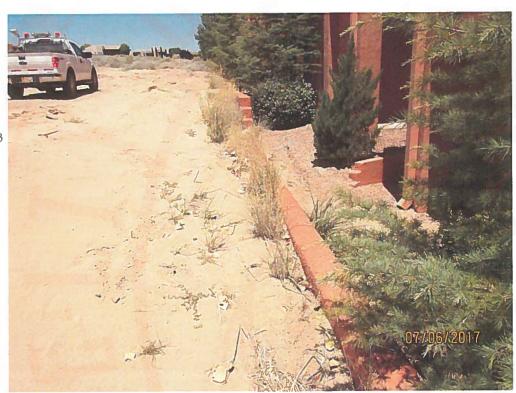
No BMP along northern edge of the site.

1. Install a sediment BMP to prevent sediment from leaving the site along the northern edge of the site as shown on the approved ESC plan.

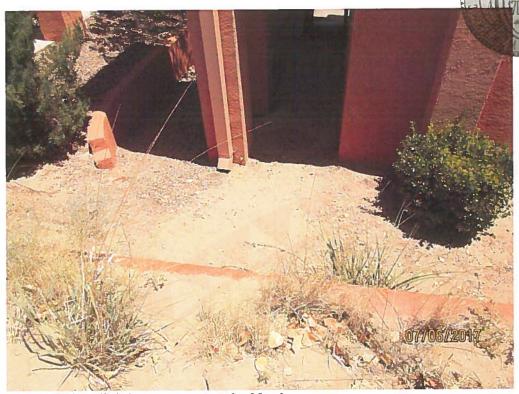
Sediment in adjoining property to the North.

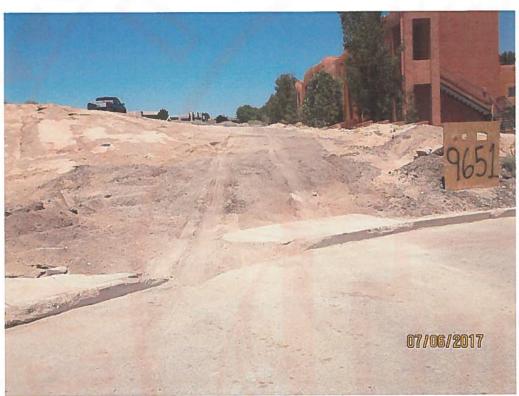
No track-out pad. Also, long and steep area with no sediment BMP.

3. Install a track-out pad/stabilized construction entrance per the detail on the approved ESC plan.

4. The approved plan shows the track-out pad on the south side of the cul-de-sac. This was intentional as there is a long and steep slope up to the Phase 1 building site. If you choose to build the track-out pad on the west side of the cul-de-sac (uphill), then a swale or berm should be built to direct flows away from the track-out pad.

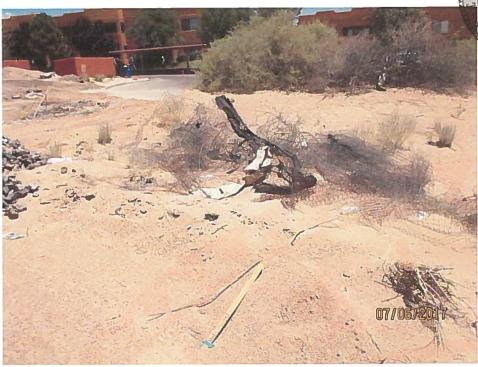
Trash

2. Install a trash receptacle and place trash in it.
