CITY OF ALBUQUERQUE

Sites: 1) Take 5 Car Wash on Lot 2C at 10084 Coors NW - B14E010C - NMR1005E5, including 2) Construction support activities at Lot 5 of Cottonwood Crossing Phase 2 and 3) Tract 13-A of Black Ranch at 10112 Coors Blvd. NW – B14E013

Re: Investigation of History of Violations for Erosion and Sediment Control within the "Common Plan of Development or Sale" at Black Ranch Tracts 13 & 14

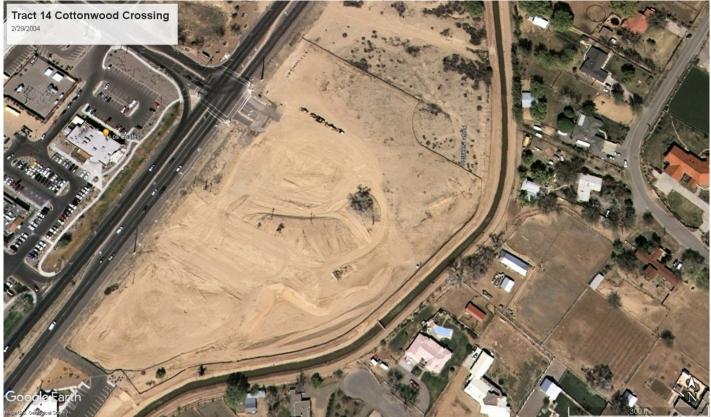
• **"Tract 14 Cottonwood Crossing",** is a 9.769-acre Site Plan for Building Permit signed on 2/10/2004. Earthwork began in 2004 (See Google Earth photo next page).

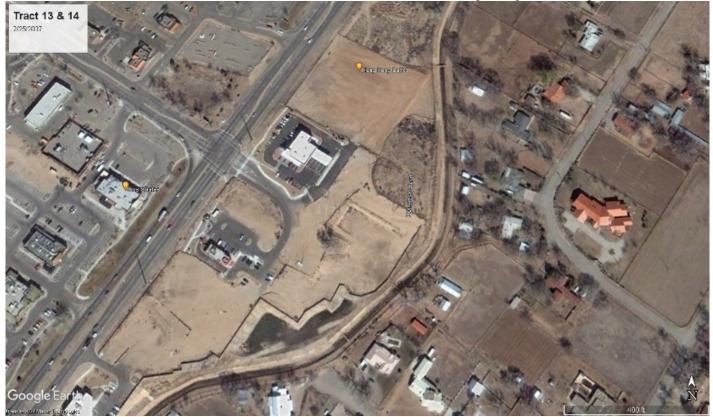
Popeye's, Nusenda, and the AMAFCA Pond had been developed by 2007, leaving lots 2, 4, and 5 disturbed (see photo below).

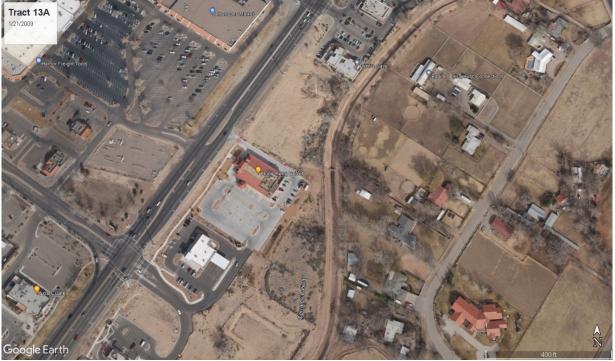
and was completed in 2009 (below), leaving 2 acres on Lot 13-A bare dirt.

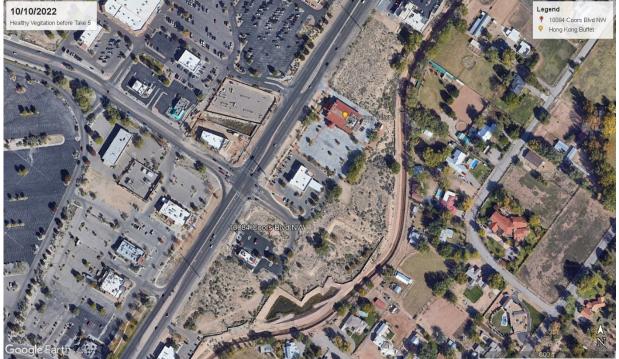
• Technically, these are two separate plans, but they are contiguous and have an overlapping history of construction activities from 2004 to 2009. A 0.96-acre archaeological site straddles the line between 13 and 14 and has been preserved and dedicated to the City of Albuquerque. On the remaining Lots 2, 4, 5, and 13-A, a healthy stand of vegetation grew during 13 years of inactivity, from 2009 to 2022 (below).

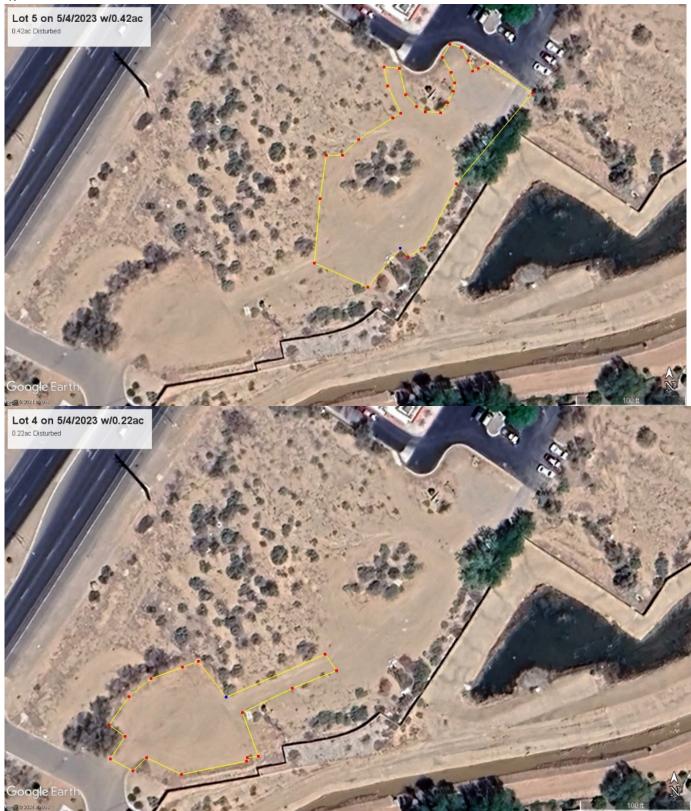
• Take 5 Car Wash construction began in 2023. The Google Earth aerial photo taken on 5/4/2023 (below) shows a 0.5-acre disturbance on Lot 2-C, 0.4-acre disturbance on Lot 5, and 0.2-acre disturbance on Lot 4.

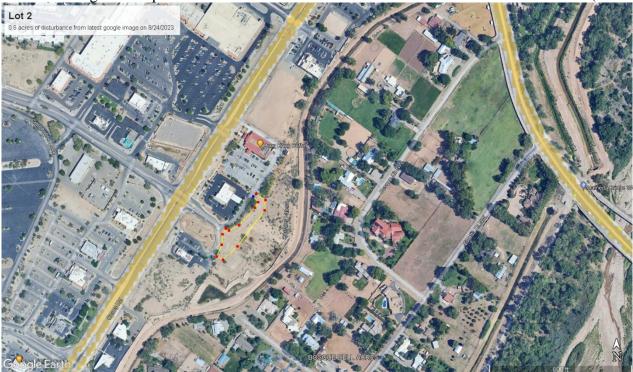
Mayor Timothy M. Keller Then the Google Earth photo on 8/24/2023 shows a 0.6-acre disturbance on lots 2A and 2B (below) and

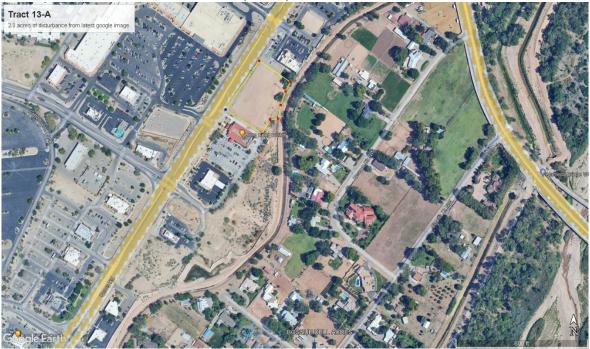
a 2.0-acre disturbance on Tract 13-A (below).

Within 6 months of the commencement of construction activities, 3.2 acres of offsite land was disturbed around the Take 5 Car Wash. Whether taken together or separately, Tracts 13 and 14 seem to fit the broad interpretation of the "Common Plan of Development or Sale."

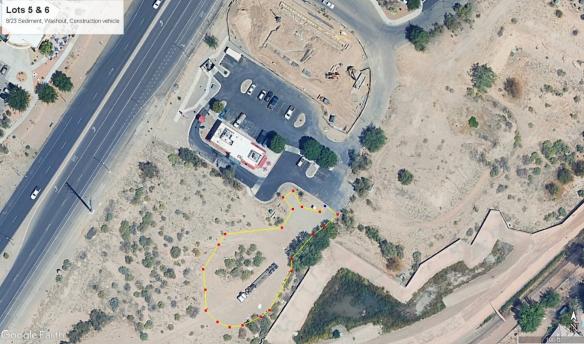
• The 8/24/23 photo (below) also shows construction support activities (Washout and construction vehicles) on Lot 5 and sediment in the parking lot on the low side of the Take 5 construction on Lot 2-C.

- The disturbed area on Lot 4 had been stabilized with gravel since the most recent Google Earth photo, and access to Lots 2-A and 2-B had been prevented with a security fence. However, the city inspection on 6/17/24 documented ongoing construction support activities on Lot 5, including concrete washout, construction vehicles, a waste container, and porta-potties. As of the date of this investigation the area of "Construction Support Activities" on Lot 5 had not been stabilized so Notice of Violation #5 (NOV#5) is being sent separately to Take 5 and the owner of Lot 5. The activities on Tract 13-A haven't been linked to the Take 5 Car Wash by any of the photos, so the timing of that land-disturbing activity may be a coincidence. A separate Notice of Violation will be sent to the owner of Lot 13-A.
