March 6th, 2018

Site: Glendesto

Re: Drainage Ordinance (14-5-2-1) Violations for Erosion and Sediment Control and Construction Site Waste(s)

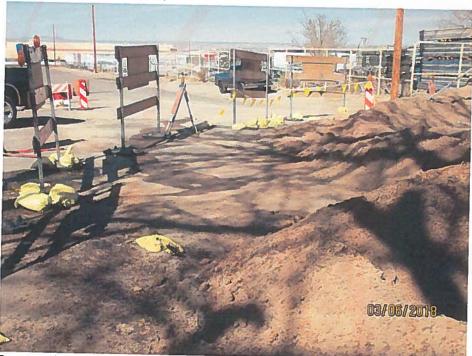
Intersection of San Pedro and Glendale.

- 1. Provide sediment BMPs for the work shown on the Work Order construction plans. These include filter socks at Modesto and San Pedro, inlet protection and sweeping. See approved Erosion and Sediment Control Plan.

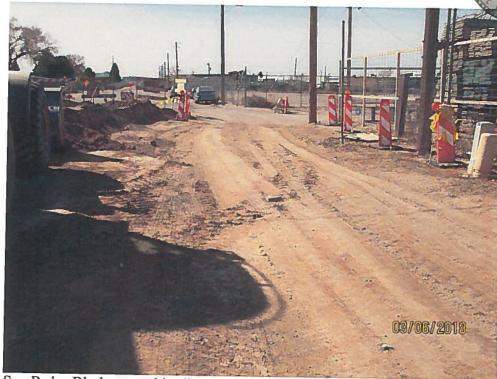
San Pedro Blvd covered in dirt. No BMPs

- 2. Remove sediment from San Pedro Blvd and Modesto Ave west of San Pedro.
- 3. Sediment is not to be observed in Modesto Ave west of San Pedro and on the south-bound lane of San Pedro.

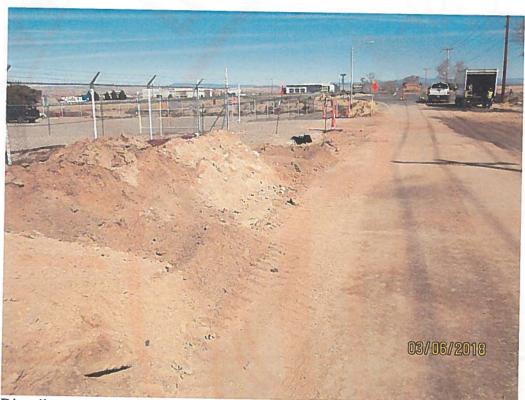
Dirt pile on shoulder of San Pedro, No BMPs. Drains to unprotected inlet.

- 6. Remove concrete wash-out in the street.
- 7. Provide an acceptable wash-out facility on-site and have workers use it.
- 8. Proved a sediment BMP for the dirt pile in easement street or remove it. Do not stockpile dirt in the street without a sediment BMP.

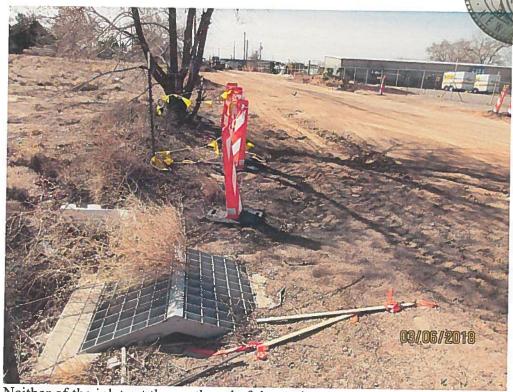
Neither of the inlets at the north end of the project had inlet protection.

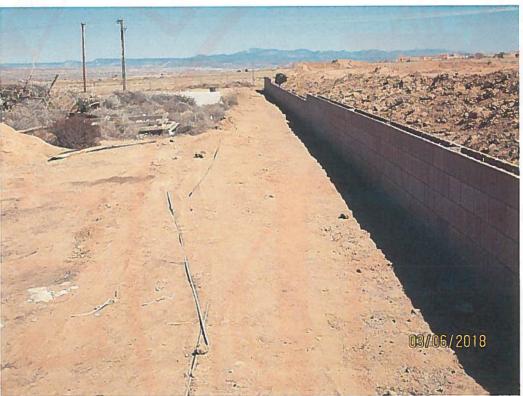
Disturbed area outside project boundaries with no sediment BMPs.

- 9. Provide sediment BMP(s) for the disturbed area west of the project.

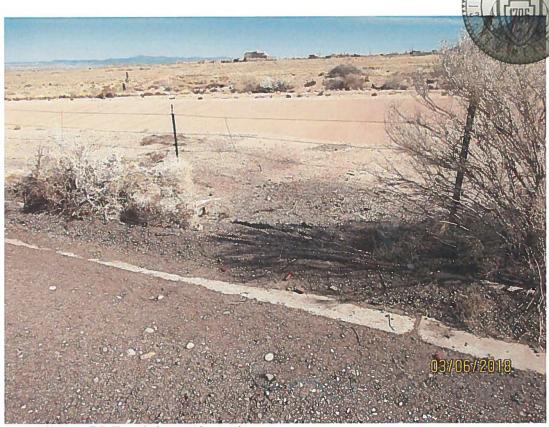
No sediment BMP at inlet to channel.

- 4. Provide inlet protection at the side inlet to the channel.
- 5. Remove sediment in gutter pan on easement street uphill from the side inlet to the channel and keep the gutter pan free of sediment.

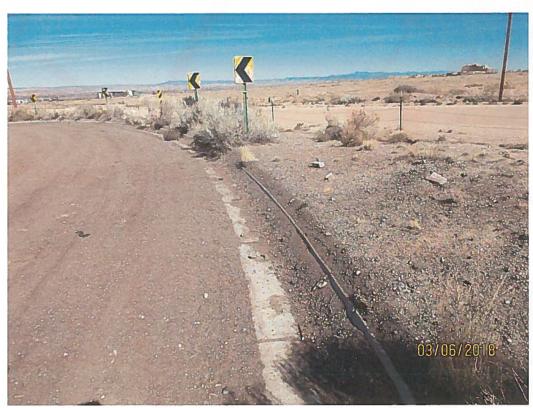
Sediment in gutter in the easement street.
