CITY OF ALBUQUERQUE

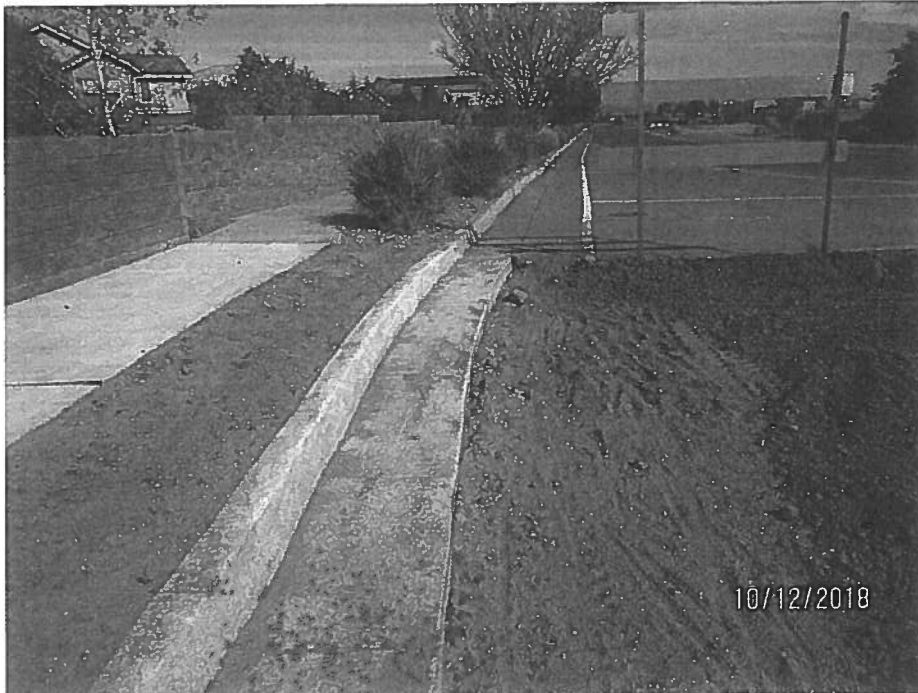
Wyoming Blvd North end-no sediment BMP.

1. Provide a posting per paragraph 1.5 of the NPDES CGP.
2. Provide a sediment BMP for the buffer area along Eagle Rock Ave.
3. ~~Remove sediment from the gutter in Eagle Rock Ave.~~
4. ~~Provide inlet protection.~~
5. Provide a sediment BMP or stabilize the area uphill from the channel with no sediment BMP.
6. Provide a sediment BMP for graded lots.
7. Provide a sediment BMPs for east and west gutters on site.
8. Remove the construction waste pile with litter near channel.
9. Provide a waste receptacle.
10. ~~Remove the concrete wash-out in Wyoming ROW.~~
11. ~~Provide a wash-out facility.~~
12. Provide a sediment BMP at gutter at the south and north ends of the Wyoming ROW and gap in sediment BMP at the south end of Wyoming Blvd.
